Tokelau

Building Control

25 August – 11 September 2019

This report has been prepared by Peter Burnet, Principal Technical Lead, with the assistance of Mark Fitzpatrick, Assessor Building Control Officer at Wellington City Council, after a visit to the atolls of Nukunonu and Atafu, Tokelau, from 25 August to 11 September 2019.

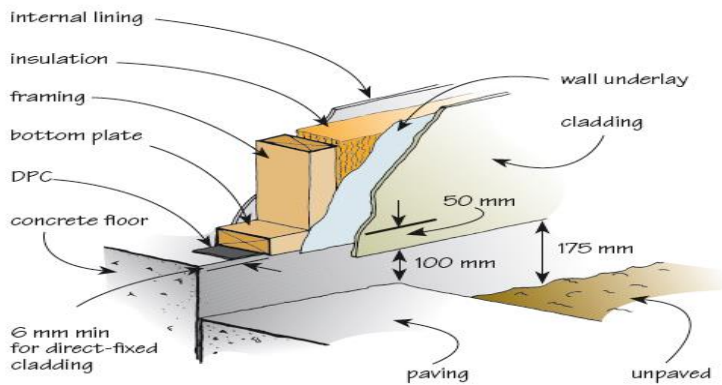
- Fibre cement cladding has been installed with no ground clearance. This has the potential for moisture to be drawn up into the cladding, which can lead to the cladding delaminating.
- Head flashing installations to the aluminium windows are incorrect and will not provide the intended protection against water ingress.

1. Head flashings should be installed, so that the face of flashing fits closely up against the face of aluminium window, as per the figure below.
2. Cladding systems should be installed to meet the requirements of the manufacturer, and this should be documented during the approval stage of the proposed work. As a general rule, cladding should have a minimum clearance of 100mm from a paved area or 175mm from unpaved areas – see figure below.
3. Sill blocks should be used in any future blockwork buildings as per Figure E3.15 Tokelau Home Building manual Vol 2.

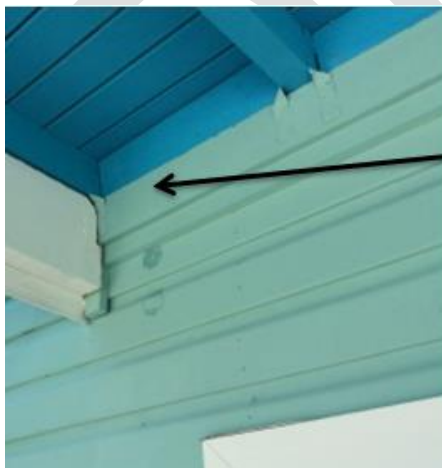
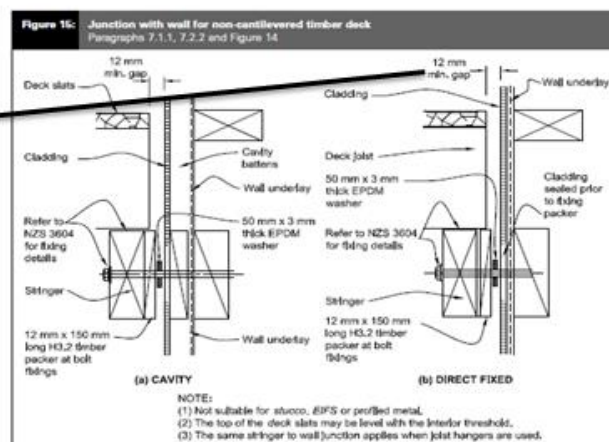
The upper level deck has been installed hard up to the cladding. This should have a drainage path (see below photo with detail from the New Zealand building code acceptable solution).

1. Install head flashing as per detail below, or at the very least, in place of a metal flashing, an exterior silicon sealant should be applied to the top the head facing, to provide extra protection. Ensure decks attached to building have a 12mm gap to allow water to drain.

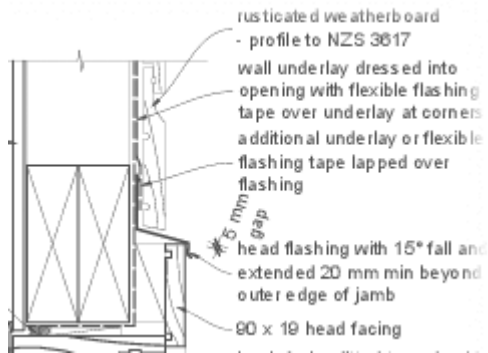
This building was still being completed but was up to a good standard of construction with design features that will provide protection from the weather. Head flashings had not been installed to the windows but this was mitigated by the installation of facings around the window, and the protection provided by the verandas.

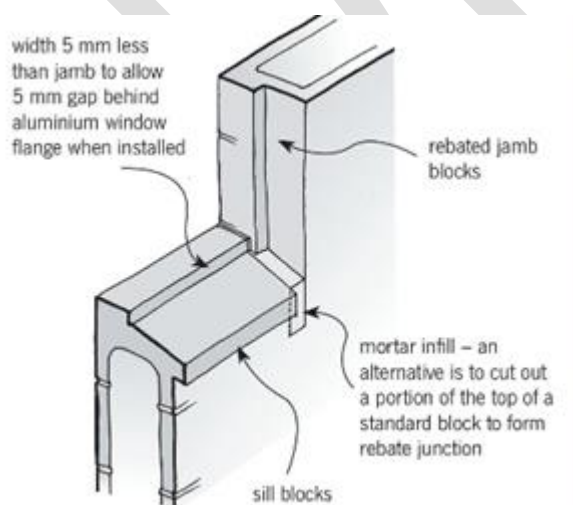
The school has a major weather-tightness issue that causes the building to flood during heavy rain, and has the potential risk of injury to staff and students, from slipping on the wet tiles.

Both of these issues are due to poor design, as there is no protection from the prevailing weather from the seaward facing side of the building, and poor construction methods.

1. Installing window facings and applying an external plaster system, to provide a waterproofing coating to the blockwork, should address/reduce the weather-tightness issue if applied correctly.
2. I would also recommend that the seaward facing side of the building have a veranda installed that mirrors the other side of the building, as this will help protect the cladding system being exposed to water penetration.

Sill blocks should be used in any further blockwork buildings.

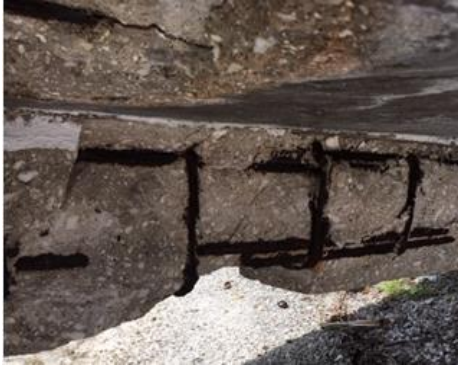
Structural failure of the bridge is likely, due to the supporting beams suffering from what is known as concrete cancer. Concrete cancer is caused when the steel reinforcing within a concrete slab begins to rust. As the steel rusts, it expands, displacing the concrete around it, causing it to become brittle and crack. The reason for this is generally due to the reinforcing steel being too close to the surface, or poor concrete that has allowed water to penetrate the surface and reach the reinforcing steel.

1. A full structural review is urgently undertaken by a structural engineer to provide a solution to remediate the bridge. In the interim, it is recommended that only light traffic use the bridge.

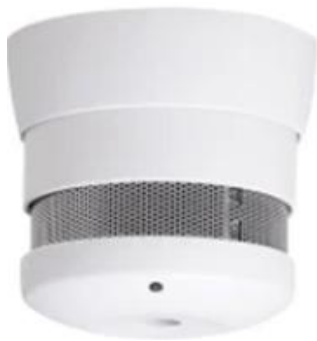
This building has been built to a good standard, although there are some issues with the standard of finishing that have led to the deterioration of some elements in the building. They should be fixed, as part of general repairs and maintenance of the building. There were no early warning systems to alert occupants to escape the building in the event of a fire.

1. Maintenance programme be put in place.
2. Long-life battery photoelectric smoke alarms should be installed in each of the units. These are reasonably priced and have been proven to save lives.

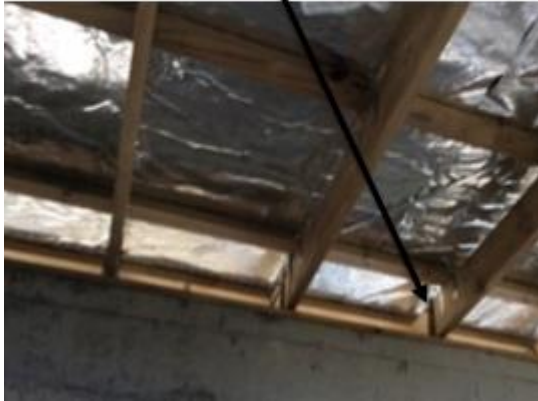
This building is being built to a good standard. This building also did not have stainless steel fixings, which would be advisable to use due to the high salt spray the building will be exposed to.

Recommend use of stainless steel fixings

1. Fixings should be specified as needing to be stainless steel for future builds.

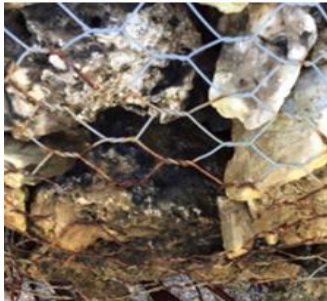
Sea walls have been constructed using mesh that is not durable and is starting to rust, which will lead to them failing.

1. Good quality stainless steel mesh is used in future if this type of wall is to be constructed.
