Reducing the risks of cyclone storm surge inundation on the atolls of Tokelau

Atafu

**NIWA Client Report: HAM2005-119
July 2005**

NIWA Project: UNS05201

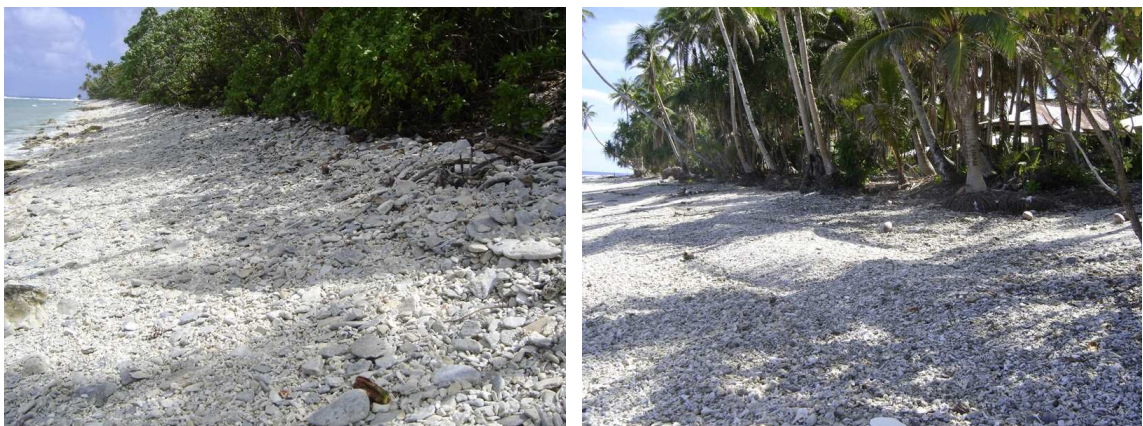
Figure 4: Storm ridge built up on the ocean side on the motu of Fenuafala (Fakaofu) where there is a healthy coral rubble beach with little overwashing occurring during cyclone Percy (left), and the beach along the village on Atafu (right) where much of the coral rubble has been removed (still ongoing) which will have significantly contributed to the cut back of the beach crest and overwashing that occurred during cyclone Percy (and previous cyclones).

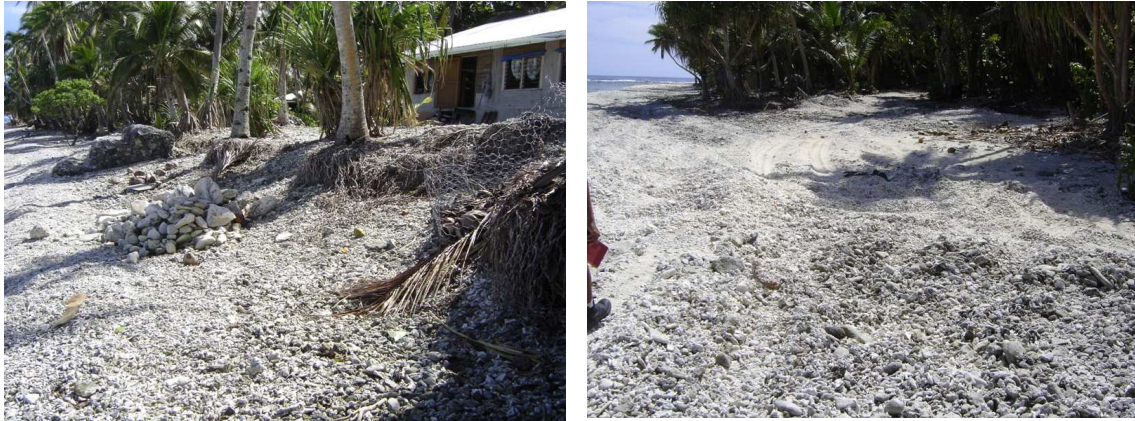
Cyclone Percy and previous cyclones along approximately 650 m of the ocean beach from the boat channel to opposite the northern end of the school.

Figure 6: The removal of sand or coral rubble from anywhere along the west coastline (up to and including the area in front of the pig pens) will impact on the natural supply of beach material to the south, substantially reducing the protection to the village provided by the beach. Small scale removal of larger coral rubble over many years from the ocean beach in front of the village appears to be a contributing factor to potentially increased overtopping and overwashing of the beach in this area.

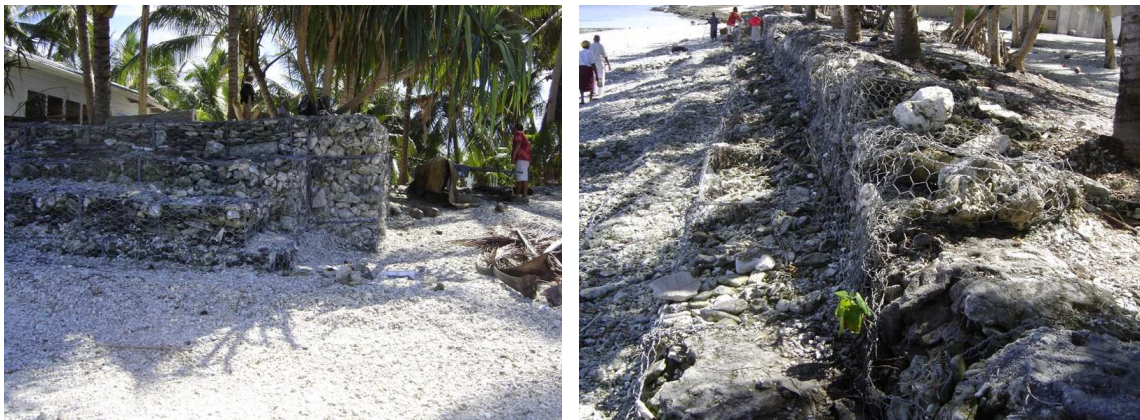
Approximately 130 m of gabions have been constructed to the south of the access point to the boat channel and about 200 m to the north. The rubble used to fill many of

the gabions is rounded and not well suited for effective packing within the baskets. However, at the southern end, a section of approximately 30 m protecting a house is in good condition having been well constructed, using flat, well rounded stones, and maintained (Figure 8, left). The remainder of the southern section, from a small access gap to the reef channel access is in much poorer condition (Figure 8, right). The top 3 gabion baskets are typically exposed above the beach that fronts the toe of the structure along this section. Approximately 60 to 70% of these baskets have burst at the top. At present the sides of the baskets are generally intact with much of the coral rubble still in situ. However, further deterioration of the wall will be rapid. Over a distance of about 20 m to the south of the reef access point, the crest of the wall has been heightened by adding a second layer of baskets (Figure 9, left).

Figure 8: Southern section of gabion seawall on the ocean side at the southern end (left) and looking towards the boat channel access point (right).

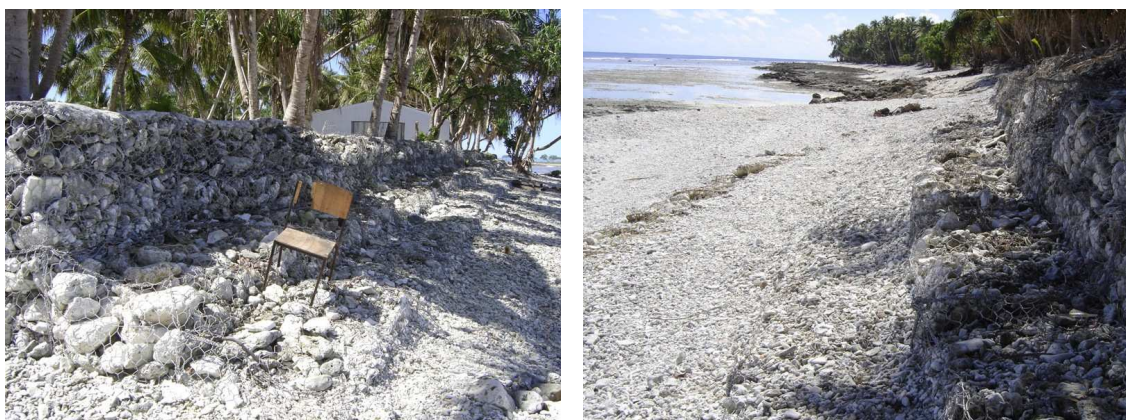
Immediately north of the channel access point (Figure 9, right), only a thin layer of coral rubble covers the bottom half of the gabion wall. Many of the baskets are damaged at the toe of the structure. A second layer of gabion baskets, placed on the crest of the wall along approximately 50 m, is also in poor condition. However, north of this section, along much of the remainder of the structure, the gabions are in better condition, with only minor damage. This is largely due to better construction and the protection provided by a wider beach fronting the wall, with only the top one or two gabions exposed, and in some areas well vegetated immediately behind the crest of the structure (Figure 10).

Figure 9: Gabion wall south (left) and north (right) at the channel access point.

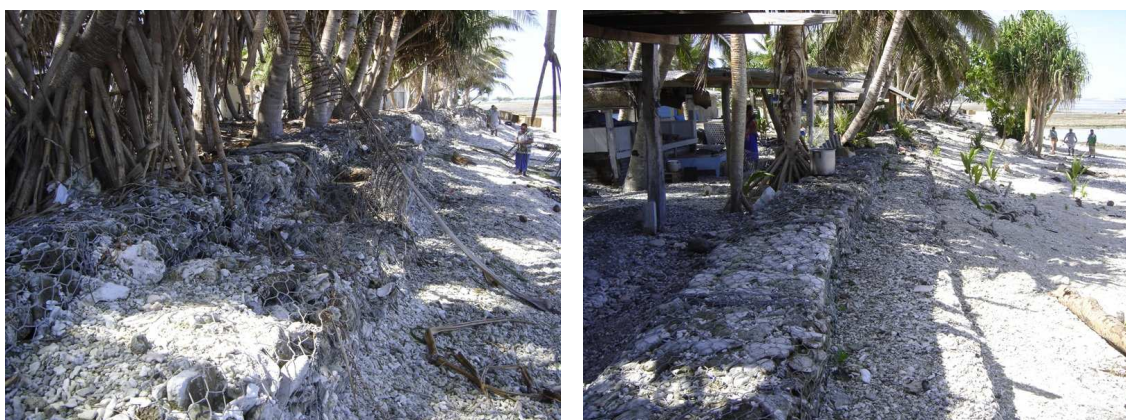
Figure 10: Gabion baskets in a reasonable condition towards the northern end of the gabion seawall.

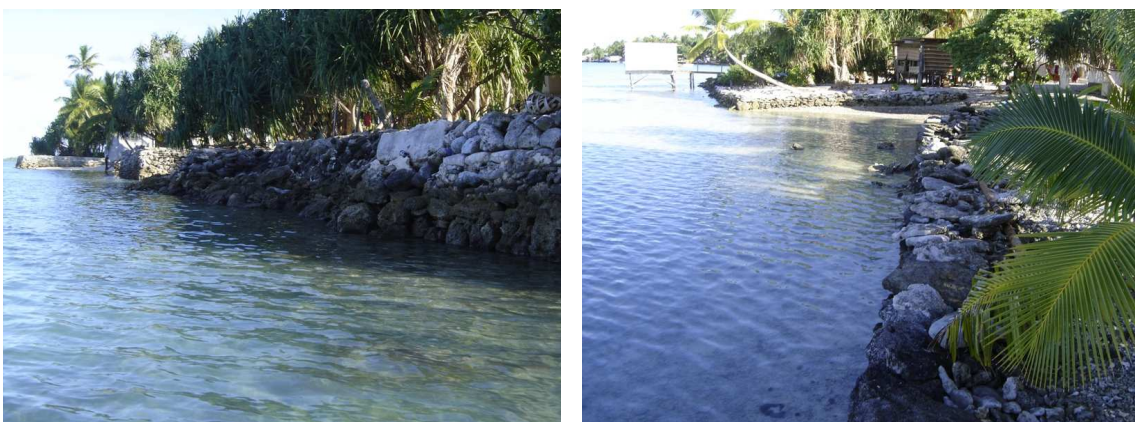
Most walls have low vertical faces of traditional coral slab construction, Figure 12. The crests of some walls have been cemented to improve stability, while gabion baskets have been placed on a couple of short stretches to increase wall elevation. The condition of the many sections of walls varies considerably, from those that are well maintained, to those that provide minimal protection.

Figure 12: Coral block walls on the lagoon shore of Atafu.

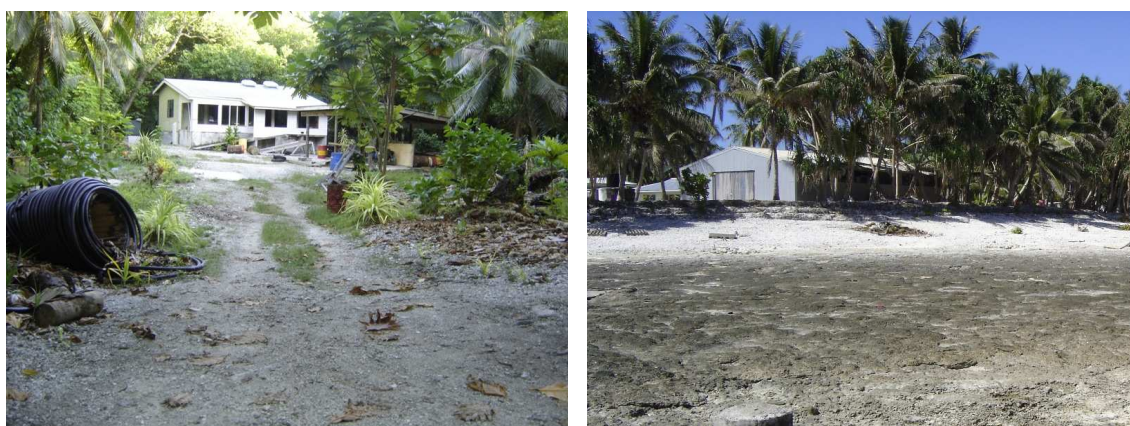
Most of the key community buildings and infrastructure have been well sited on Atafu - for example the power generator, (Figure 14, left). The community buildings at most risk are the bulk storage sheds (Figure 14, right). The UNDAC Cyclone Percy damage assessment (Laurence & Hill, 2005) noted that around half the stock was washed away, and other stock had to be written off, with the sheds all damaged to some extent. However, subsequent discussions suggested that most of the stock had been

Figure 14: The location and construction of Atafu’s power generation building (left) is a good example of community infrastructure at low risk from storm surge inundation risk. It is located well inland, in a stable area of the motu. If high storm surge levels in the lagoon do result in some minor inundation, the floor level is well above likely inundation levels. The bulk storage sheds (right) have a history of having their contents, and the structures themselves damaged during cyclone events.

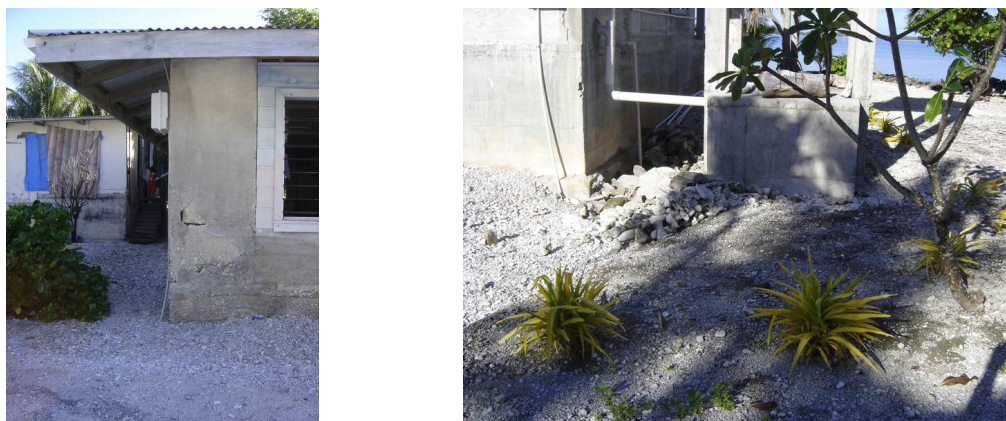
Figure 15: Damage to a building (left) likely due to debris impact, and scouring around the foundation (right) caused by overwashing water during Cyclone Percy. Both properties are located on low-lying land on the lagoon side on the promontory east of the school.

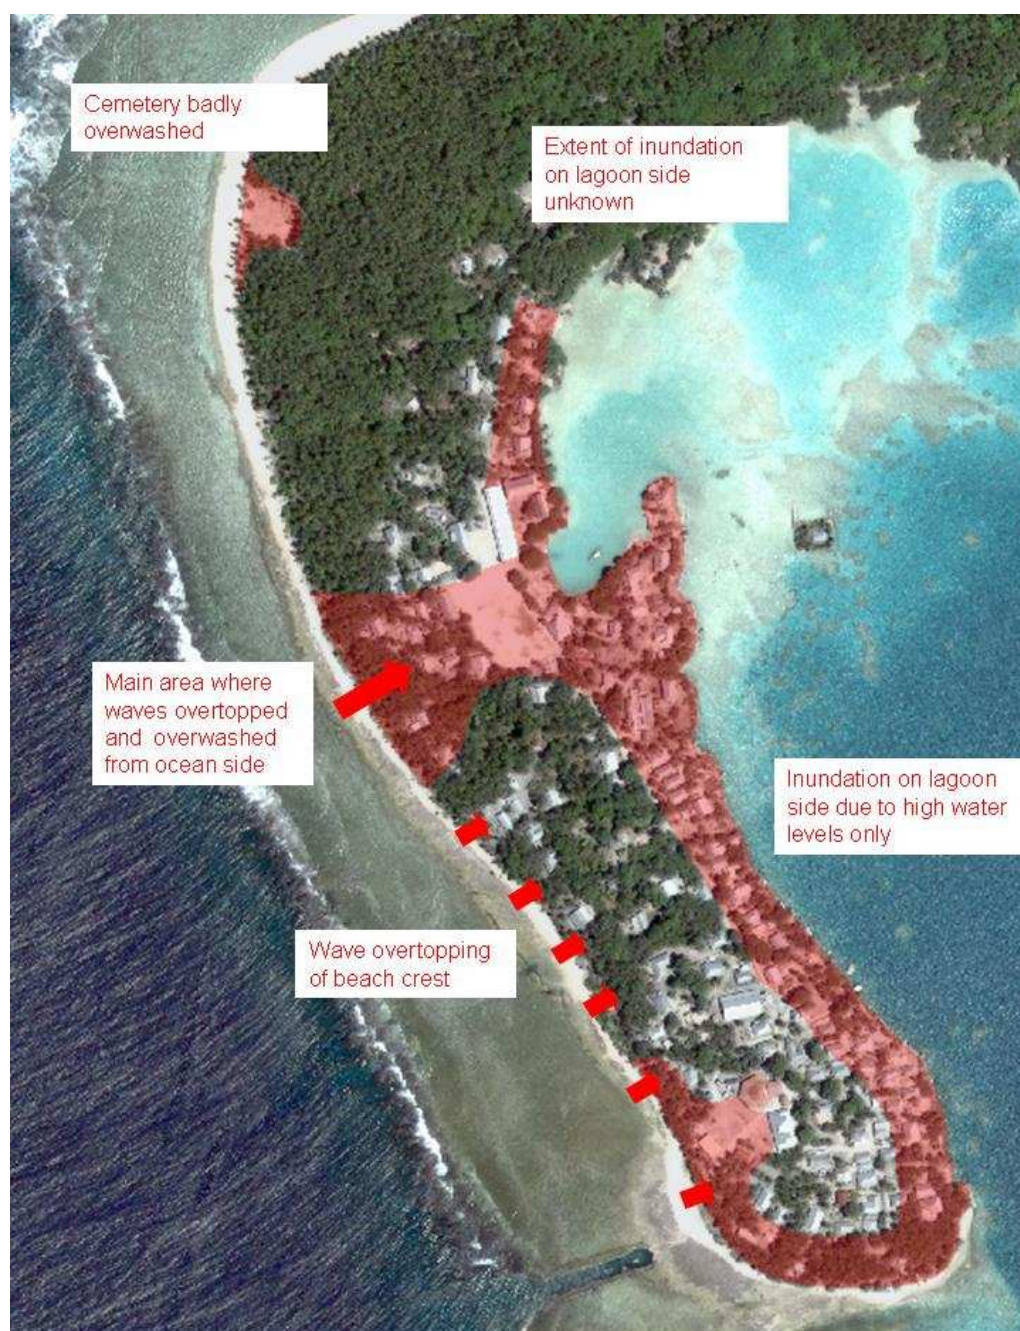
Figure 18: Approximate areas on the inhabited area of the motu inundated during Cyclone Percy. Note inundation will not have occurred at the same time at all locations.

The main location where waves overwashed from the ocean to the lagoon side was around the school area. From discussions with residents in this area, similar overwashing occurred during Cyclones Val, Ofa, Tusi and in 1966. Waves also overtopped the gabion seawalls, inundating the cleared area in front of the administration buildings and entering the bulk storage sheds.
