Reducing the risks of cyclone storm surge inundation on the atolls of Tokelau

Fakaofu

**NIWA Client Report: HAM2006-077
March 2006**

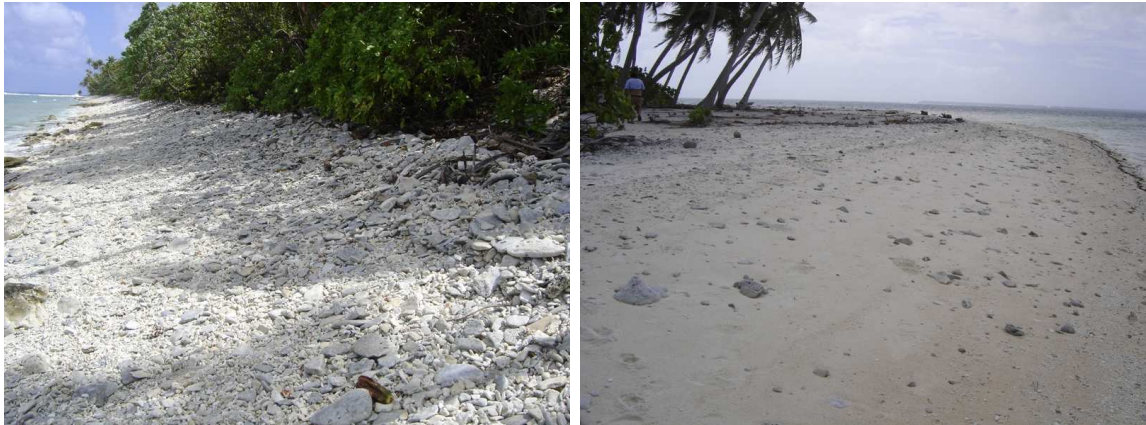
Figure 2: The southern coastline of Fenuafala (left) showing accumulation of coral rubble on the beach in the aftermath of Cyclone Percy, and eastern end (right) where there has been long term accretion and build up of land.

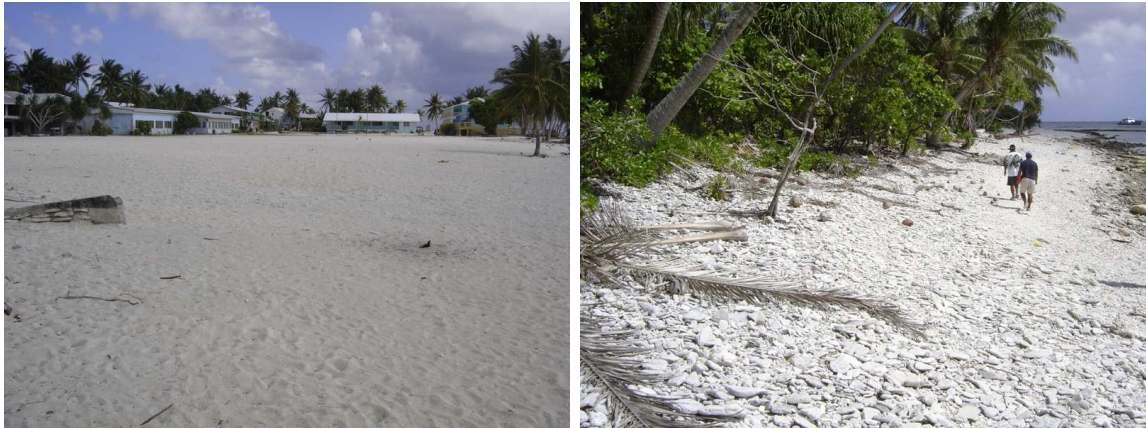
Figure 7: The school playing fields which experienced considerable inundation during cyclone Percy eroding much of the top layers of sand (right), and the lagoon coastline further west (left) which is backed by a well vegetated hinterland result in inundation being minimal.

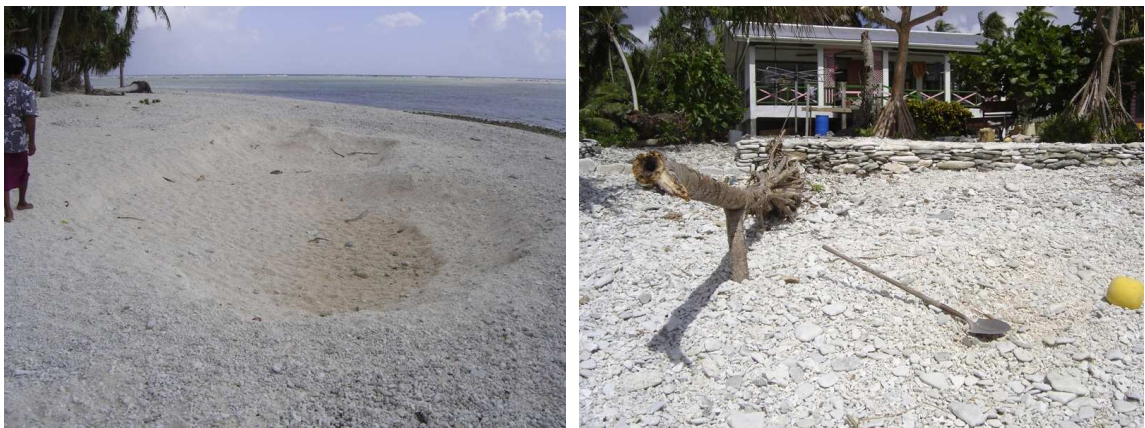
Figure 8: The continued removal of sand (right) or coral rubble (left) from anywhere around the coastline of Fenuafala will have a detrimental effect on the level of protection provided to the village from the beach system.

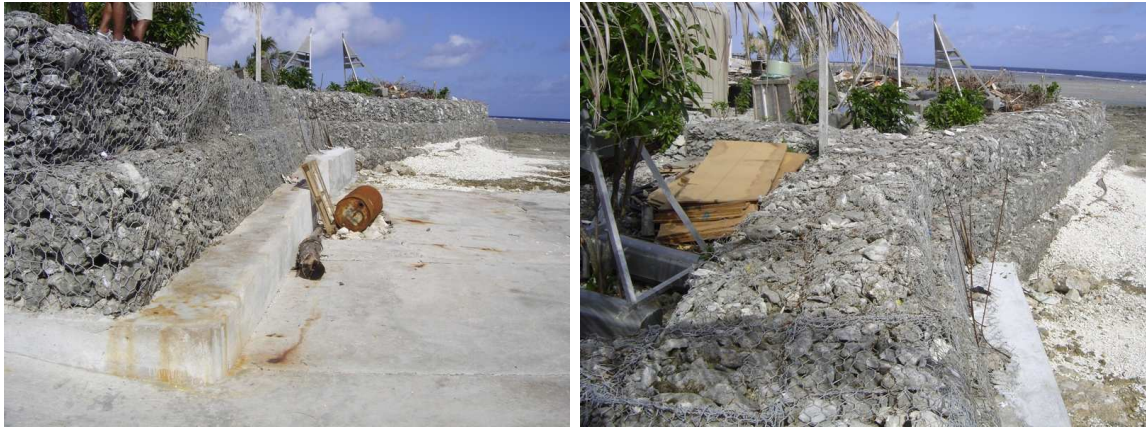
(Figures 10 to 12). This is an important section of defence (Section 1, Figure 9). If it were to fail there would be a significant loss of land, and a number of community buildings potentially lost (bulk storage sheds, freezer facility) as well as a number of residential properties affected.

Figure 10: Gabion wall (Section 1) immediately south of the boat channel on Fale. Note the concrete beam protecting the toe of the structure along part of the length (left) and the split baskets on the top layer (right).

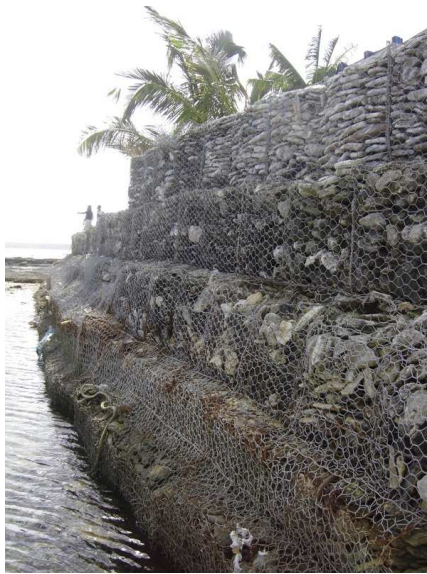
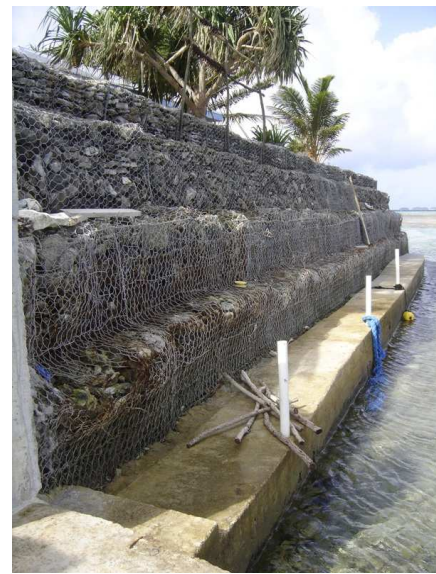
Maintenance activities have been periodically carried out including stitching unformed gabion baskets to the structure to repair baskets that have split (Figure 11, left) and installing concrete toe beams (Figure 11, right), reflecting that much of the damage to the gabions occurs along the lower sections that are within the range of the tide. The concrete toe beams have been constructed in two ways: (1) the bottom gabion has been faced with a layer of concrete (Figure 11, right), or (2) a thin reinforced concrete face is backfilled with coral rubble (Figure 12, left). Both construction methods are not robust and can be damaged relatively easily in storms as has happened at a number of locations (Figure 12, right).

Figure 11: Gabion wall along the southern coast of Fale

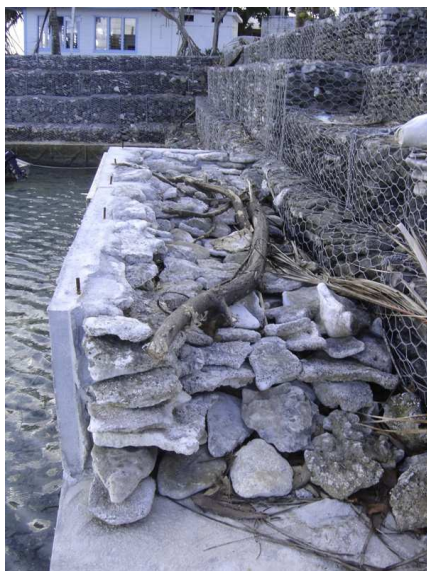
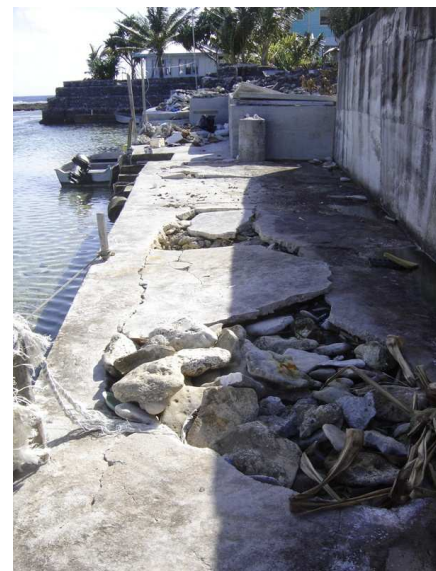
Figure 12: Typical concrete and coral rubble construction (left) and resulting damage (right).

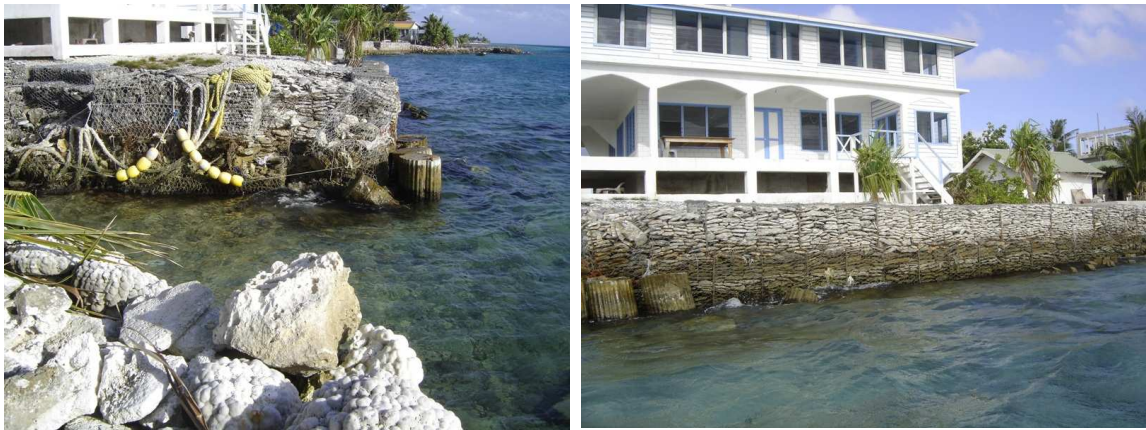
The other main section of community defence fronts the new Administration building is located on the south east corner of Fale (Section 8, Figure 9). The building is fronted by a gabion seawall, that has been well constructed and is reasonable condition apart from some gabion damage at the southern end (Figure 13, left). However, the gabions have been stacked to create a vertical wall, rather than stepped, which is resulting in the wall tilting seawards (poor foundation of the structure may also be contributing to this) due to the forces created by the backfill behind the wall. There have been a number of attempts made to stabilise the toe with concrete, none of which have been successful.

Figure 13: Gabion wall fronting the Administration Building. The picture on the left shows the damaged gabions at the southern end of the wall. Note the *Piorities Sp.* coral heads in the foreground which have been collected from live coral bommies (*Akau*) within the lagoon. The use of such coral heads is not recommended, both on environmental grounds and because they are not well suited for either filling gabion baskets or used as fill given that they do not pack well.

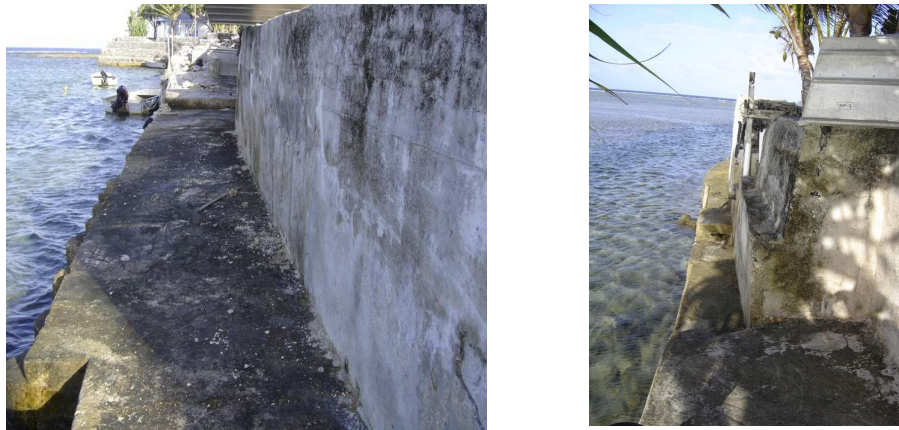
Along the southern coastline, the two main sections of vertical concrete wall (Sections 2 and 4, Figure 9) are substantial (Figure 14) with frequent variations in profile to accommodate access and boat tie up areas. The walls have typically been constructed using a thin concrete facing over gabions or coral block walls rather than mass concrete. Whilst some damage to the concrete is evident, particularly along Section 2, (e.g., shown in Figure 12 right) the walls are still functioning effectively. However, once the concrete facing is damaged, deterioration of the wall could be rapid during periods of large waves with the potential for much of the concrete facing to be lost and the wall significantly damaged.

Figure 14: Vertical concrete walls along Section 2 (left), and Section 4 (right).

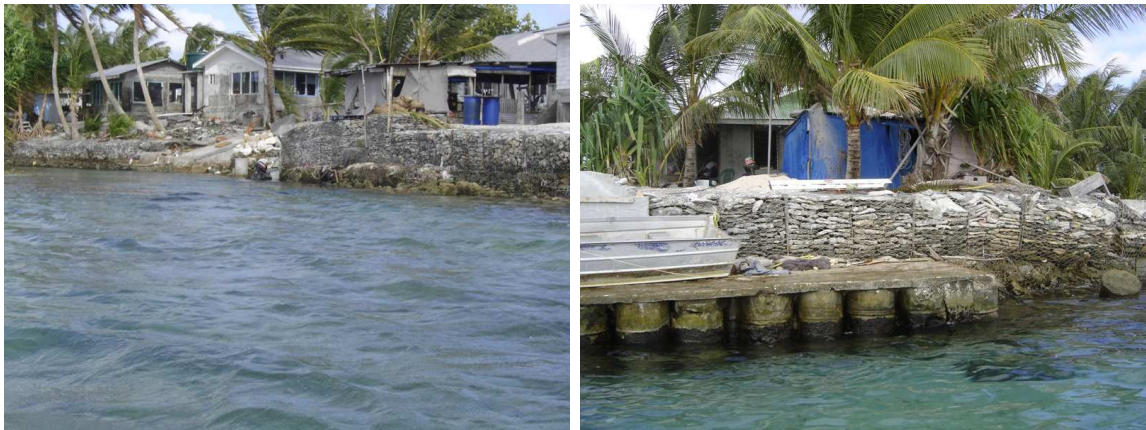
With the exception of the vertical construction of the gabion baskets, the walls have generally been well built (the exception being the section around the ongoing reclamation at the northern end on the lagoon shore (Section 15, Figure 9)). The crest of the gabion seawall sections have typically been built no higher than the land level backing the wall, reducing the potential for damage to the baskets at the crest, and the gabions have been well packed with coral rubble of a suitable size and shape (which will be suitable for reuse when the seawalls need to be replaced).

Figure 15: Gabion wall sections 5 (right) and 10 (left) showing damage due to a combination of stacking gabion baskets vertically and foundation damage due to poor construction and basket deterioration.

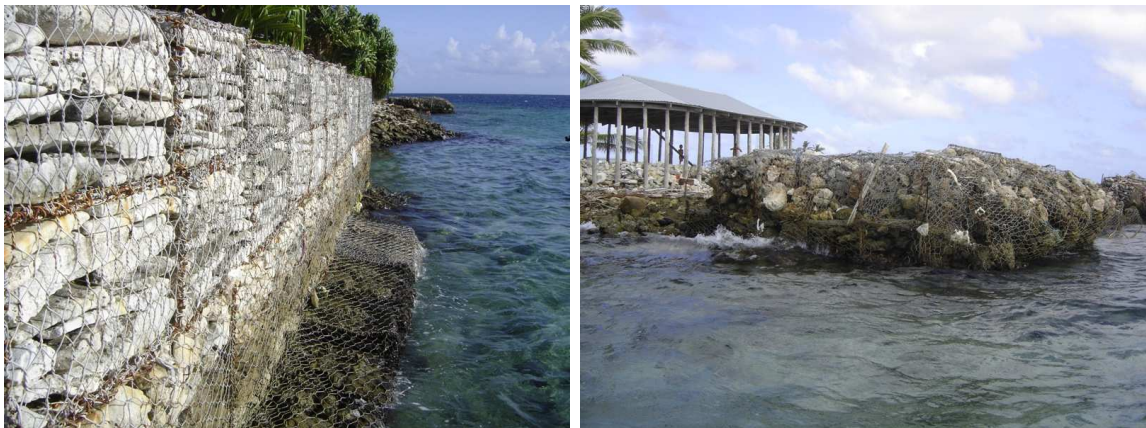
Figure 16: Well-built section of gabion (Section 13) but now experiencing deterioration of the bottom layers (left) and, poor construction and inappropriate use of gabion baskets to form the boundary of a reclamation at the northern end of the lagoon shore (Section 15).

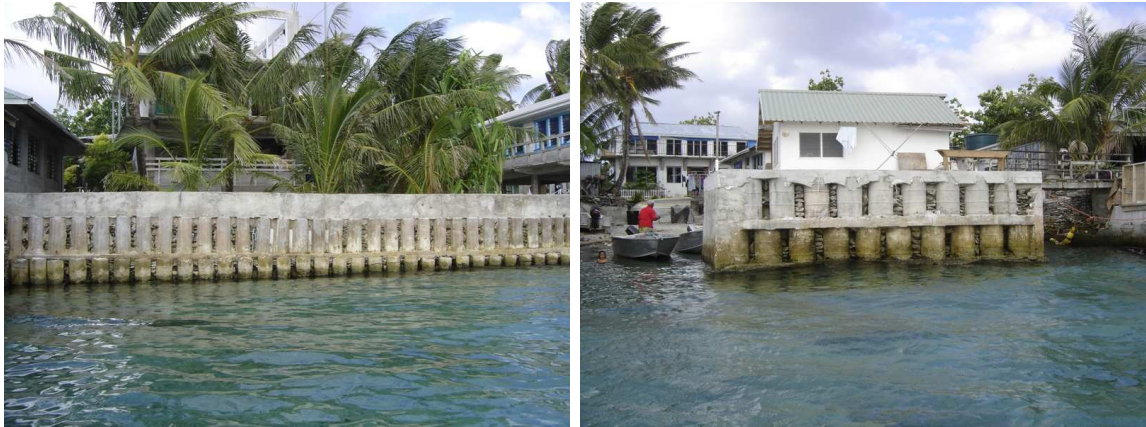
southern side of the island. However, such a construction method will still be relatively prone to damage during large waves and is likely to have a similar lifespan to a well constructed gabion wall along such a coastline. Whilst the gaps in the wall, backed by the coral rubble / gabions may have a small influence in reducing wave reflections compared to a solid concrete wall, both the wall and any surface behind the wall are more likely to experience damage due to high wave-induced pressures within the backfill during large wave conditions.

Figure 17: Seawall section 11 (left) where concrete pillars have been placed in front of gabion baskets, and Section 9, (right), where the wall has been constructed using fuel drums for formwork with coral rubble fill behind the wall.

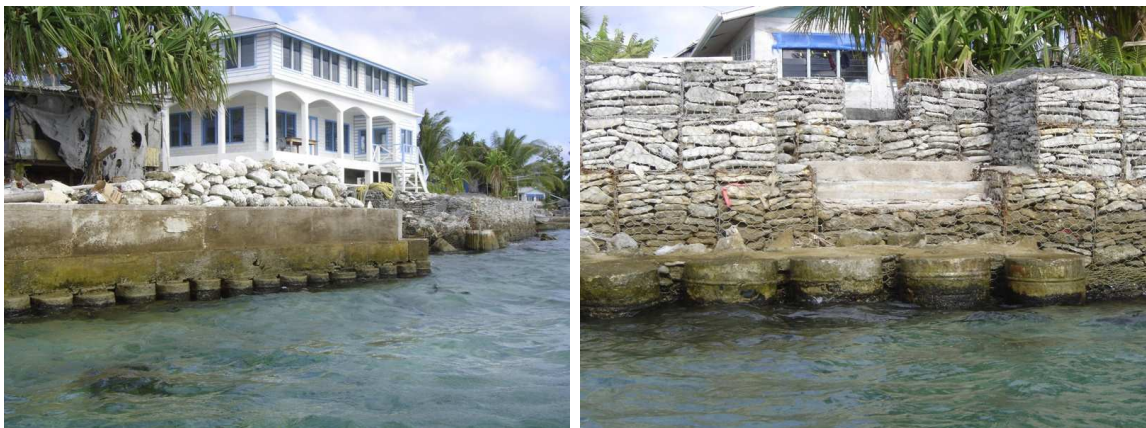
Figure 18: Concrete pillars constructed using fuel drums for formwork to provide the foundations (Section 7, left) and to provide toe protection to damaged gabion foundations (Section 13, right).

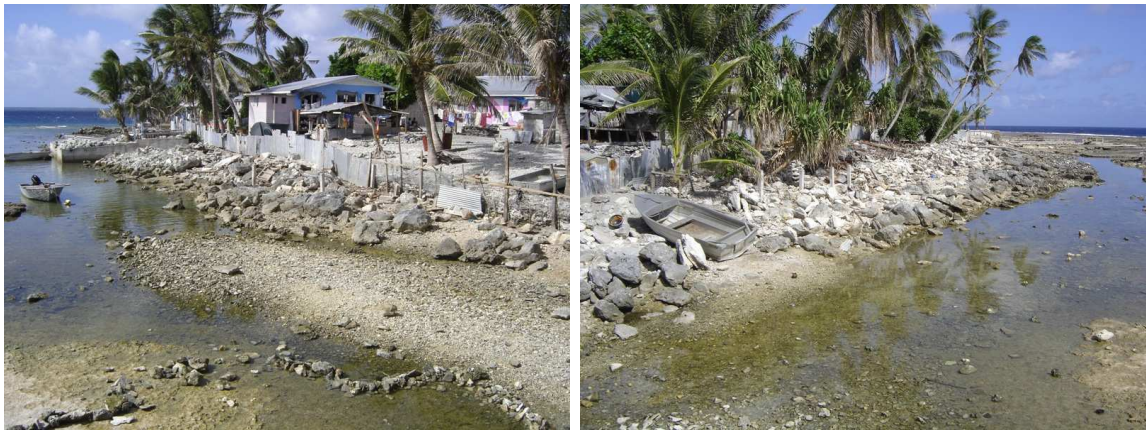
Less land reclamation has occurred along the north-western shoreline with the shallow sloping beach still evident. However, housing and other associated buildings are built on the upper beach making them susceptible to wave damage during storm surge events when water levels are above level of the large area of *te papa* upon which the pig pens are located. Coral rubble, from a boat access channel excavated in the *te papa* and from other sources covers a substantial part of the beach and provides useful armouring that helps dissipate waves reaching the northern shoreline.

Figure 20: Northern section of coast (left) showing ongoing section of reclamation (to the left of the picture) and coastline east of the bridge, and (right) west of the bridge.
