GOVERNMENT OF TOKELAU

ASSET MANAGEMENT PLAN

Issue Information	
Issue Purpose	Draft for Comment
Issue Date	August 2014
Version Number	1.0

Authorisation	
Tokelau	Jovilisi Suveinakama
Date	August 2014
Prepared By	Kierie Zeelie, Ross Waugh
Reviewed By	Ross Waugh
Report Number	69-143-1001 AMP

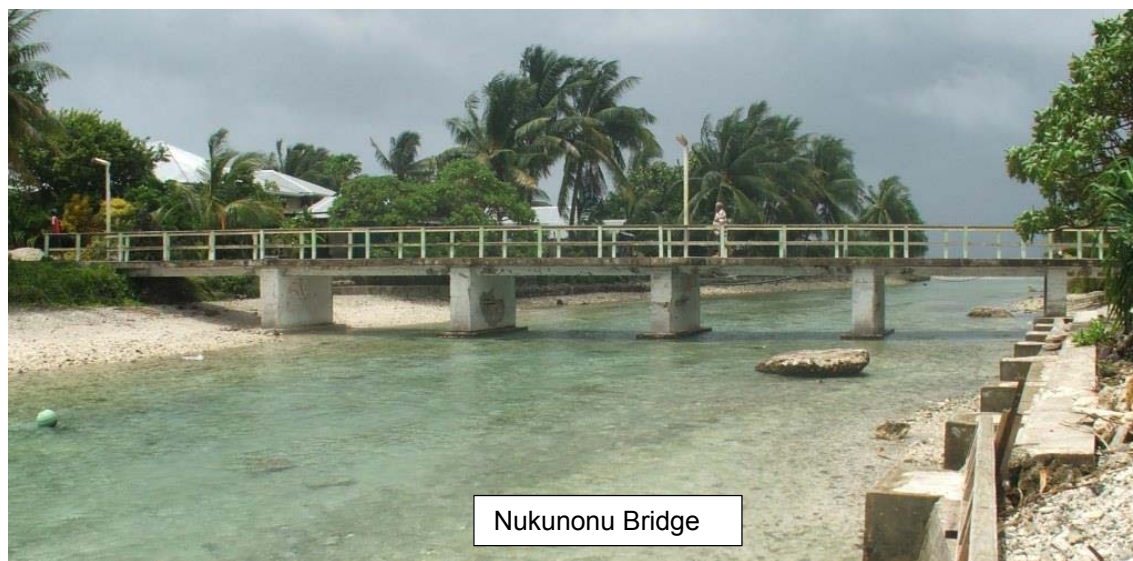
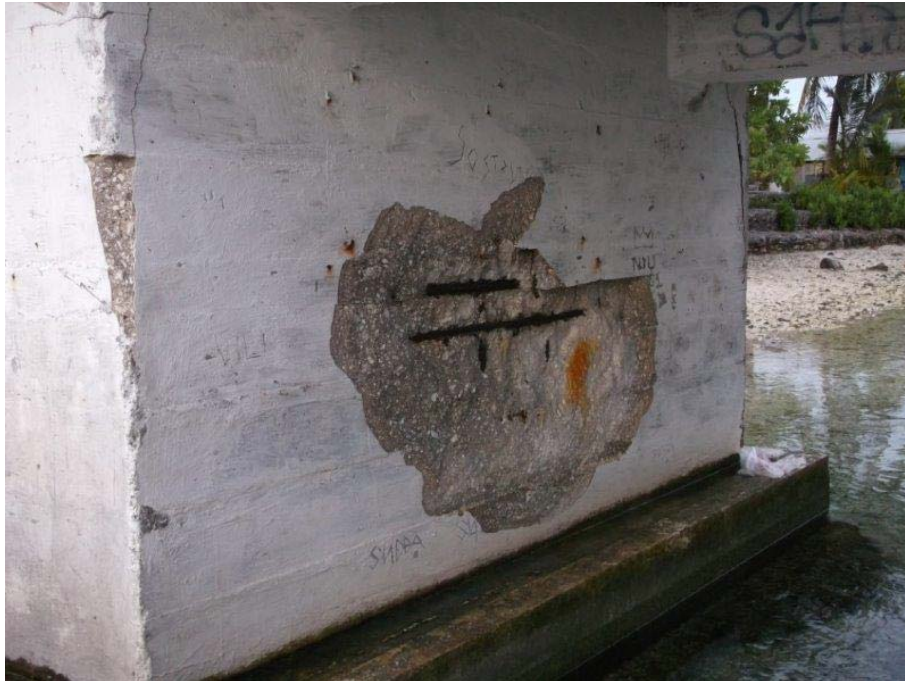
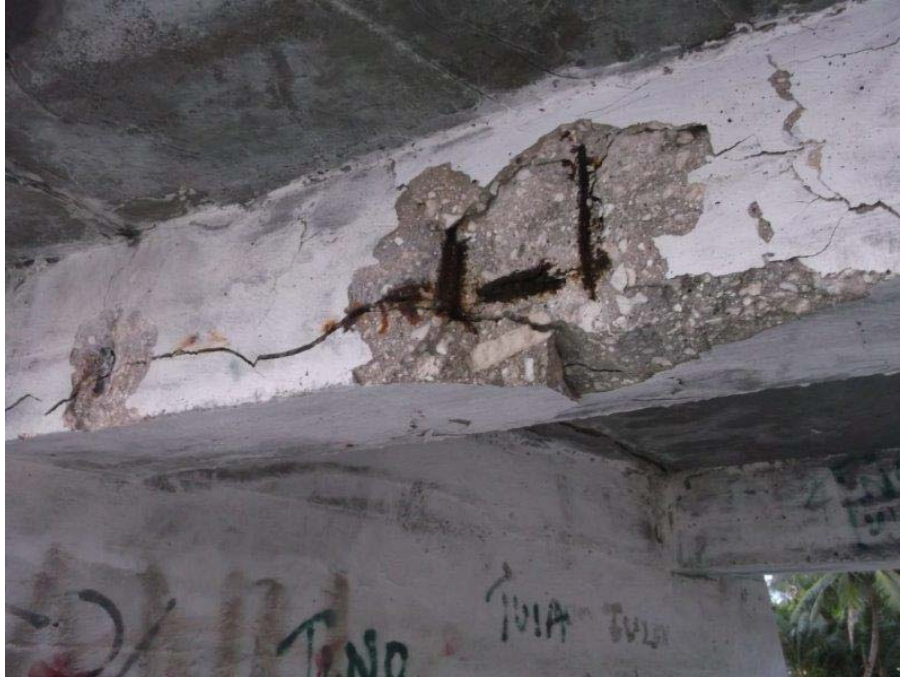
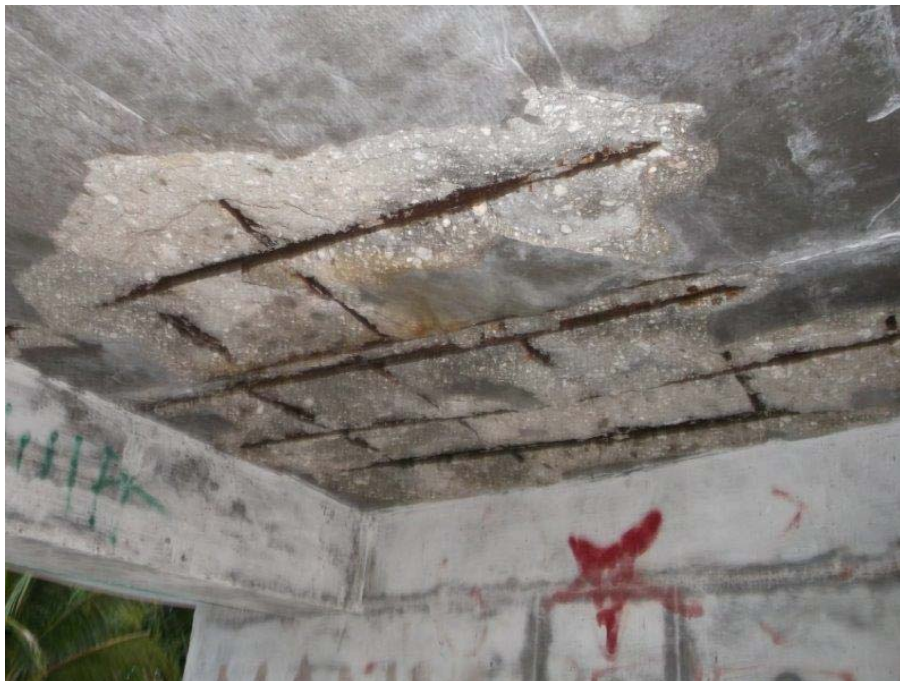
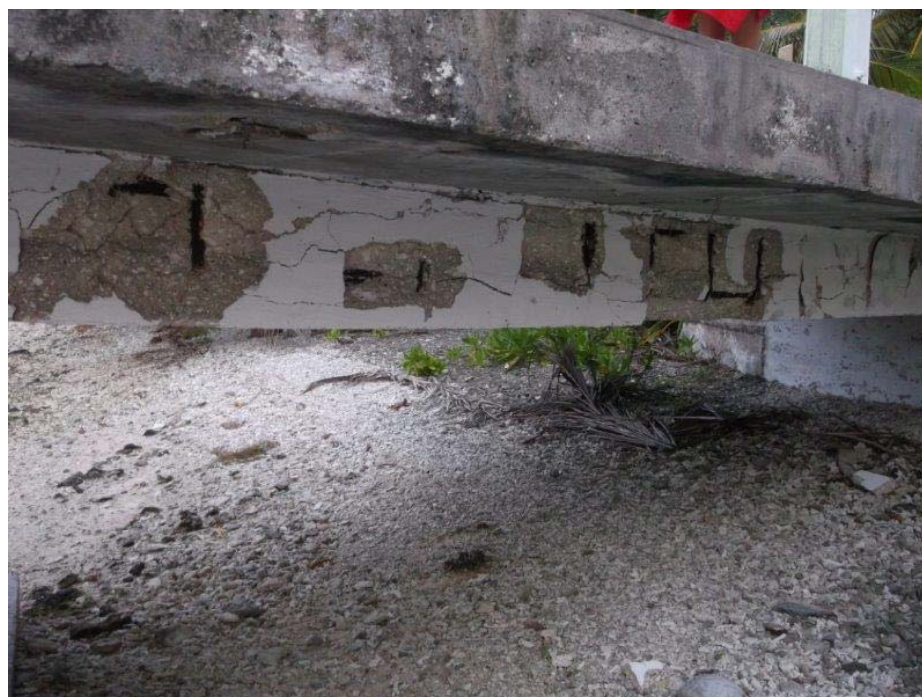
There are significant concrete spalling and corrosion to exposed reinforcement in the underside of the bridge deck, the beams and bridge piers/columns. A superficial assessment estimates that if no remedial action is done the bridge life is less than 5 years and pose a significant risk to the community.

Having reviewed the photos from the site inspection. We are of the opinion that it will not be cost effective to repair the concrete spalling to the bridge spans as we believe that the exposed reinforcing steel has lost to much sectional area.
