Reducing the risks of cyclone storm surge inundation on the atolls of Tokelau

Nukunonu

**NIWA Client Report: HAM2006-078
June 2006**

United Nations Development Programme

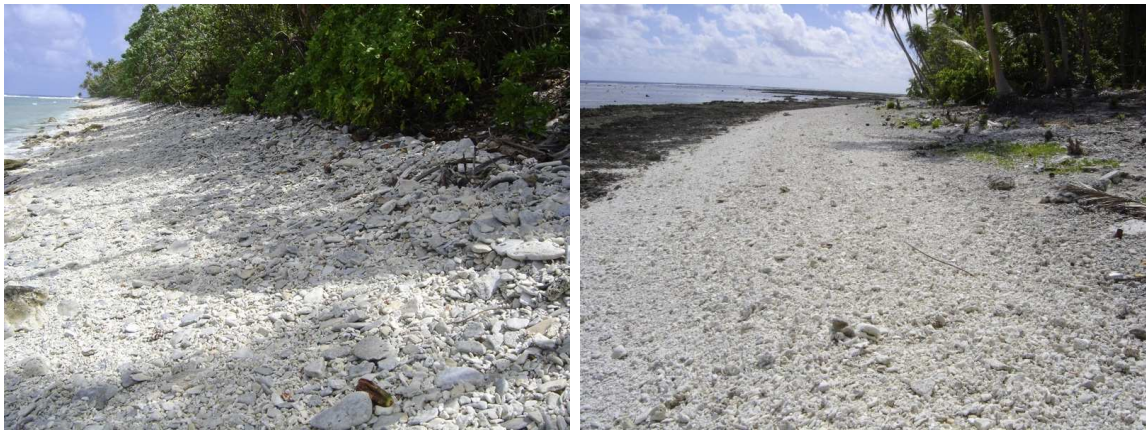
Figure 4: Storm ridge built up on the ocean side on the motu of Fenuafala (Fakaofu) where there is a healthy coral rubble beach with little overwashing occurring during cyclone Percy (left), and the beach at the northern end of Nukunonu (right) which is composed of smaller material which results in a flatter beach and a greater likelihood of overwashing during cyclone events.

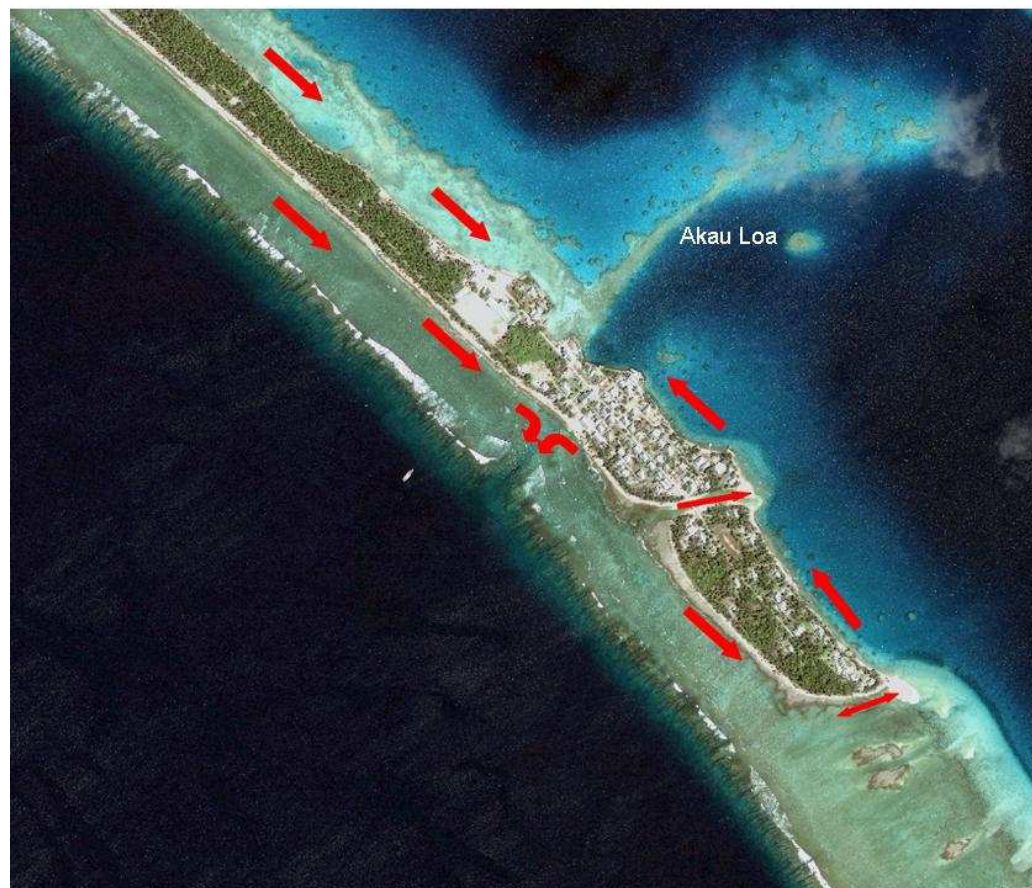
Figure 5: Dominant directions of sediment movement along the coastline of Nukunonu and Motuhaga (adapted from McLean, 1993).

build up at the southern side (Figure 6; left) but accelerated “downdrift” erosion immediately to the north (Figure 6; right) and is shown conceptually in Figure 7. Beach sediments will also be moved in a net northward direction along the southern part of the lagoon coast on Nukunonu motu but the rate will be low given the amount of human modification on this shore. North of the Luana Liki Hotel the shelter provided by *Akau Loa* from waves from the east through south will result in a net southerly movement of beach sediment along the central part of the lagoon shore on Nukunonu motu (Figure 5).

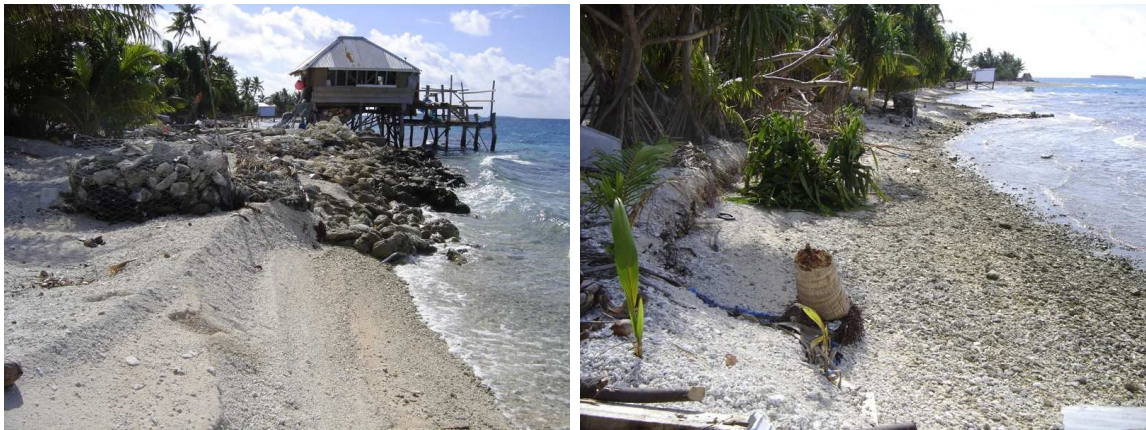
Figure 6: Build up of sand on the beach to the south of the seawall/reclamation mid-way along the lagoon shore of Motuhaga (left) and associated increase in erosion to the immediate north (right).

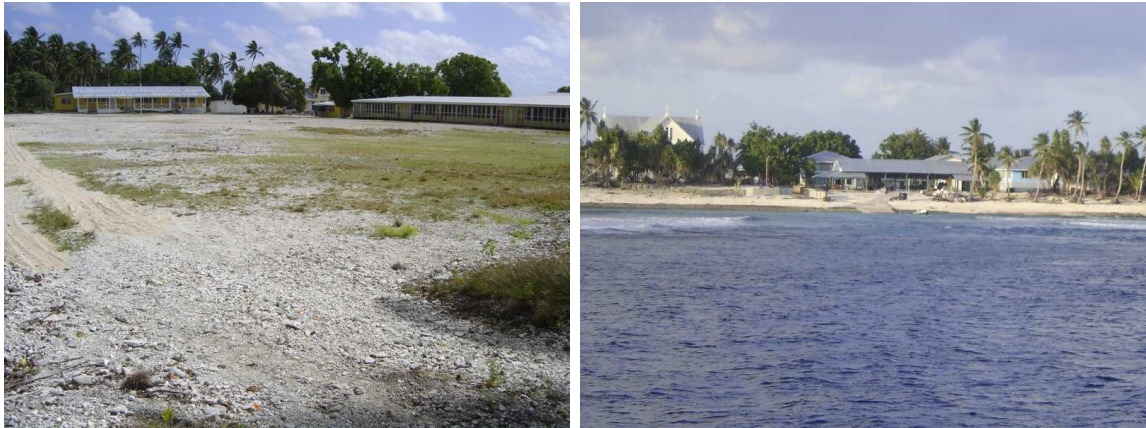
Figure 8: Overwashing of Nukunono motu at the location of the school (left) and at the location of the boat channel (right) was most severe during Cyclone Percy and most previous cyclones, exacerbated by the lack of vegetation.

boat channel, Figure 8. This is a pattern that has been evident when overwashing has occurred during cyclones to have affected the Tokelau atolls over the last century (e.g., the reports by Bakx, 1987 and Richards, 1990, 1991).

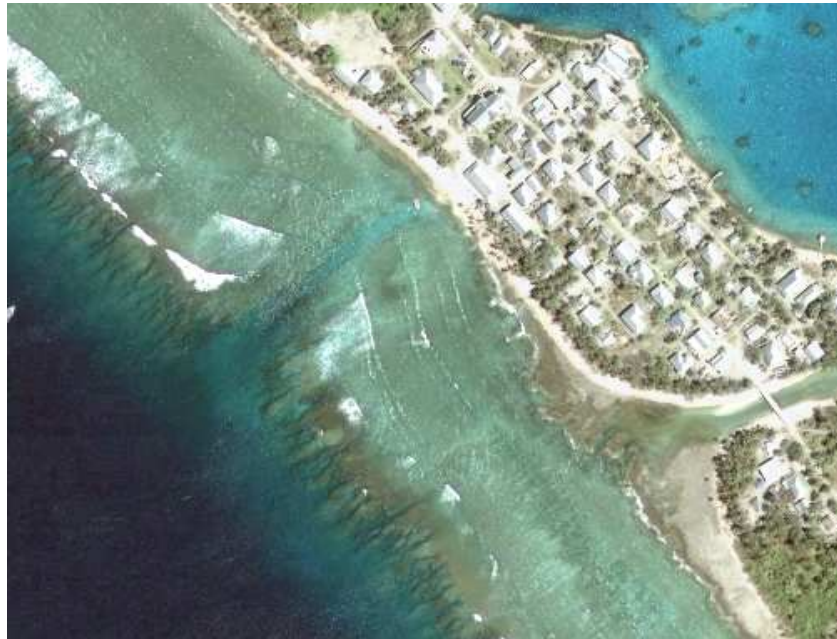
Figure 9: The reef channel at Nukunonu provides an example of the influence of waves translating over the reef flat and the resulting effect on the shape of the coastline.

The main problem with the boat channel is that the landward end has been built too close to the beach (see Ramsay, 2005c). Wave-induced currents over the reef flat result in beach sediments being eroded and transported seaward out through the channel. This effect increases as waves get larger. During cyclone conditions significant amounts of beach sediment can be lost either into the channel, or transported down the channel and lost off the seaward edge of the reef. Guidance to mitigate such impacts are summarised in Ramsay (2005c).

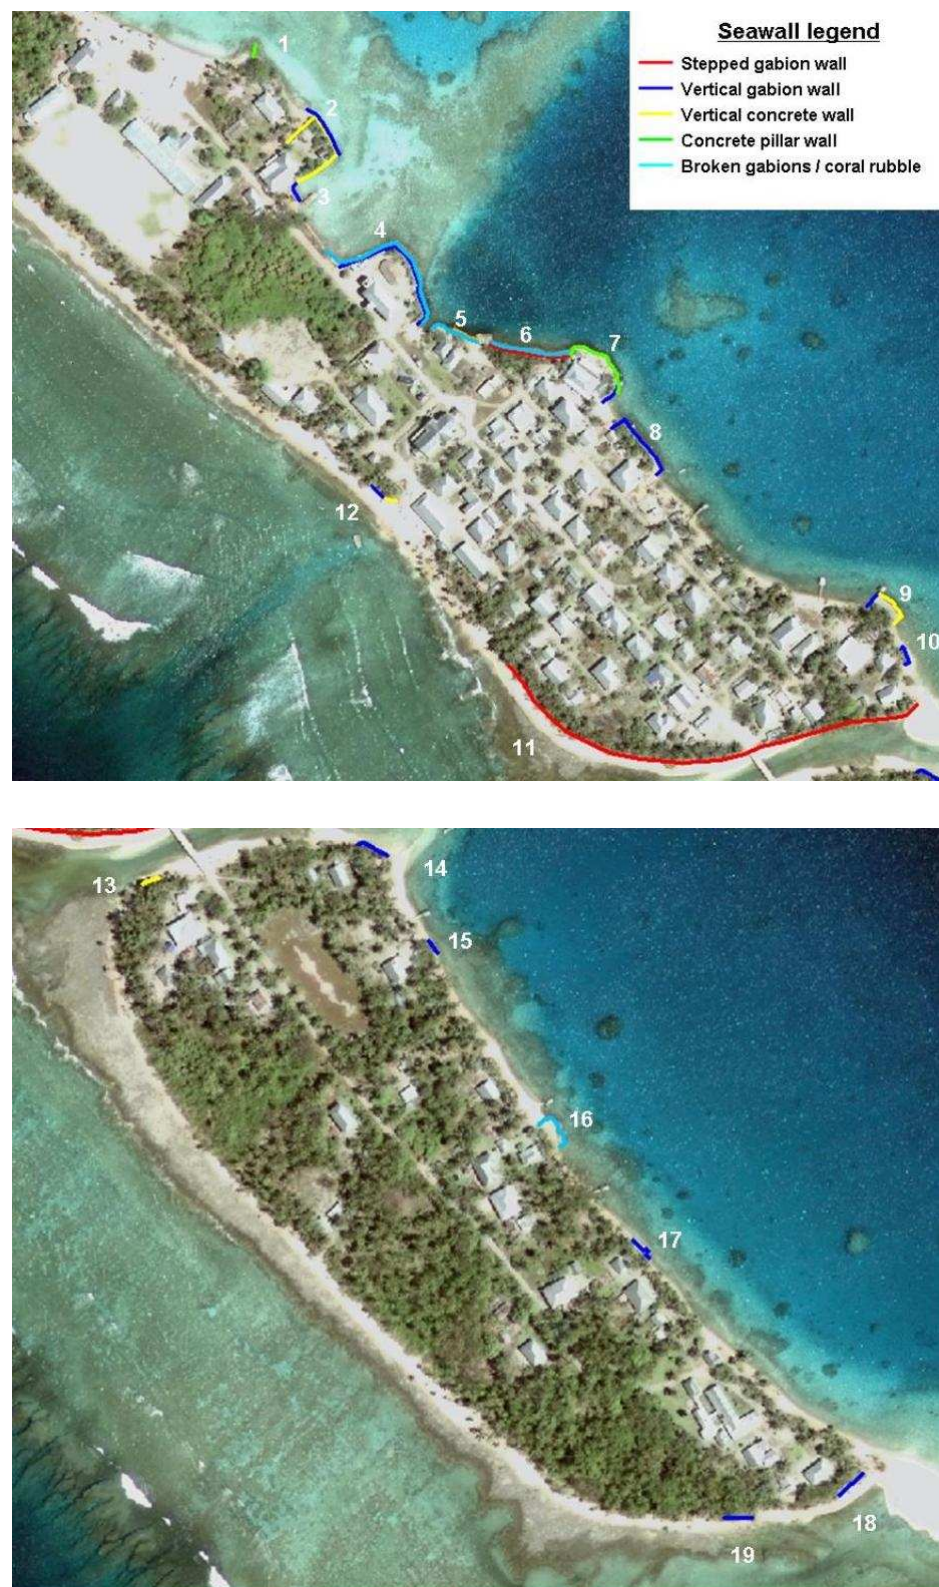
Figure 10: Summary of the location and type of seawalls constructed around Nukunonu motu (top) and Motuhaga motu (bottom).

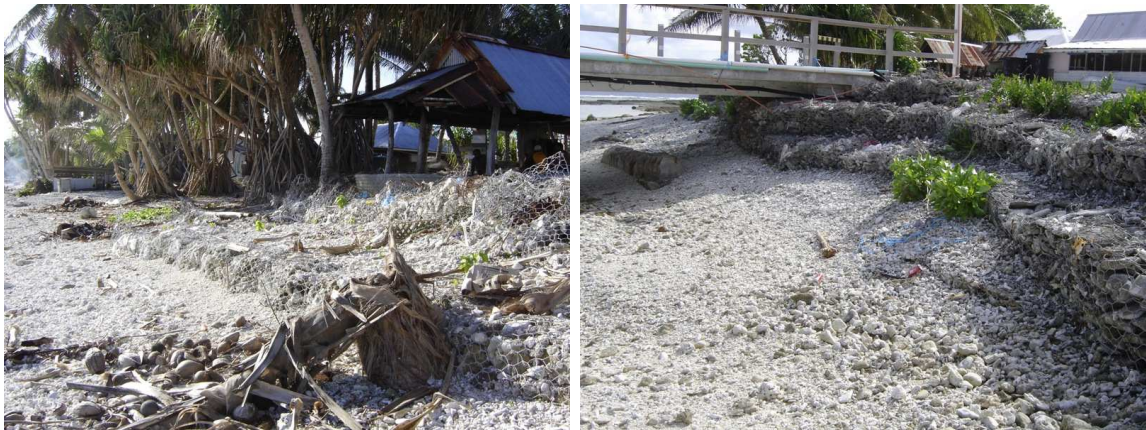
Figure 11: Badly damaged section of the gabion wall at the northern end of the main structure (left) and to the immediate lagoon side of the bridge (right).

On the lagoon side of the bridge, the gabions are still in a reasonable condition with the exception of a 20 m length immediately adjacent to the bridge where there is damage to the tops of a high percentage of the top three layers of gabions. A 75 m section also suffers from being undermined (Figure 12, right). The gabions are still in a reasonable condition, and if repairs to the foundation were made quickly could prevent further, more serious, damage to the defence at this section

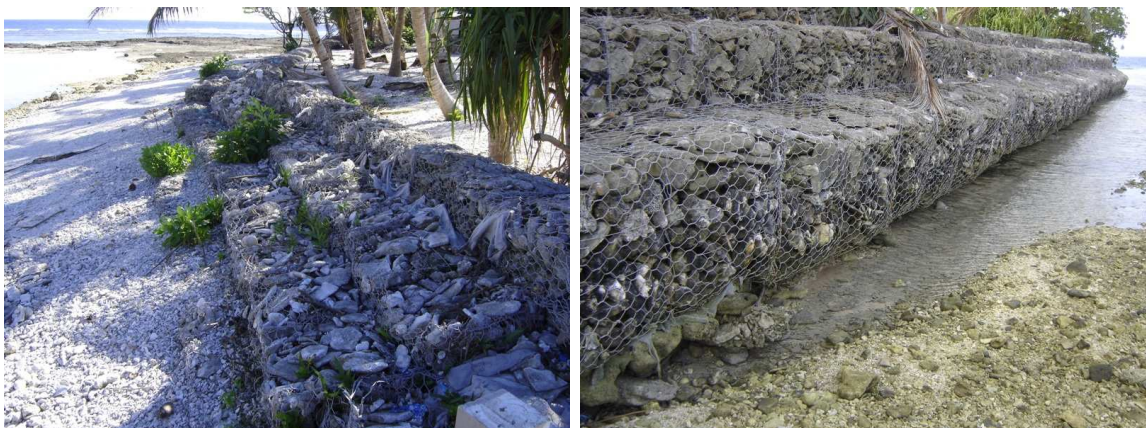
Figure 12: Section of gabion wall with beach covering the bottom half of the structure along the ocean side showing the damaged tops to the gabions baskets (left) and undermining of the gabion revetment along the lagoon side of the channel (right).

Build up of beach material along the ocean side at the southern end of Nukunonu motu has resulted in a thin beach forming at the toe of the structure (Figure 12; left), helping to protect it during more normal occurring wave conditions with mainly the top 3 to 4 gabions exposed.

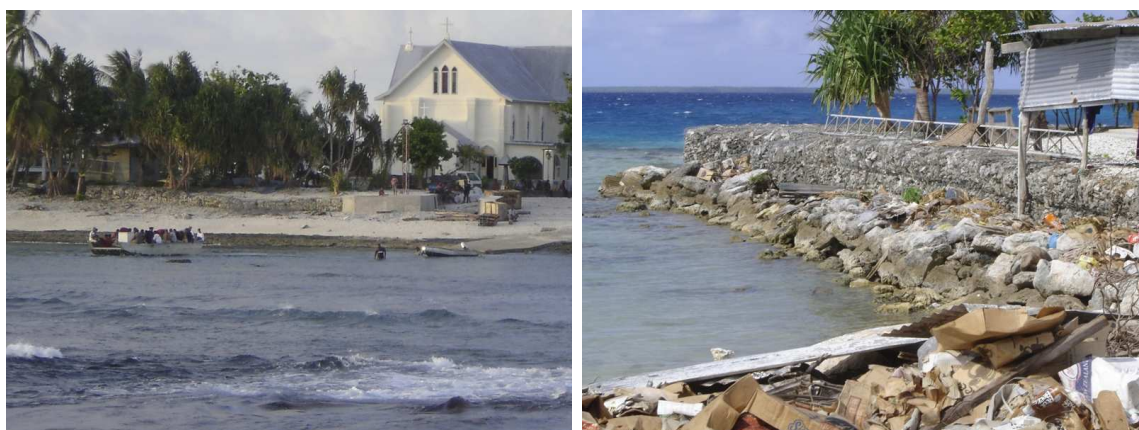
Figure 13: Gabion wall to the immediate north of the boat channel part of which has been faced with cement (left) and the gabion wall, with coral rubble toe protection around the area reclaimed for the meeting fale (right).

A short length of vertical gabion wall has also been built on the ocean side between the northern end of the boat channel and the old power generation building (Figure 13; left). The southern end of the wall has been faced with cement to produce a smooth vertical wall. The wall has been built part way down the active beach and appears to have subsided due to lowering of the beach along the central section. This may well be due to the influence of the wall on the beach at this location and not only increases the risk of damage to the wall, but also increases the potential of overwashing of the motu at this location. The location of the wall and construction (vertical and with a concrete face) is far from ideal for the ocean side of the motu.

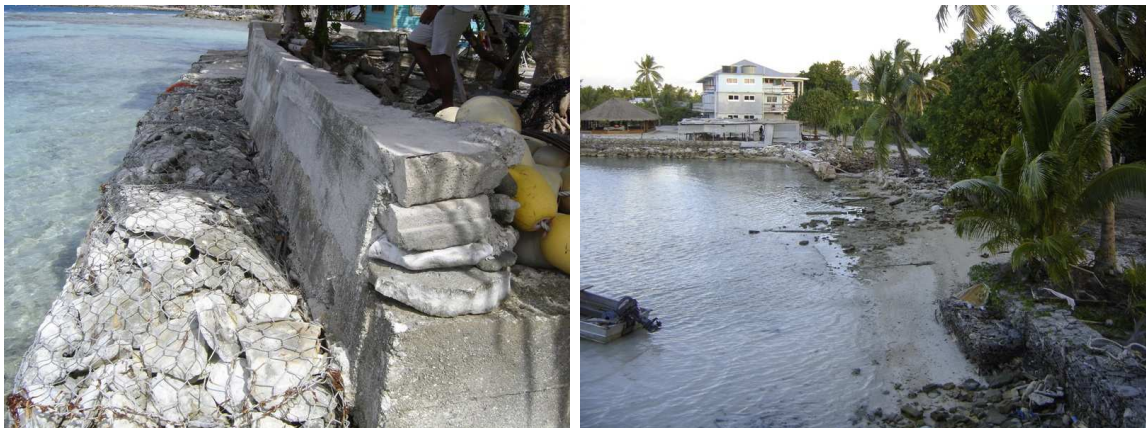
Figure 14: Gabion lower wall and concrete upper on the lagoon side of the reclamation upon which the Luana Liki Hotel is located (left) and between the hotel and the reclamation upon which the meeting fale is located (right).

Around the hotel, a vertical concrete (sections of mass concrete and concrete faced coral rubble) retaining wall provides the boundary for the reclamation upon which the hotel is located. On the lagoon face two layers of gabions provide toe protection to the wall and appear to be well constructed and in a relatively good condition (Figure 14; left). The walls along the flanks of the reclamation are less well constructed but are not as exposed. Between the hotel and the reclamation on which the new meeting Fale and Faiefa building is located, there is a short stretch of gabion wall at the northern end and a large pile of rubble to the south (Figure 14; right).

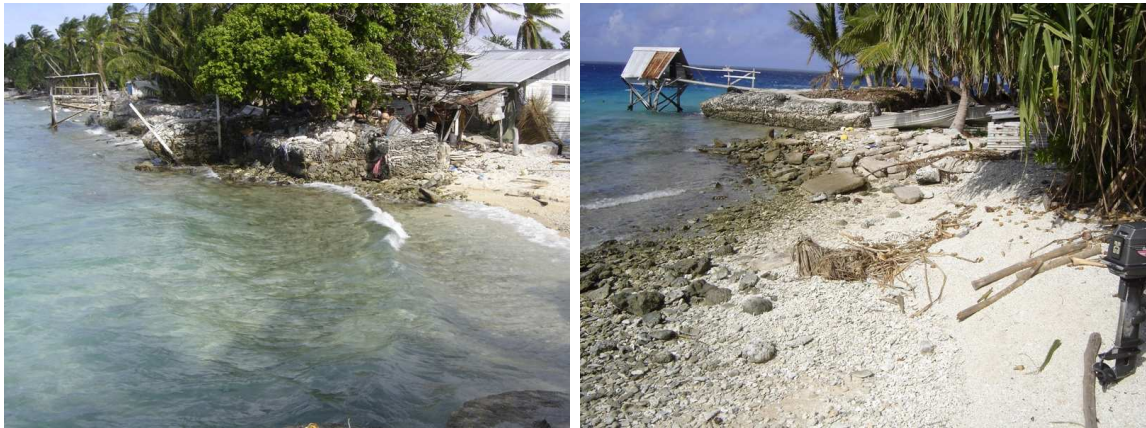
Figure 15: Gabions, poorly founded and constructed, being used for reclamation (Section 8 left; section 9 right).

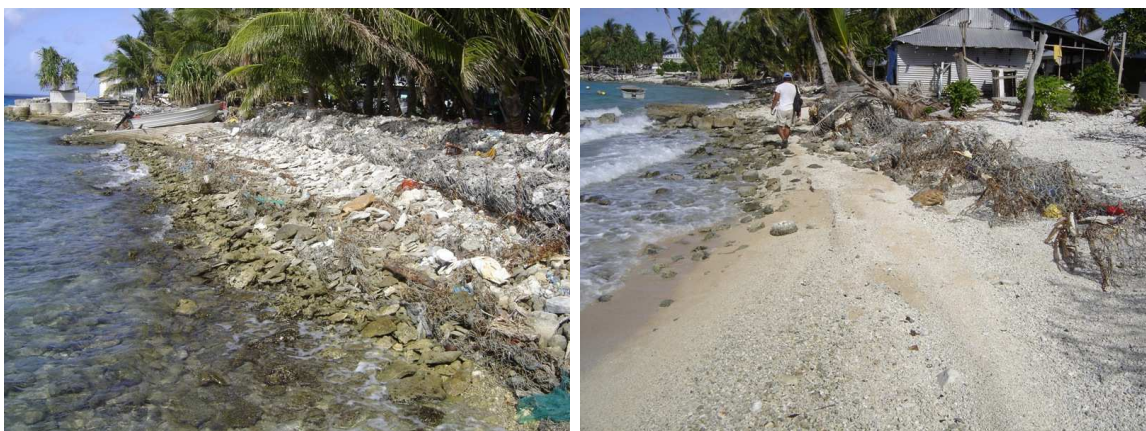
Figure 16: Gabion wall where the lower baskets have rotted away (Section 6 left), and as a single line of gabions that provides virtually no protection to the land behind and is easily damaged (right).

- Using the gabions for mooring boats and other uses which rapidly results in the baskets bursting and corroding away (Figure 16; left). Note the corroding lower gabions have resulted in piles of coral rubble fronting the gabions higher up the beach. Whilst not intended as a coast protection structure, the coral rubble over the lower beach provides effective toe protection to the higher gabions forming a relatively effective defence.

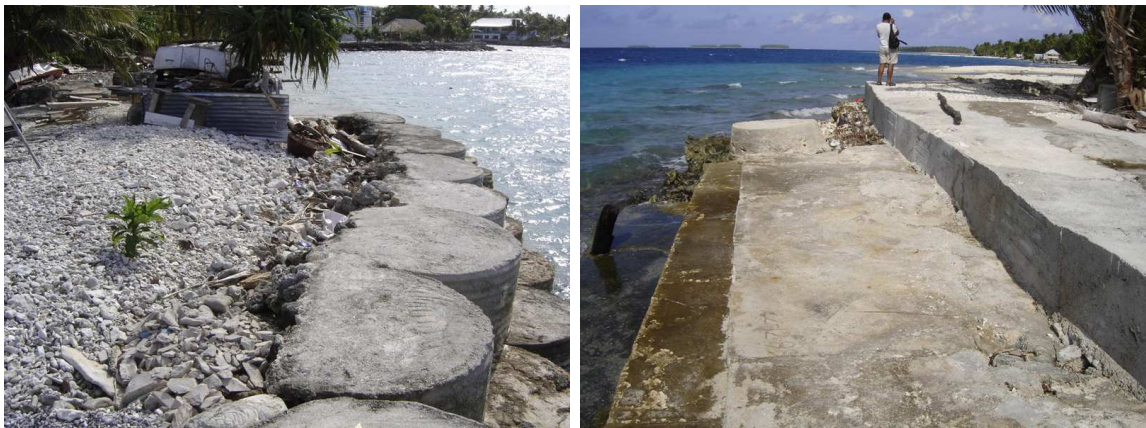
Figure 17: Mass concrete pillar wall section (Section 7, left), and mass concrete with gabions underneath (Section 9, right).

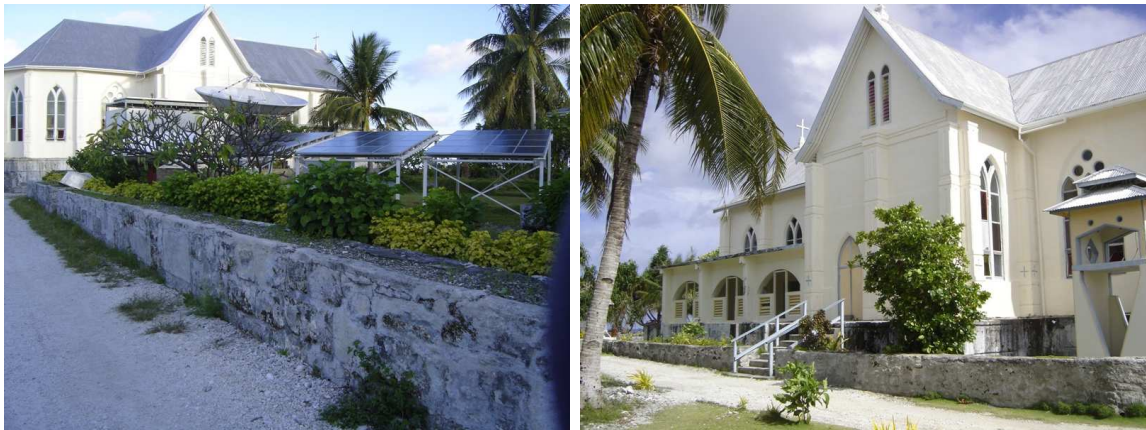
Figure 18: Boundary walls around the church and satellite installation.

Boundary walls located around the church and satellite installation (Figure 18) also function as a coastal defence during cyclone conditions. If access points were sealed prior to cyclone events, the walls would reduce water entering the areas around these buildings under the more commonly occurring overwashing events (although the walls would be overtopped during severe events) reducing the risks of fast flowing water and debris around these buildings (see Figure 26 taken during Cyclone Percy). However, such a measure does result in overwashing water being channelled between the walls which can lead to fast flows and scouring. Despite this it is a good example of an effective structural solution reducing the risk of certain areas being inundated with little impact on the natural coastal processes, and is appropriate for locations in the centre of the motu such as around the church.

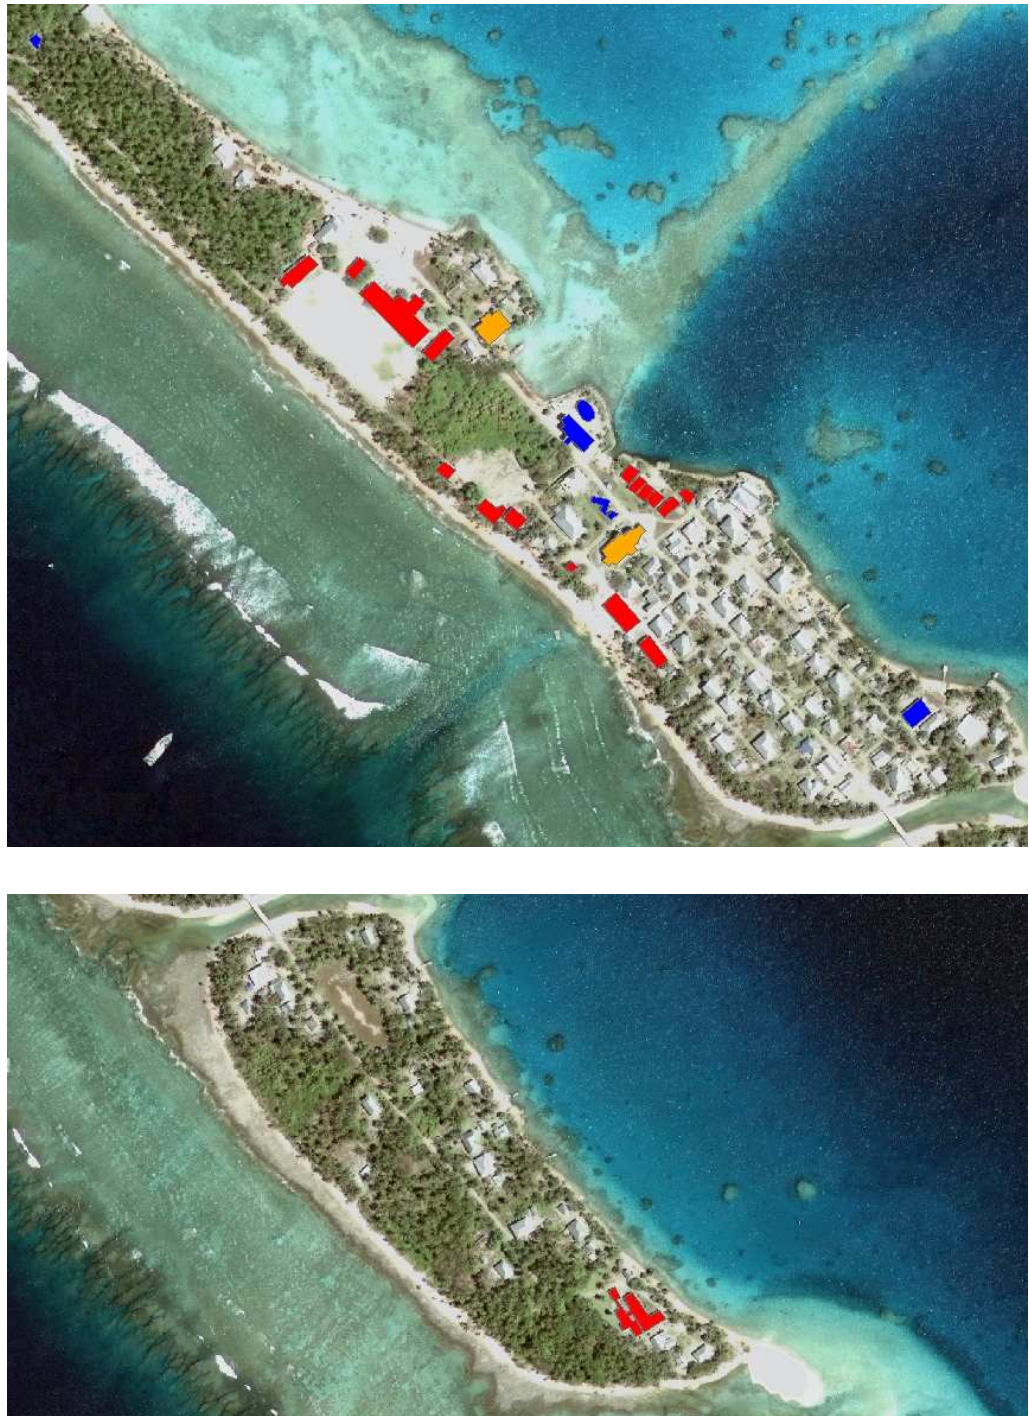
Figure 19: The relative risk of inundation or damage to community buildings on Nukunono (top) and Motuhaga (bottom) due to overwashing waves. Red = high risk, Orange = medium risk, blue = low risk.

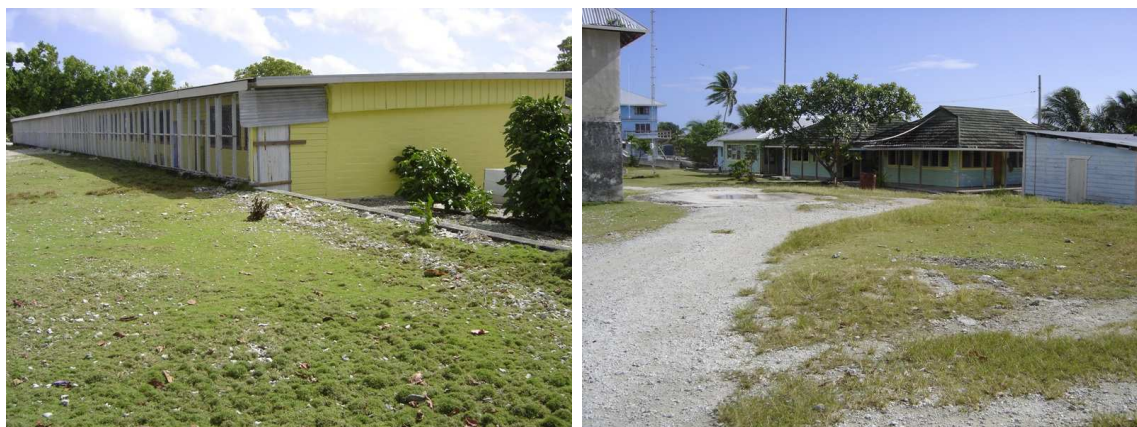
Figure 20: High risk community buildings including the school buildings (left) and the village store, Co-op, police, finance and health offices (right) which are located in areas prone to overwashing and also have low floor levels.

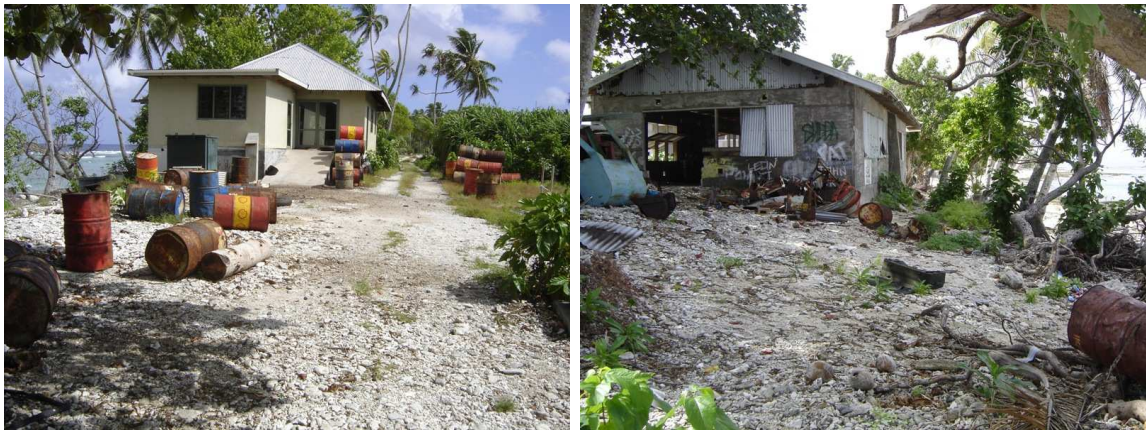
Figure 21: The generator building (left) and fuel storage building (right) are located right on the crest of the beach on the ocean side making them highly susceptible to damage.

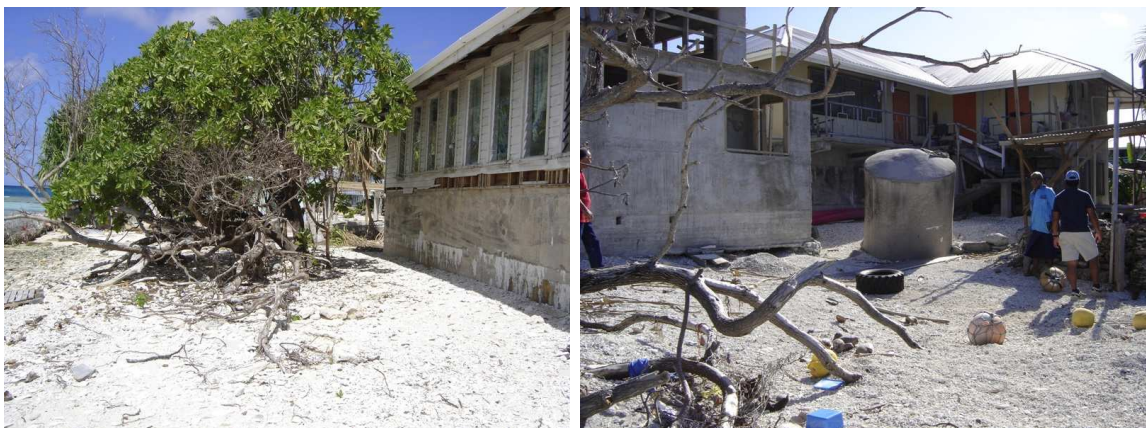
Figure 22: Damage to housing located too close to the beach on the lagoon side of Nukunonu.

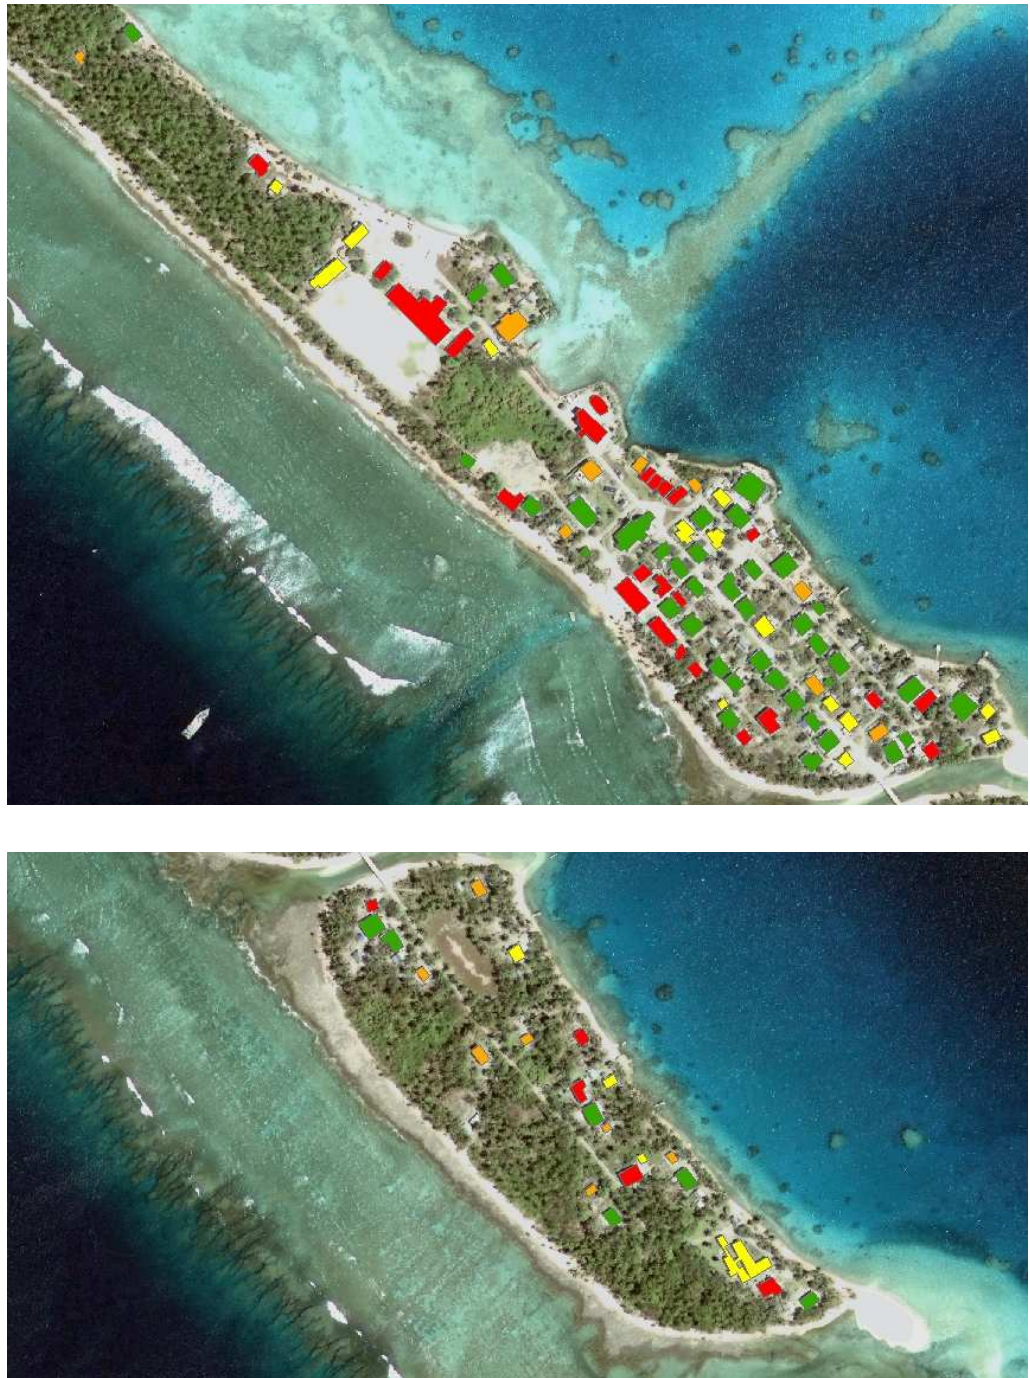
Figure 24: Floor levels of all buildings relative to surrounding ground levels on Nukunono (top) and Motuhaga (bottom). Red = < 0.2 m, Orange = 0.2 - 0.5 m, Yellow = 0.5 – 1 m, Green = >1 m.

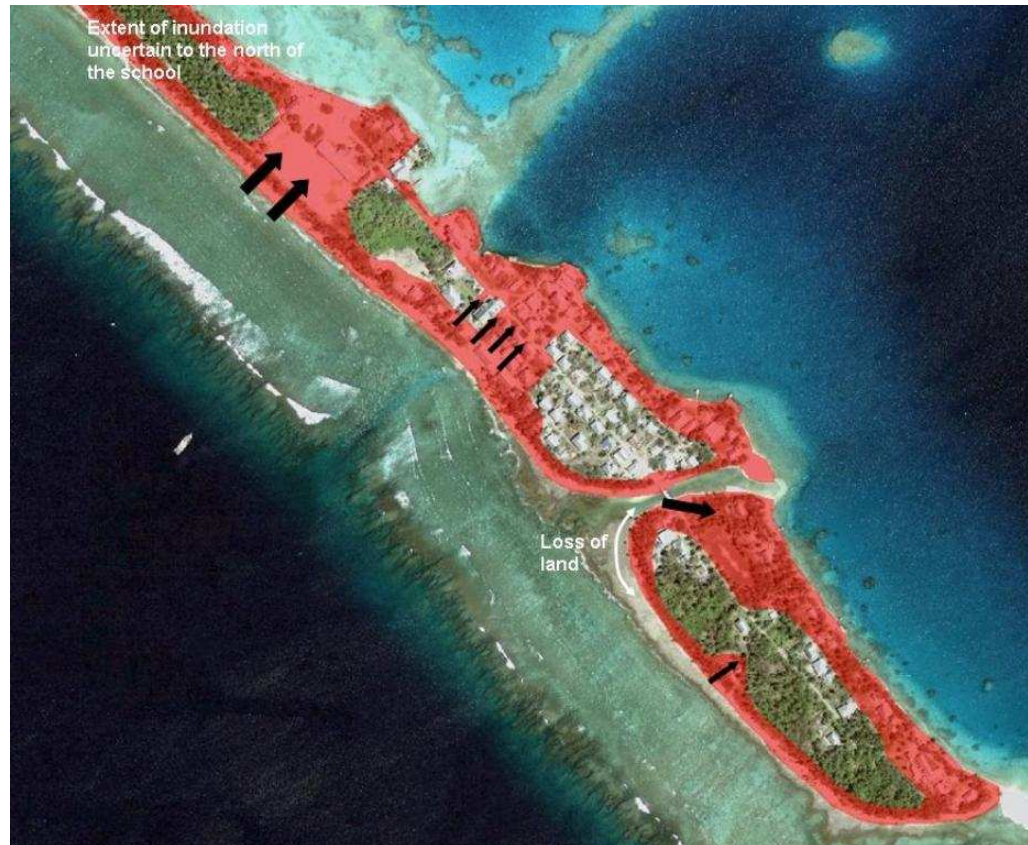
Figure 25: Approximate areas on Nukunonu inundated during Cyclone Percy. Note inundation will not have occurred at the same time at all locations. Black arrows indicate main areas of overwashing from the ocean side. The extent of overwashing to the north of the school is uncertain.

From the damage assessment report, and our own discussions with the *Taupulega* and other members of the Nukunonu community, Figure 25 attempts to summarise the total extent of inundation during Cyclone Percy on Nukunonu.

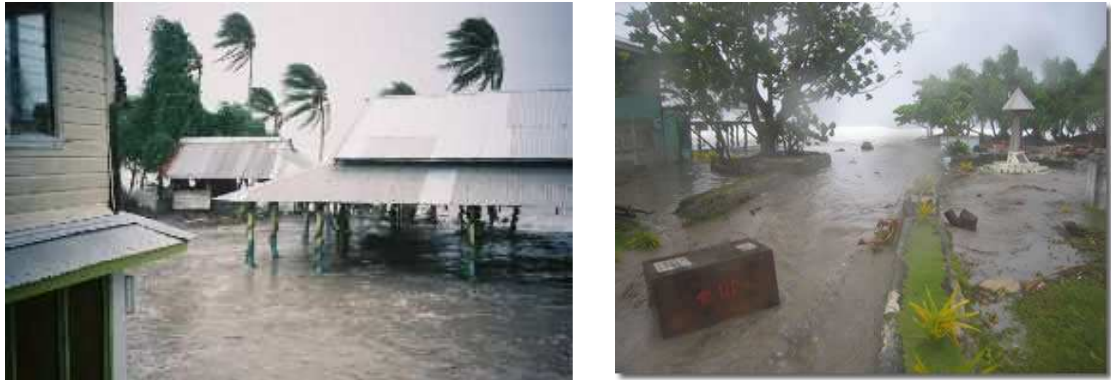
Figure 26: Overwashing to the south of the church opposite the boat channel during Cyclone Percy (Photographs courtesy of <http://www.mfat.govt.nz/foreign/tokelau/tokelauindex.html>).

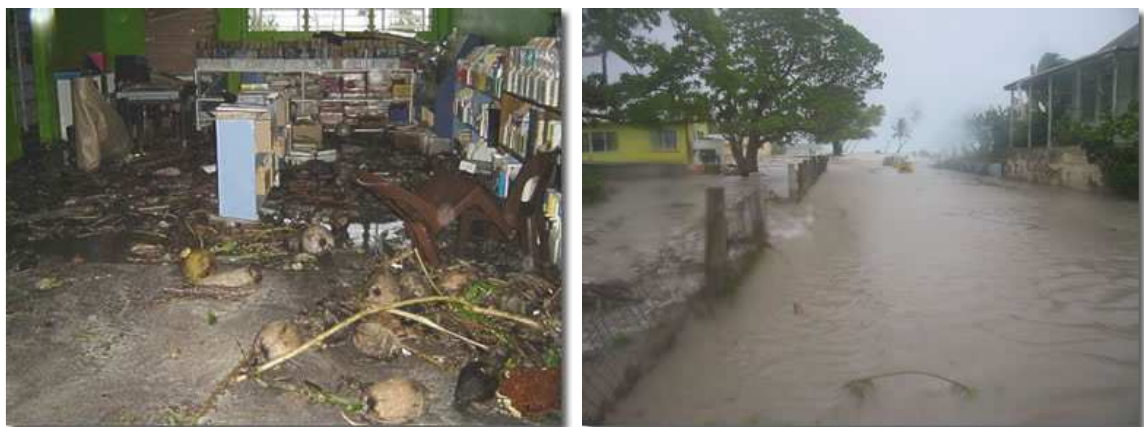
Figure 27: Inundation damage in the school building (left) and inundation looking north (right) from the Luana Liki Hotel on the lagoon side (Photographs courtesy of <http://www.mfat.govt.nz/foreign/tokelau/tokelauindex.html>).

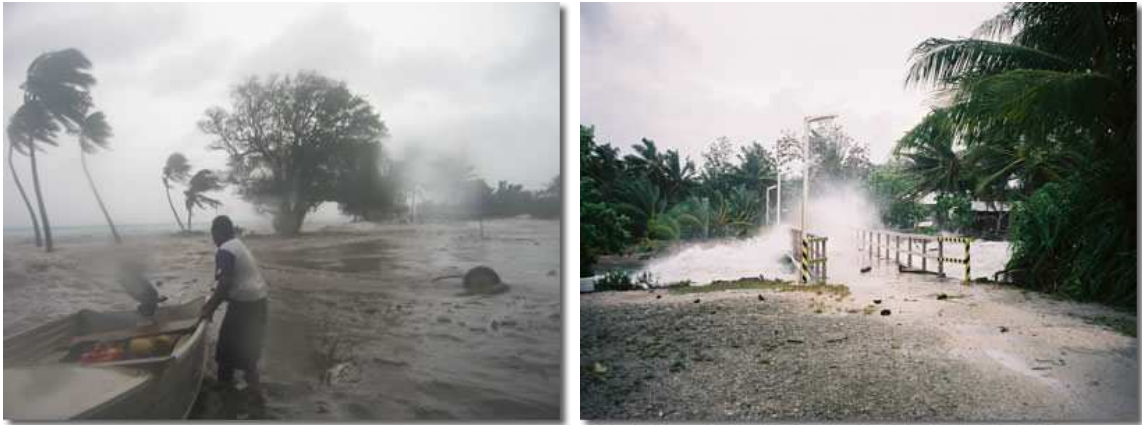
Figure 28: Inundation from the lagoon side opposite the basketball court (right) and wave overtopping of the bridge (Photographs courtesy of <http://www.mfat.govt.nz/foreign/tokelau/tokelauindex.html>).

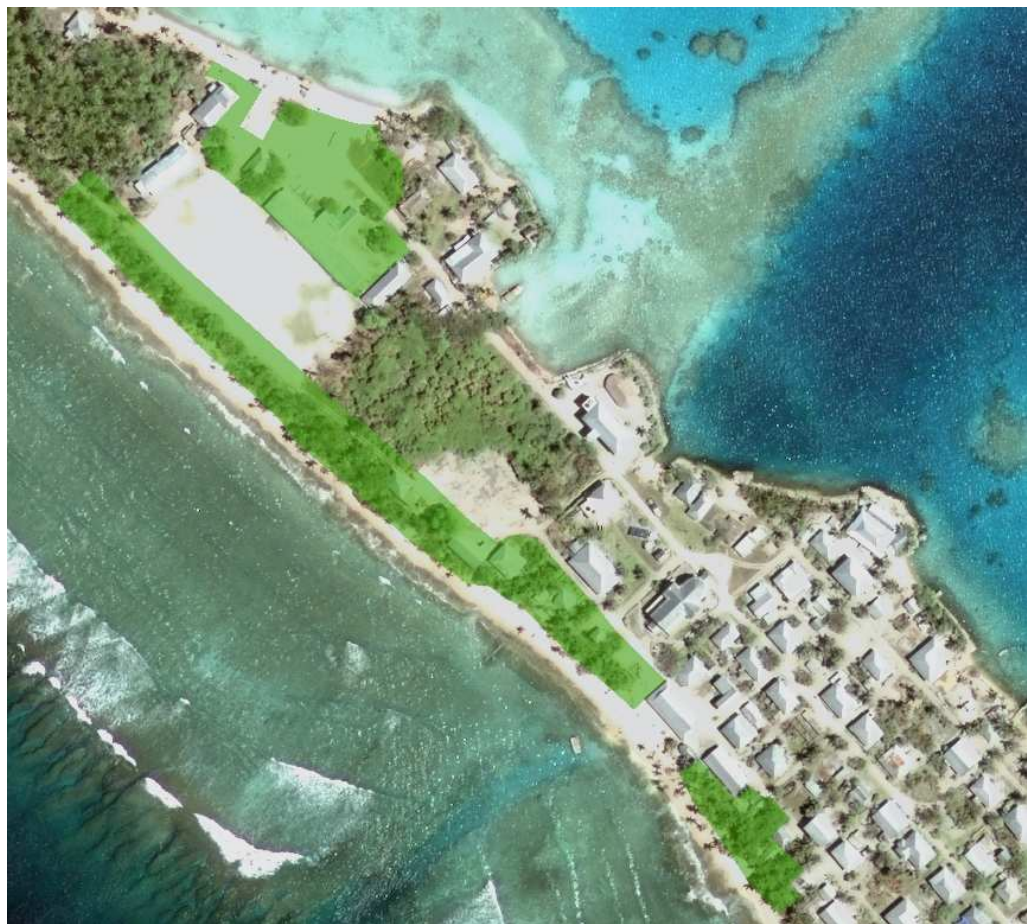
Figure 29: Suggested areas where replanting initiatives should be focused.

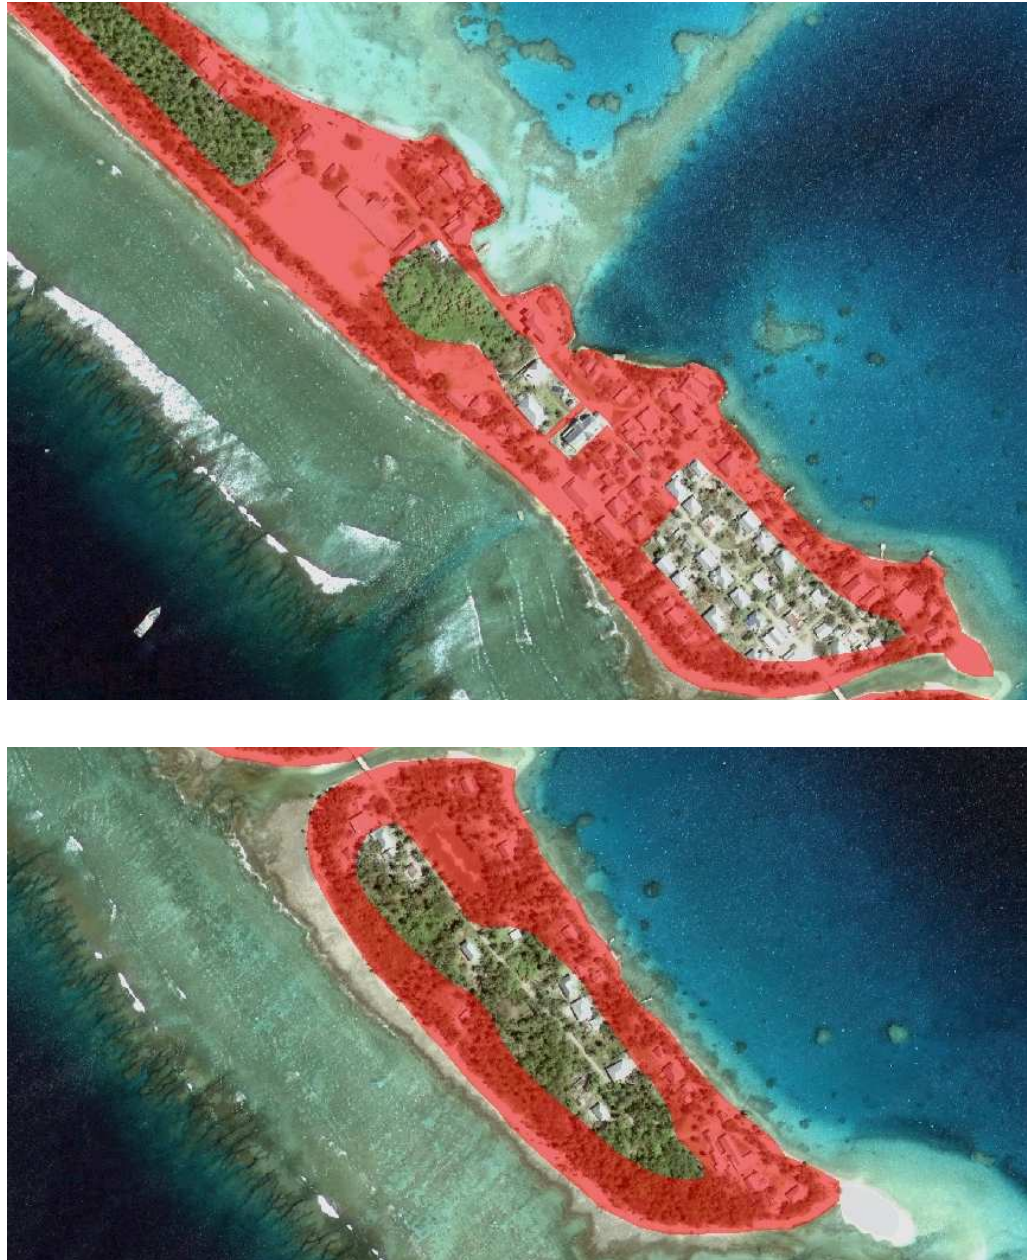
Figure 30: Summary of land areas within Nukunonu (top) and Motuhaga (bottom) at high risk from inundation. This does not imply areas not highlighted will not experience inundation. Note: areas inundated north of the school were not inspected but the same general buffer zones around both the ocean and lagoon side should be applied to any new development.

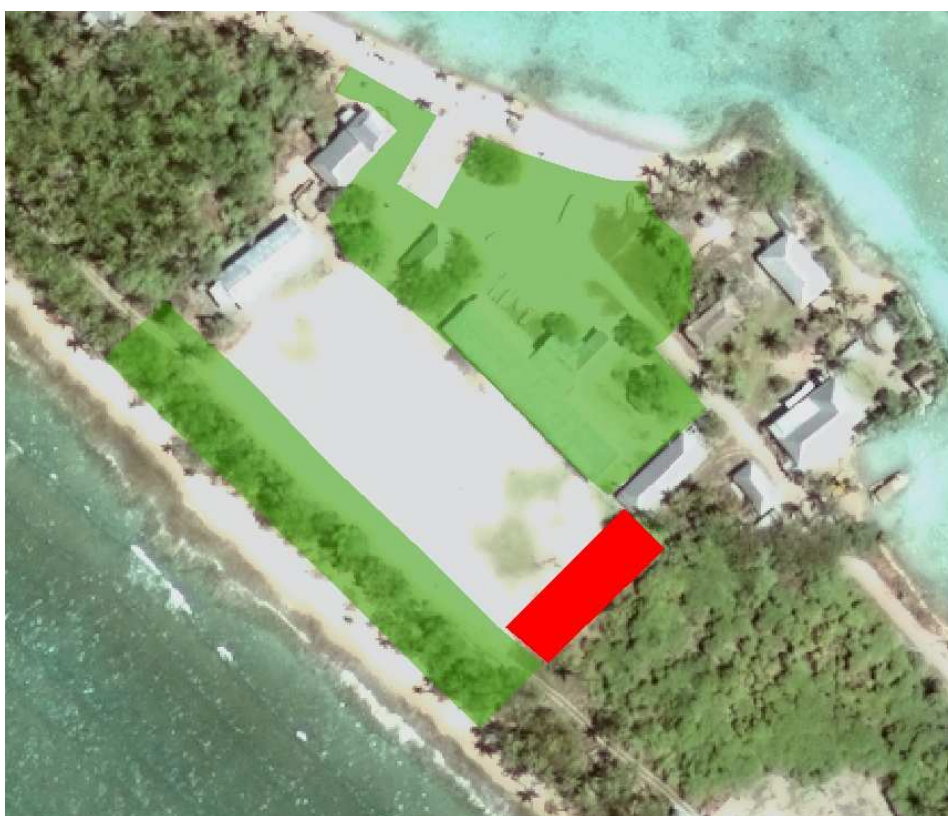
Figure 31: Suggested re-position of the main school building (red) and associated area of vegetation planting (green) to help reduce wave overwashing.

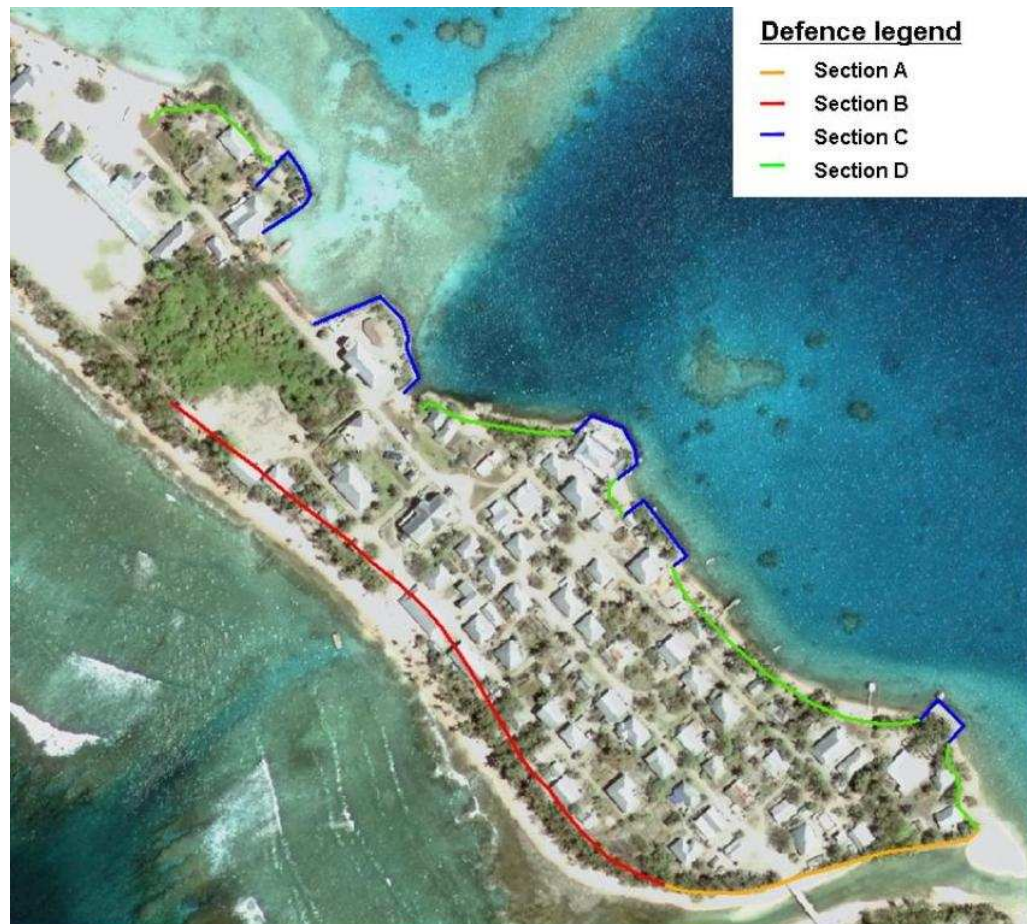
Figure 35: Summary of defence sections for different seawall design profiles around the village on Nukunonu (Figures 36 to 39 for details). The position of the line shows the minimum distance the crest of the wall should be from the vegetation or shore line.
