GOVERNMENT OF TOKELAU

ASSET MANAGEMENT PLAN

Issue Information	
Issue Purpose	Draft for Comment
Issue Date	August 2014
Version Number	1.0

Authorisation	
Tokelau	Jovilisi Suveinakama
Date	August 2014
Prepared By	Kierie Zeelie, Ross Waugh
Reviewed By	Ross Waugh
Report Number	69-143-1001 AMP

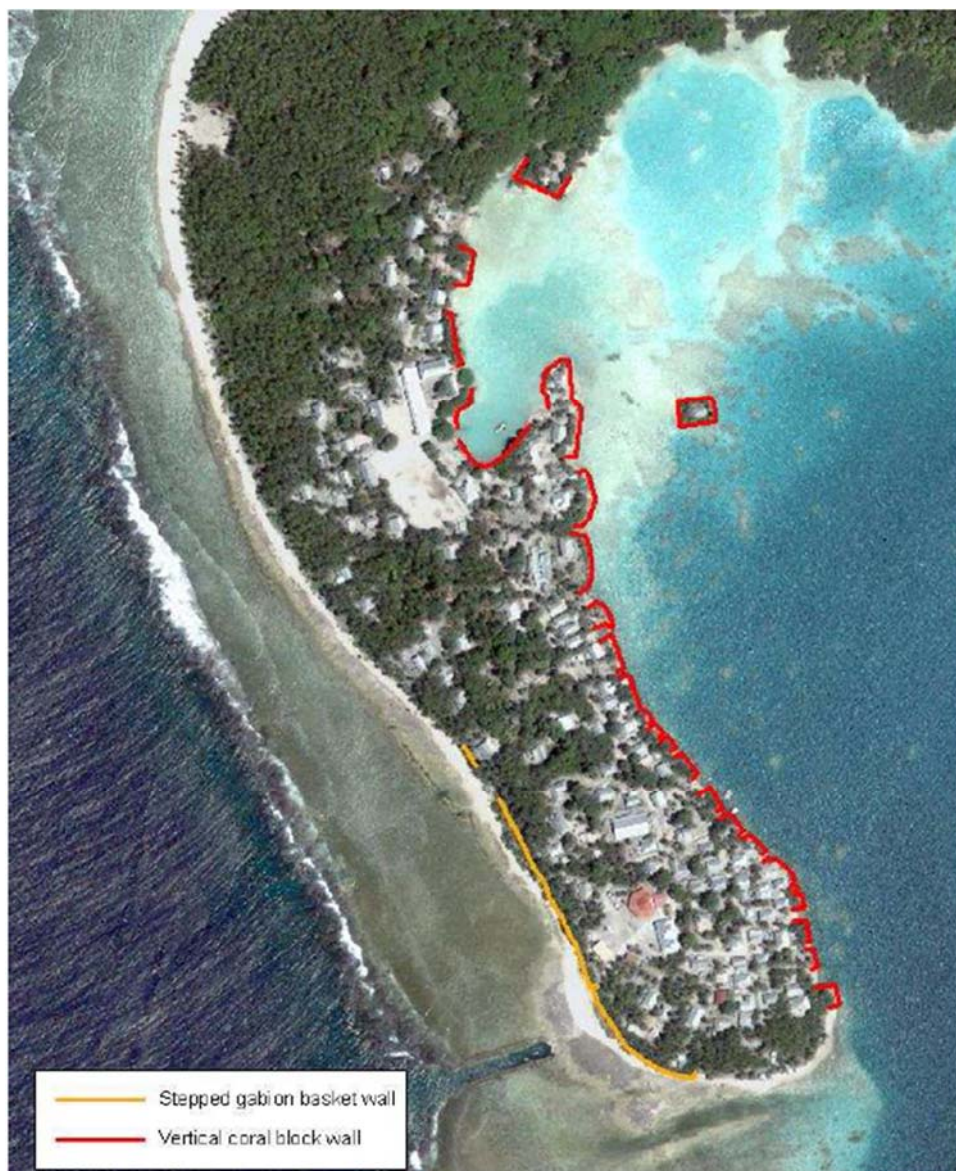
The report “Reducing the Risks of Cyclone storm surge inundation on the atolls of Tokelau – Atafu (2005)” details the existing coastal defences and provides a range of options for future risk management of storm surge inundation. The figure below taken from this report shows the extent of seawalls on Atafu.

The condition of the seawalls are in various states of repair, but in general the seawall are considered to be in a condition grade 2, good.

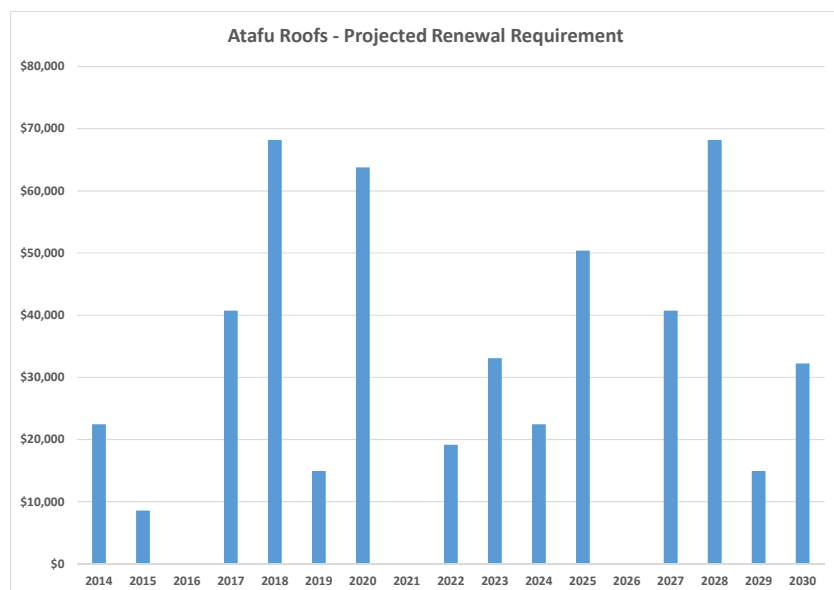
The majority of roofs in Tokelau are corrugated iron and staff interviews suggest that the expected lives of the corrugated iron/steel roofs are severely affected by a harsh marine environment. In general, unpainted steel roofs in New Zealand have an expected life of 20 years, but in Tokelau that expectation is halved to 10 years.

Taking the estimated size of each corrugated iron roof and estimated installation date and using an estimated replacement cost of \$55/m² a projected roof renewal requirement was developed. This requires a total of \$500,000 for roof renewals over the next 15 years with an average of \$33,000 per year. This should be funded out of the building depreciation component.

The viability of changing roofing materials should be investigated (IP 1).

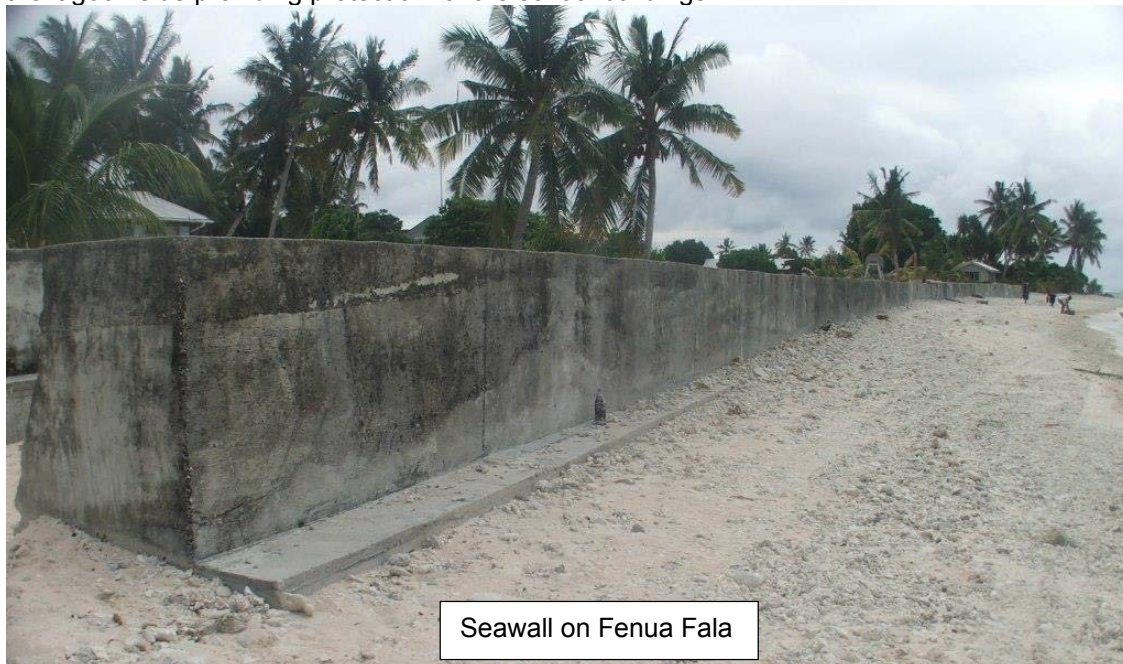
On Fenua Fala there is only one seawall, mass concrete structure, approximately 150 metres long on the lagoon side providing protection for the school buildings.

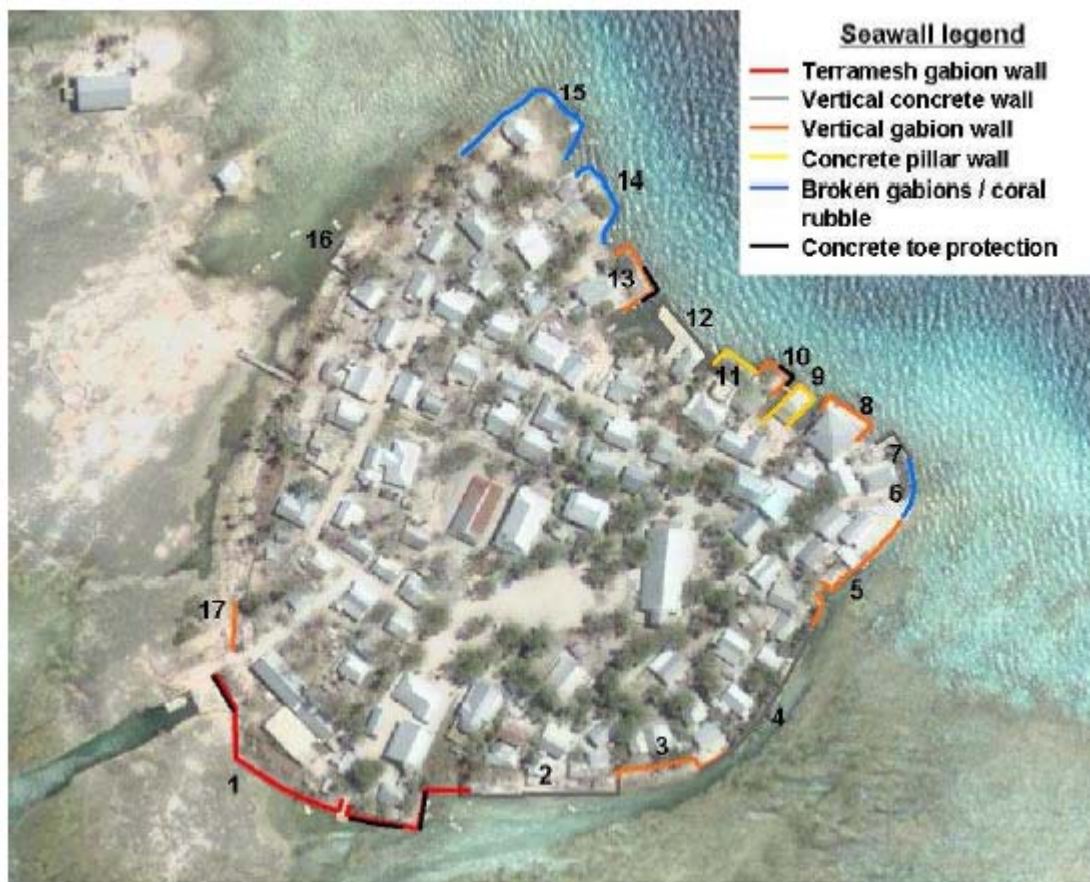
of storm surge inundation. The figure below taken from this report shows the extent of seawalls on Fale.

The condition of the seawalls are in various states of repair, but in general the seawalls are considered to be in a condition grade 2, good.

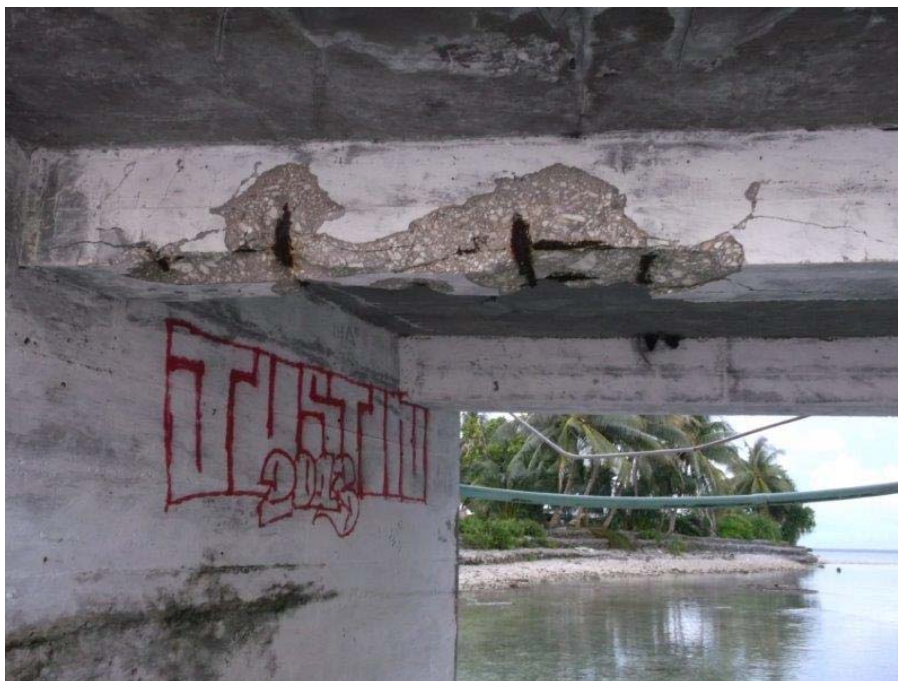
There are significant concrete spalling and corrosion to exposed reinforcement in the underside of the bridge deck, the beams and bridge piers/columns. A superficial assessment estimates that if no remedial action is done the bridge life is less than 5 years and pose a significant risk to the community.

Having reviewed the photos from the site inspection. We are of the opinion that it will not be cost effective to repair the concrete spalling to the bridge spans as we believe that the exposed reinforcing steel has lost to much sectional area.

The spalling to the bridge piers is repairable by treating the current corrosion and installing additional steel with additional concrete to provide adequate cover.
