Reducing the risks of cyclone storm surge inundation on the atolls of Tokelau

Atafu

**NIWA Client Report: HAM2005-119
July 2005**

NIWA Project: UNS05201

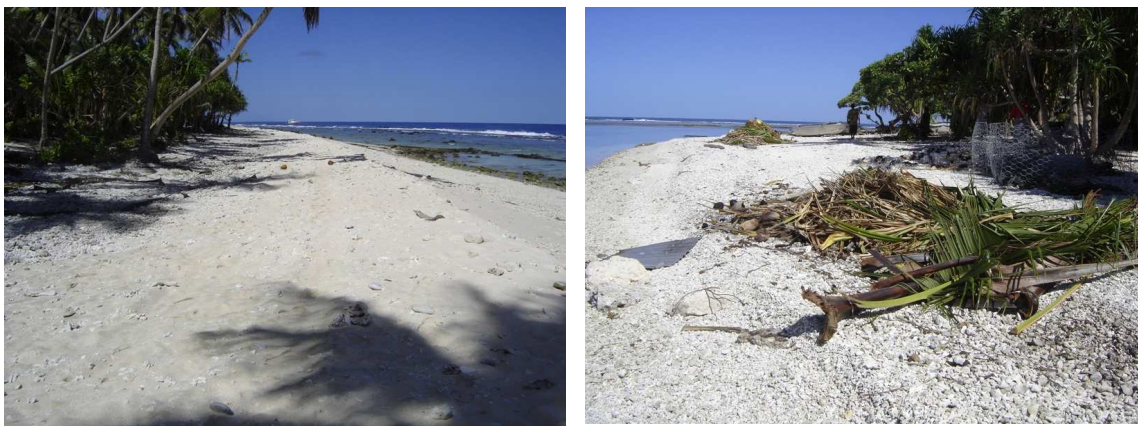
Whilst cyclones can cause erosion and damage, their occurrence is vital to the long term future of the motu on Atafu as they continue to supply fresh sand and coral rubble to build the motu around the island. This counters the loss of sand and coral rubble that occurs from the motu, due to both natural processes, such as sand being transported in to the lagoon, and increasingly, and of greater consequence, due to human impacts, e.g., sand mining.

Figure 2: Accretion along the northwest coastline (left) and at southern end (right) of Atafu.

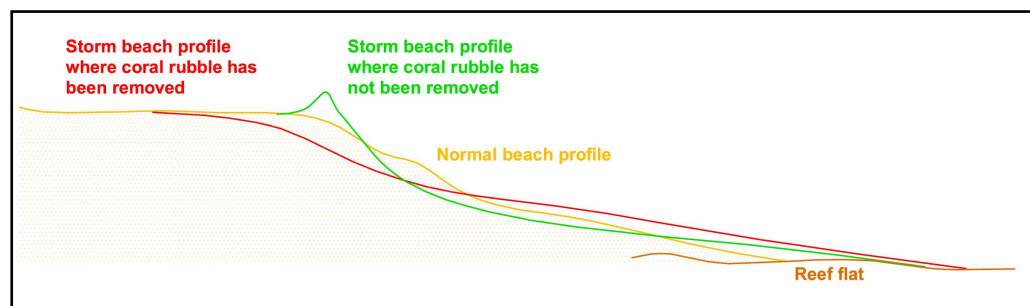
Where there is a lot of coral rubble (or smaller waves / lower water level) a storm berm will tend to build up with the upper part of the beach becoming steeper (green profile in Figure 3). An example of this is the beach on the ocean side of Fenuafala on Fakaofu (Figure 4 left). Where there is less coral rubble, i.e., the beach has more sand or small coral rubble (or where people have removed the larger coral rubble), the beach crest will tend to move landward and the beach slope becoming more shallow (red profile in Figure 3). An example is the ocean beach along the village frontage on Atafu (Figure 4 right). Such a situation makes wave overtopping and overwashing more likely to occur.

Figure 3: Beach profile change caused by large waves and the impact of removing coral rubble from the beach.

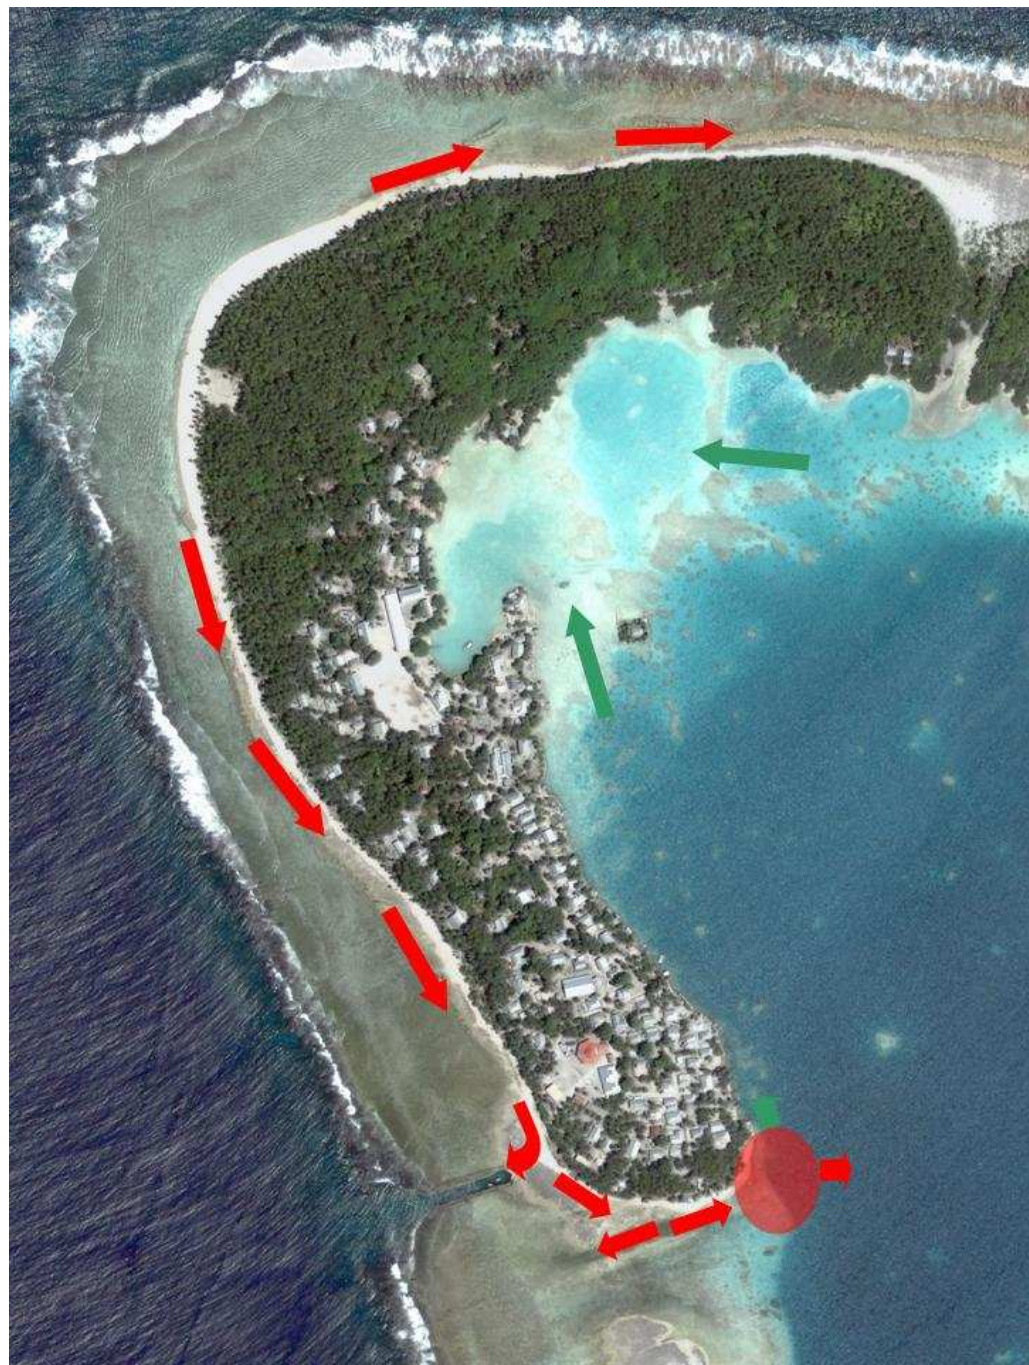
On Atafu, beach sediment tends to get moved to the south along the western facing ocean beach (Figure 5) from the area where there is natural beach build up along the north western side of the motu. In addition to build up at the southern end of the atoll during cyclone events (as happened in 1914), this further results in the southern end of the coastline tending to build up. Sand that is moved around the southern end of the motu will tend to be deposited on the lagoon side and will either be transported in to the lagoon or along the lagoon shore (for example the build up of sand against the southern section of reclamation on the lagoon side).

Figure 5: Dominant directions of sediment movement along the coastline of Atafu (adapted from McLean, 1993).

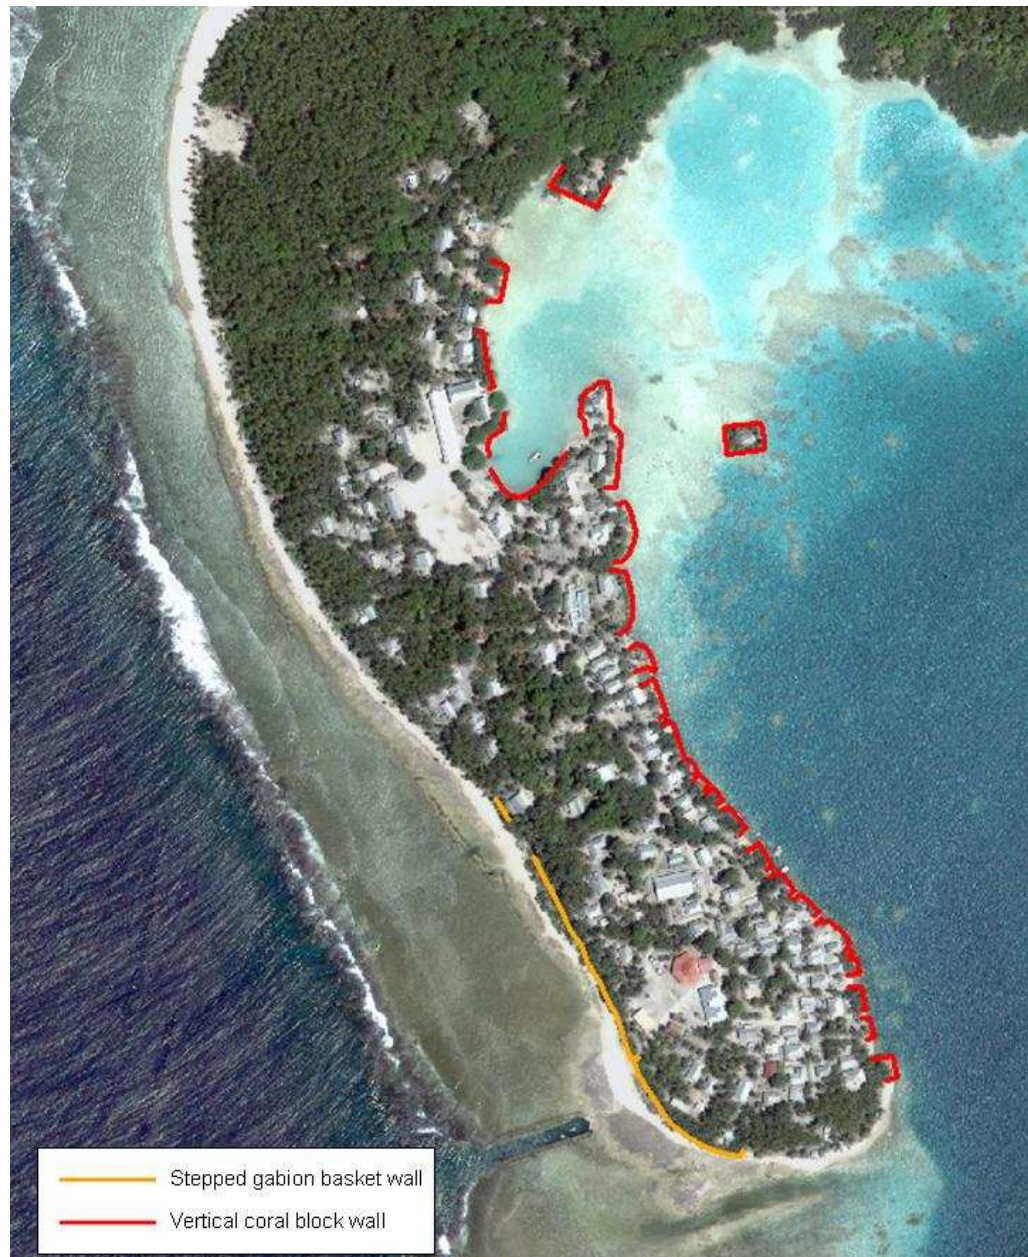
Figure 7: Summary of the location and type of seawalls constructed around Atafu.

Approximately 130 m of gabions have been constructed to the south of the access point to the boat channel and about 200 m to the north. The rubble used to fill many of

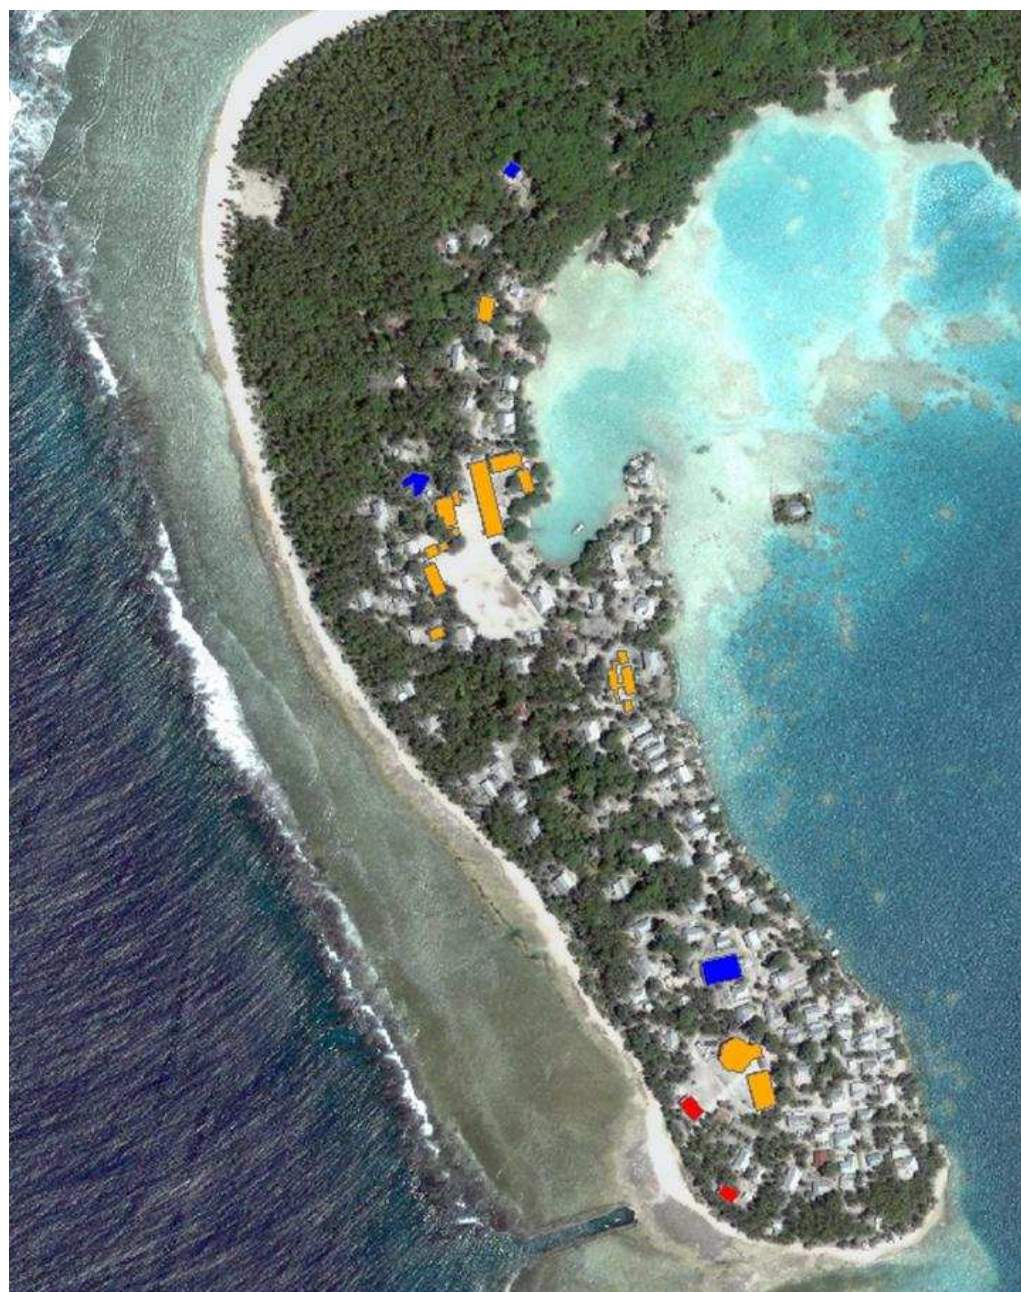
Most of the key community buildings and infrastructure have been well sited on Atafu - for example the power generator, (Figure 14, left). The community buildings at most risk are the bulk storage sheds (Figure 14, right). The UNDAC Cyclone Percy damage assessment (Laurence & Hill, 2005) noted that around half the stock was washed away, and other stock had to be written off, with the sheds all damaged to some extent. However, subsequent discussions suggested that most of the stock had been

moved to a safe location prior to the cyclone and that little stock was actually damaged despite water entering the building. No claim had been made by Atafu for replacement of damaged stock due to the cyclone.

Figure 13: The relative risk of inundation or damage to community buildings due to waves overwashing Atafu. Red = high risk, Orange = medium risk, Blue = low risk.

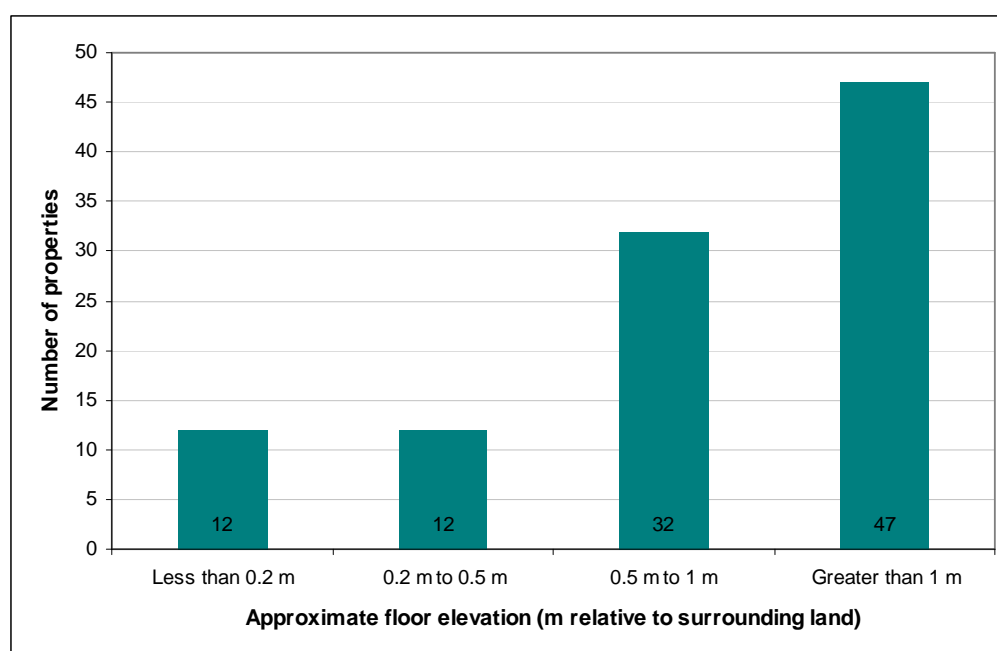
introduction of the housing grant scheme, of raising floor levels either by constructing the water tank under the house, using concrete piles or a raised concrete slab. Figures 16 and 17 summarise the number of houses and their approximate floor elevations (relative to the surrounding ground surface).

Figure 16: Summary of the number of houses with various floor levels on Atafu.

Implementation of *Recommendation 12* can be easily achieved by the *Taupulega* through continuation of the Housing Grant Scheme. If possible the emphasis should be on replacing (or relocating) existing housing with floor levels less than 0.5 m, which are located in the hazard zones identified in Figure 19 above). Comparing Figures 17 and 19, this suggests there are eight houses with floor levels below 0.5 m on the lagoon side, and around 12 houses in the high risk zone on the ocean side.

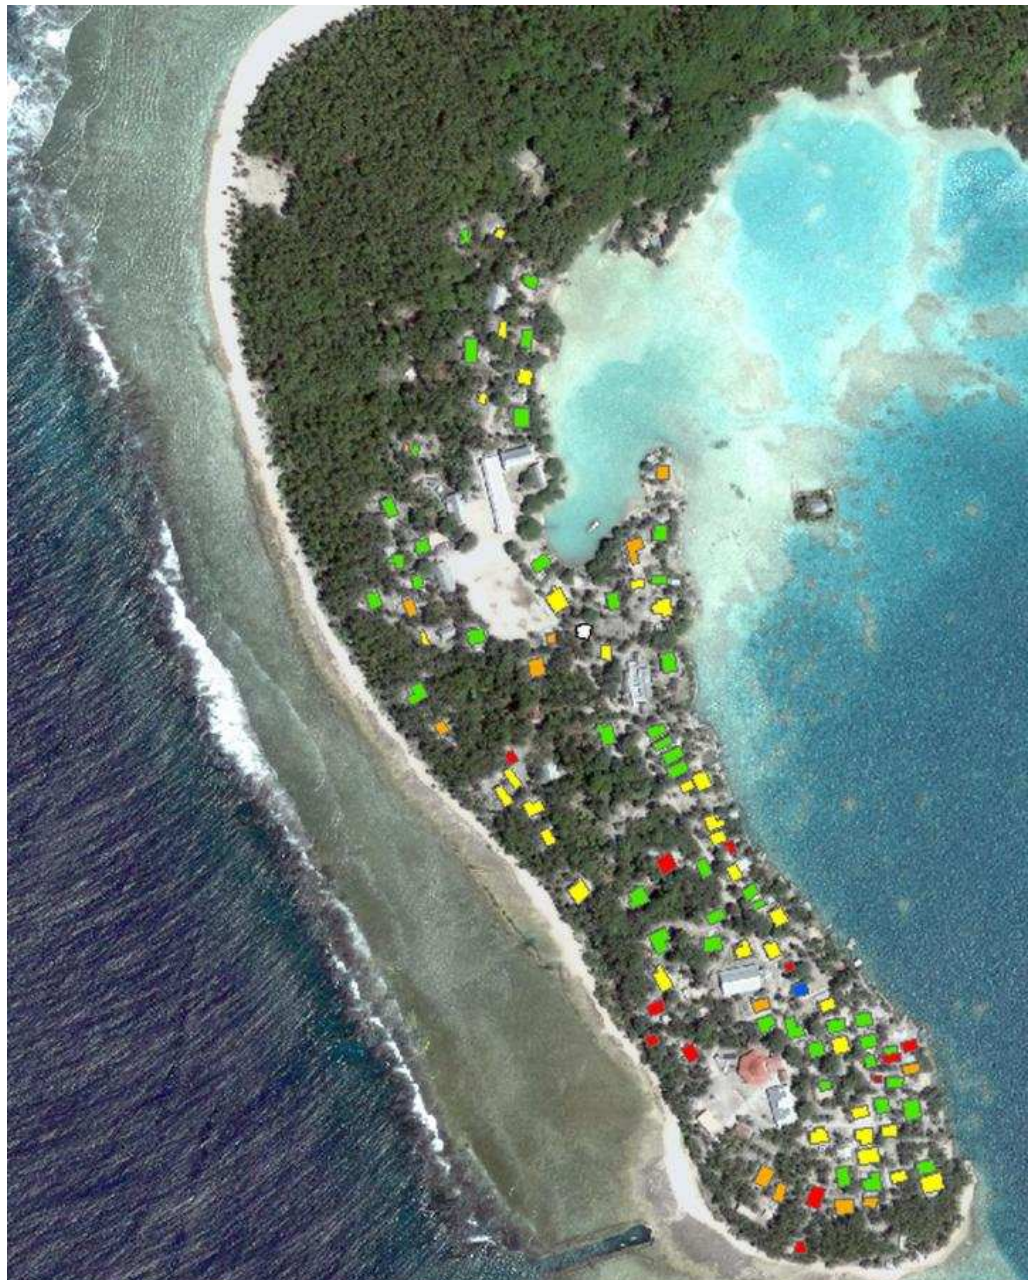
Figure 17: Floor levels of residential properties relative to surrounding ground levels. Red = < 0.2 m, Orange = 0.2 – 0.5 m, Yellow = 0.5 – 1 m, Green = 1 – 2 m, and Blue = > 2 m.

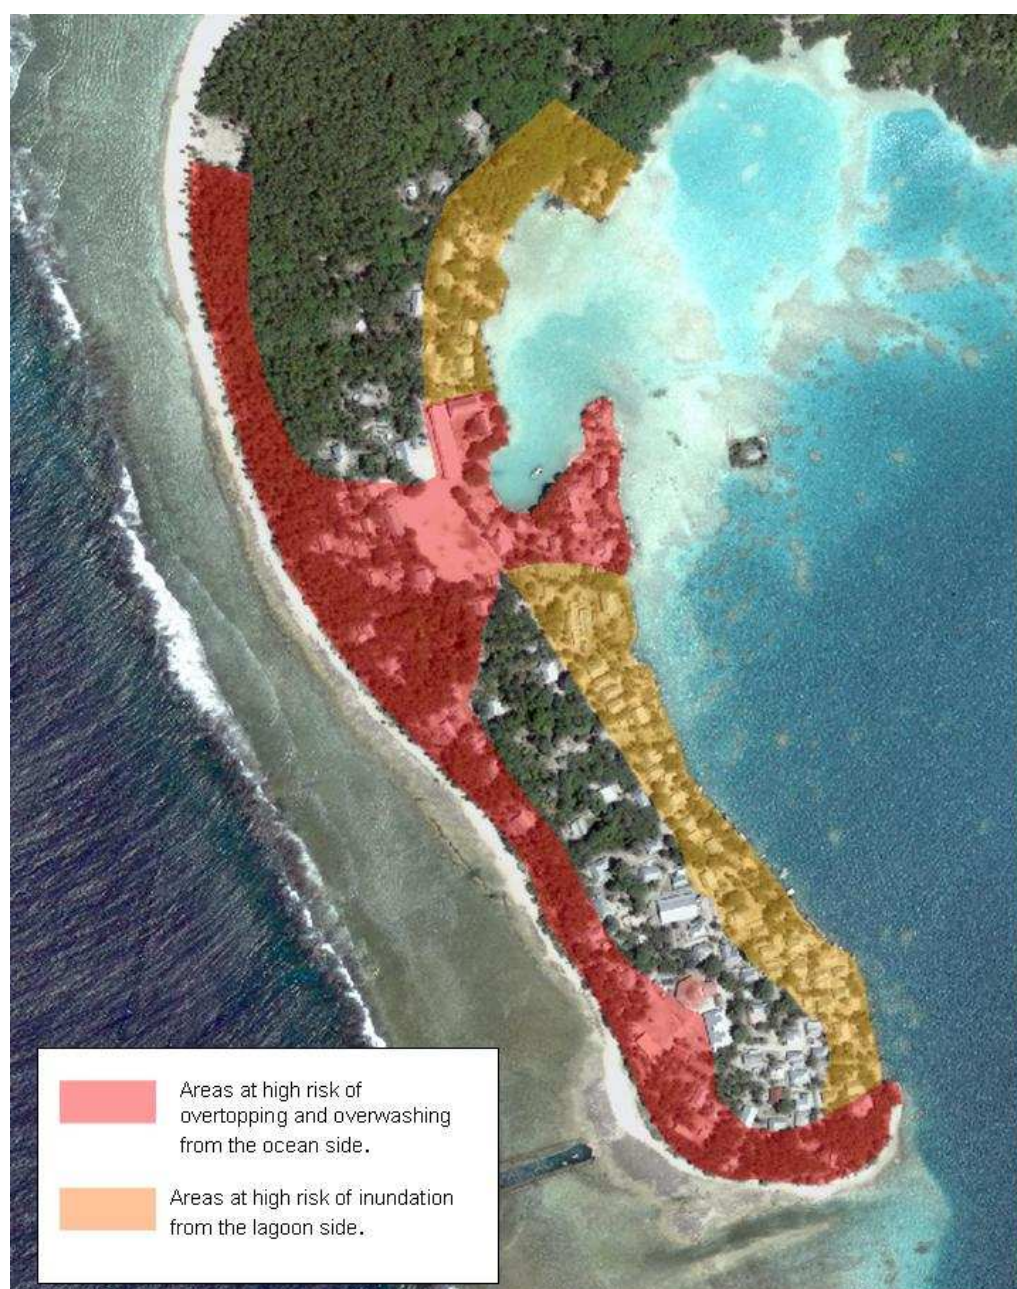
One of the most effective ways to reduce risk is avoiding building or locating essential infrastructure in areas that are known to experience inundation during cyclone events. From the inundation caused by Cyclone Percy, and from discussions with the community of inundation extents during previous cyclones, Figure 19 summarises, in a simple format, the main areas within the village that can be considered high hazard zones.

Figure 19: Summary of areas within the village at high risk from inundation. Note an inspection was not made of the northern part of Atafu but the same general buffer zones around both the ocean and lagoon coasts should be applied to any new development in this area.

Recommendation 5: No further community buildings or essential infrastructure development be constructed with the high hazard (red or orange) zones.

Recommendation 6: That the Atafu community discuss, develop and implement an approach (with assistance from land-use managing planning experts) that addresses the needs of both the community and the individual landowners, to restrict further residential building development within the high hazard red zone.

Recommendation 7: On the lagoon side (orange zone), further future residential building be allowed only if no other safer building locations are available to the particular land-owner provided that the floor level of the property is constructed to be

Whilst it cannot be stressed strongly enough, it is vital to ensure that further residential property is not constructed within the high hazard zones identified in Figure 19. If for a particular reason this cannot be avoided consideration should be given to the use of piled foundations, ensuring that the piles are well founded to withstand overwashing forces, braced where necessary, and have sufficient structural connection to the main structural frame of the house..

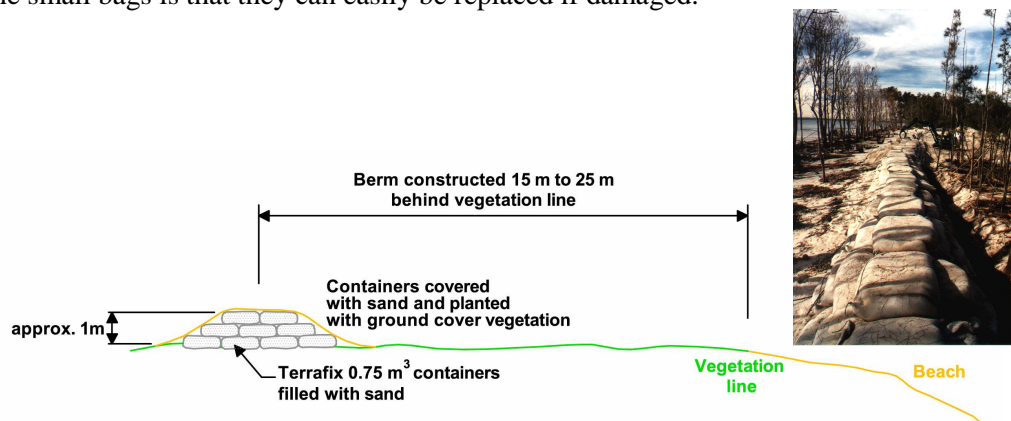
Figure 21: Berm structure created from Terrafix soft rock containers. The inset photograph shows a similar berm application (photograph courtesy of Soil Filters Australia Pty Ltd).

Two methods of construction were discussed. The first, and the preferred method, would be to create a berm using Terrafix Soft Rock³ containers (Figure 21). These are strong bags of various sizes which are filled with sand and used in marine works. Due to the lack of heavy lifting equipment the smaller sized 0.35 m³ or 0.75 m³ bags would need to be used. For stability the larger size would be preferable but this may be beyond the lifting capacity of the new Bobcat excavator that was about to be delivered to Atafu. If so, some consideration may need to be given to the hire of a larger loader / excavator from Samoa during any construction phase. The other advantage of using the small bags is that they can easily be replaced if damaged.

The completed structure would be create a berm around 1 m high. Figure 21 shows a cross-section using nine containers. On sections of the coastline where the overwashing risk is lower, or where the structure is located further back from the vegetation line, a reduced cross-section using six containers may provide sufficient stability, reducing the construction cost of the structure significantly.

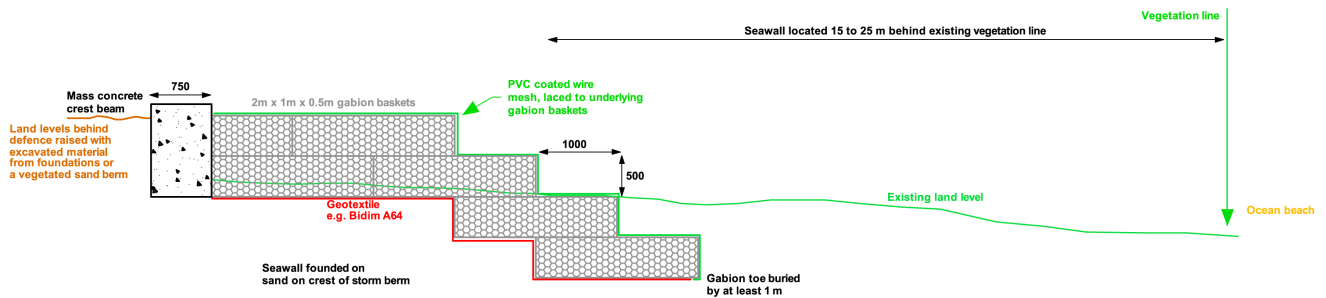
Figure 22: Gabion berm option. Dimensions in mm unless otherwise stated.

The second option is to create a gabion berm (Figure 22). As with the previous design this would be located 15 to 25 m behind the vegetation line close to or just seaward of the crest of the storm berm. It is similar to the original gabion designs suggested by Brockliss (1992), albeit located further back, with the function purely to act as a secondary line of defence in reducing wave overwashing of the entire motu. As with the scheme above, this design allows the beach system to continue to act as the primary defence and but will reduce the potential for ocean waves entering the village, particularly if the area between the vegetation line and the defence is well vegetated. The concrete crest beam will provide extra stability to the defence but it is suggested that land levels (e.g., using fill from the excavated foundations) are built up immediately behind the defence and stabilized with low ground cover vegetation.

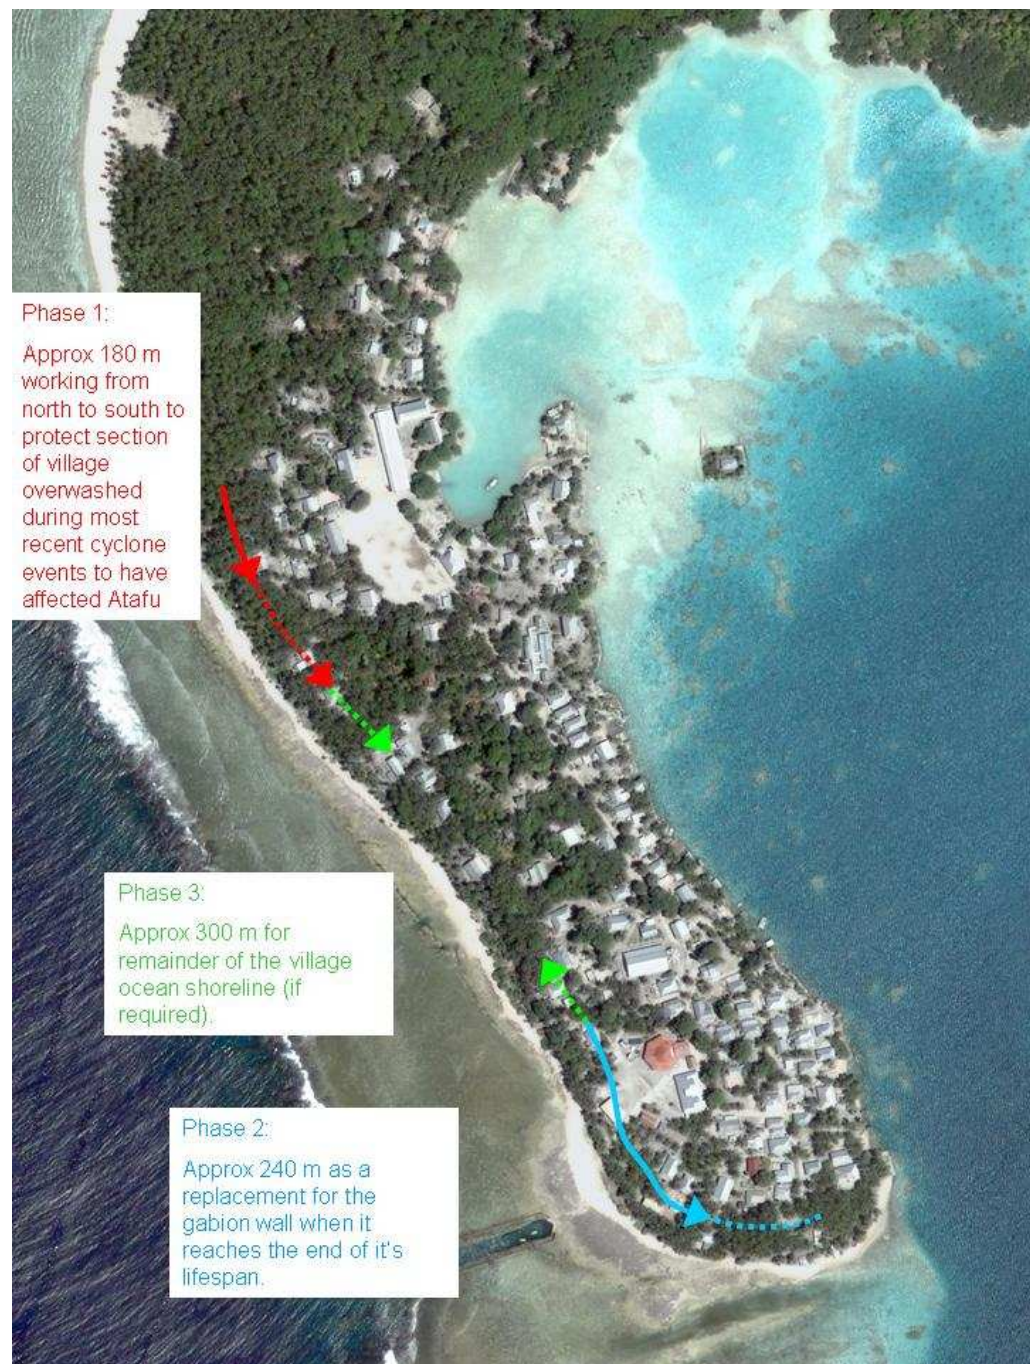
Figure 23: Construction phasing and approximate location of berm defences

The construction of such a berm along sections of the ocean frontage will be a long term endeavor dependent on both labour and funding availability. It is suggested that the first phase be treated as a demonstration phase, with review and evaluation of the methodology (construction lessons, ways to reduce labour commitment etc.) and performance, prior to the construction of further phases. It is suggested that the main

priority for the first phase should be the area to the seaward side of the school (approximately 120 m in length) that has experienced overtopping and overwashing during most of the cyclone events that have affected Atafu (Figure 23).

- Phase 2: In front of, and to the south of, the Administration buildings as a long term replacement for the gabion seawall when it reaches the end of its lifespan (it is unlikely that a direct replacement for the gabion seawall could be justified for both environmental and economic reasons).
- Phase 3: Extending southwards from the first phase.
