Reducing the risks of cyclone storm surge inundation on the atolls of Tokelau

Fakaofu

**NIWA Client Report: HAM2006-077
March 2006**

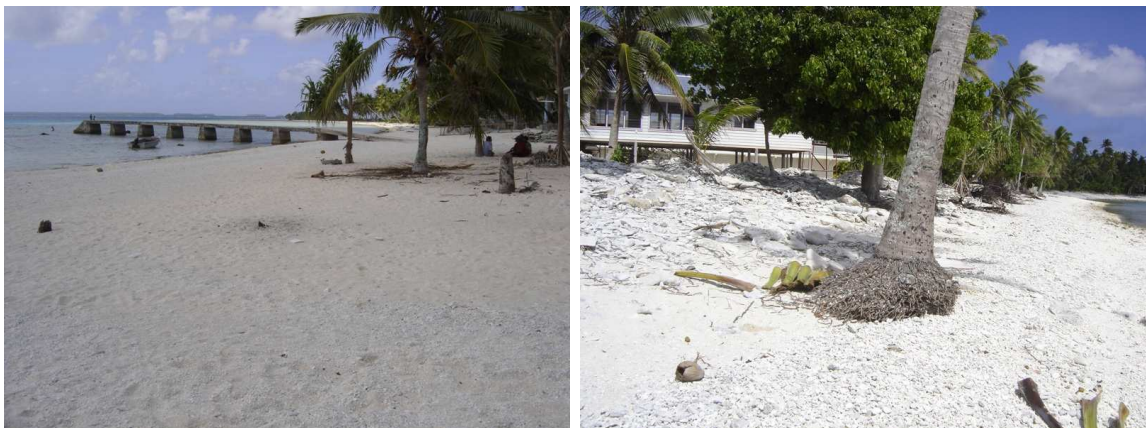
- The sandy beach along the eastern lagoon shoreline (eastern point to the school) is shallow sloping and characteristic of a relatively sheltered beach system which experiences little significant wave action (Figure 4, left). Due to its shallow nature, waves that reach the beach during cyclones dissipate over a very wide area including washing over the area behind the beach. As such a beach system rarely experiences large waves, considerable changes in the

- Between the school and the north western corner of the island, the beach sediment characteristics gradually change from a sand beach to one where coral rubble dominates, reflecting the increase in wave energy away from the lagoon towards the ocean (Figure 4, right). As the wave energy experienced on the beach increases, this tends to winnow out the finer sand sized sediment and move it along shore to a less energetic location leaving behind the coral rubble. This can be a long term process or can happen quickly for example during a particular cyclone event. This change can lead to a retreat of the shoreline as the beach profile steepens due to the increase in dominance of the larger beach material and a dynamic-equilibrium is reached between the beach material and the wave energy climate.

Figure 4: Sand beach along the eastern end of the lagoon shoreline (left), mixed coral rubble / sand beach looking towards the western end of the lagoon shore (right).

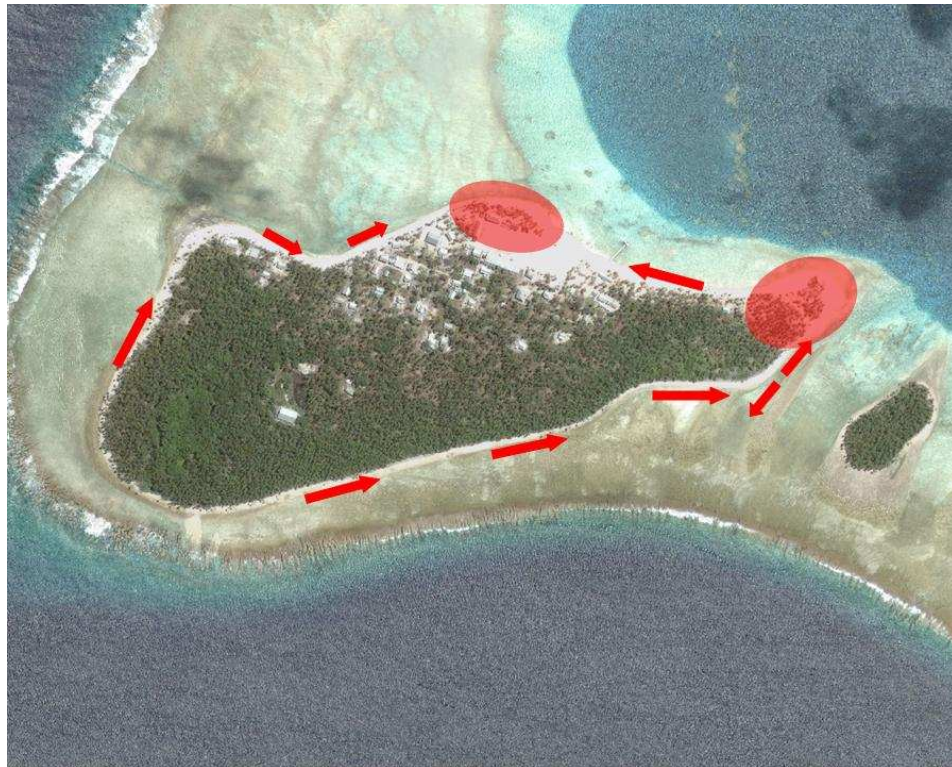
On the southern (oceanside) of Fenuafala, sand and smaller cobble rubble tends to get moved to the east which contributes to the build up of land at the eastern end of the motu (Figure 6). Sand is also transported around the eastern end and is subsequently moved in a westward direction along the lagoon shore towards the school by waves generated within the lagoon by the prevailing easterly winds. However, along the western lagoon shore, ocean swell propagating over the reef tends to move sediment in an easterly direction. This ‘meeting’ of sediment being transported along the lagoon shore results in the ‘bulge’ in the coastline upon which the school is located. McLean (1993) also suggests that the lagoon shoals towards Fenuafala with sedimentation continuing to the west of Tuimanuka reef and along the motu’s lagoon shore.

The largest changes in shoreline position (either accretion or erosion) during cyclone events tend to occur where the orientation of the coastline changes, such as at the eastern end, or “bulge” in front of the school.

Figure 6: Dominant directions of sediment movements along the coastline of Fenuafala and areas where longshore sediment transport pathways converge and accretion tends to dominate (red shaded areas).

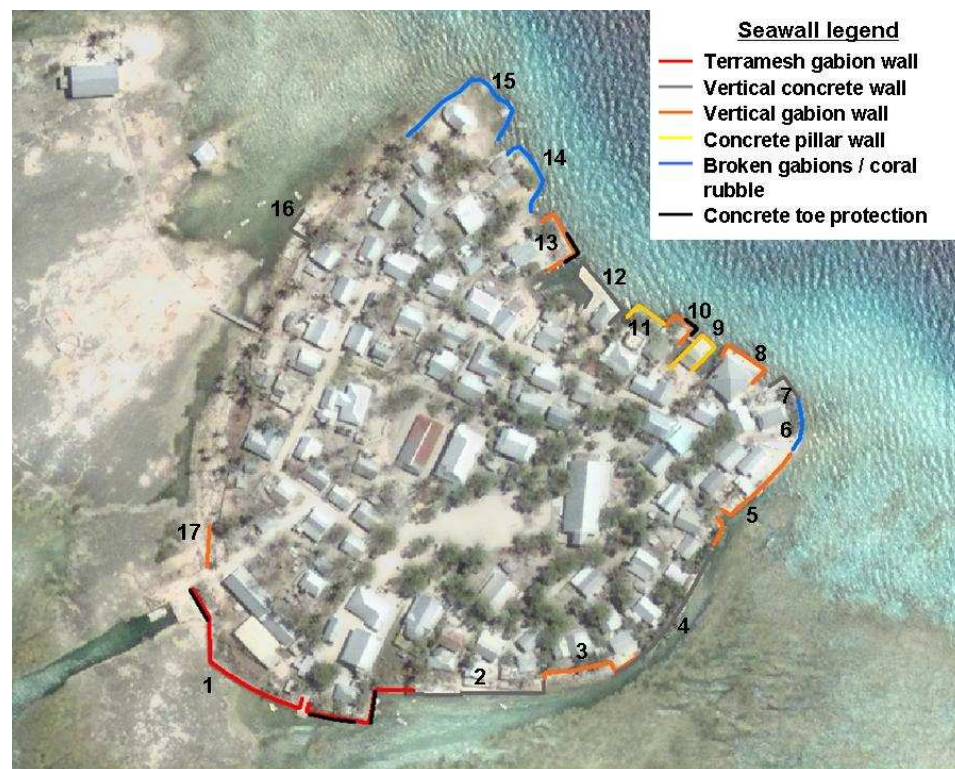
Figure 9 summarises the extent of built coastal defence structures around Fale. The motu is surrounded by a variety of seawall structures, some have been well constructed, others less so. All these defences are in various states of repair, some still performing effectively but requiring maintenance, others beyond repair and providing little protection. Essentially the motu is now artificial with the community totally dependent on the protection provided by the seawall structures.

Figure 9: Summary of the location and type of seawalls constructed around Fale.

(Figures 10 to 12). This is an important section of defence (Section 1, Figure 9). If it were to fail there would be a significant loss of land, and a number of community buildings potentially lost (bulk storage sheds, freezer facility) as well as a number of residential properties affected.

The other main section of community defence fronts the new Administration building is located on the south east corner of Fale (Section 8, Figure 9). The building is fronted by a gabion seawall, that has been well constructed and is reasonable condition apart from some gabion damage at the southern end (Figure 13, left). However, the gabions have been stacked to create a vertical wall, rather than stepped, which is resulting in the wall tilting seawards (poor foundation of the structure may also be contributing to this) due to the forces created by the backfill behind the wall. There have been a number of attempts made to stabilise the toe with concrete, none of which have been successful.

Along the southern coastline, the two main sections of vertical concrete wall (Sections 2 and 4, Figure 9) are substantial (Figure 14) with frequent variations in profile to accommodate access and boat tie up areas. The walls have typically been constructed using a thin concrete facing over gabions or coral block walls rather than mass concrete. Whilst some damage to the concrete is evident, particularly along Section 2, (e.g., shown in Figure 12 right) the walls are still functioning effectively. However, once the concrete facing is damaged, deterioration of the wall could be rapid during periods of large waves with the potential for much of the concrete facing to be lost and the wall significantly damaged.

With the exception of the vertical construction of the gabion baskets, the walls have generally been well built (the exception being the section around the ongoing reclamation at the northern end on the lagoon shore (Section 15, Figure 9)). The crest of the gabion seawall sections have typically been built no higher than the land level backing the wall, reducing the potential for damage to the baskets at the crest, and the gabions have been well packed with coral rubble of a suitable size and shape (which will be suitable for reuse when the seawalls need to be replaced).

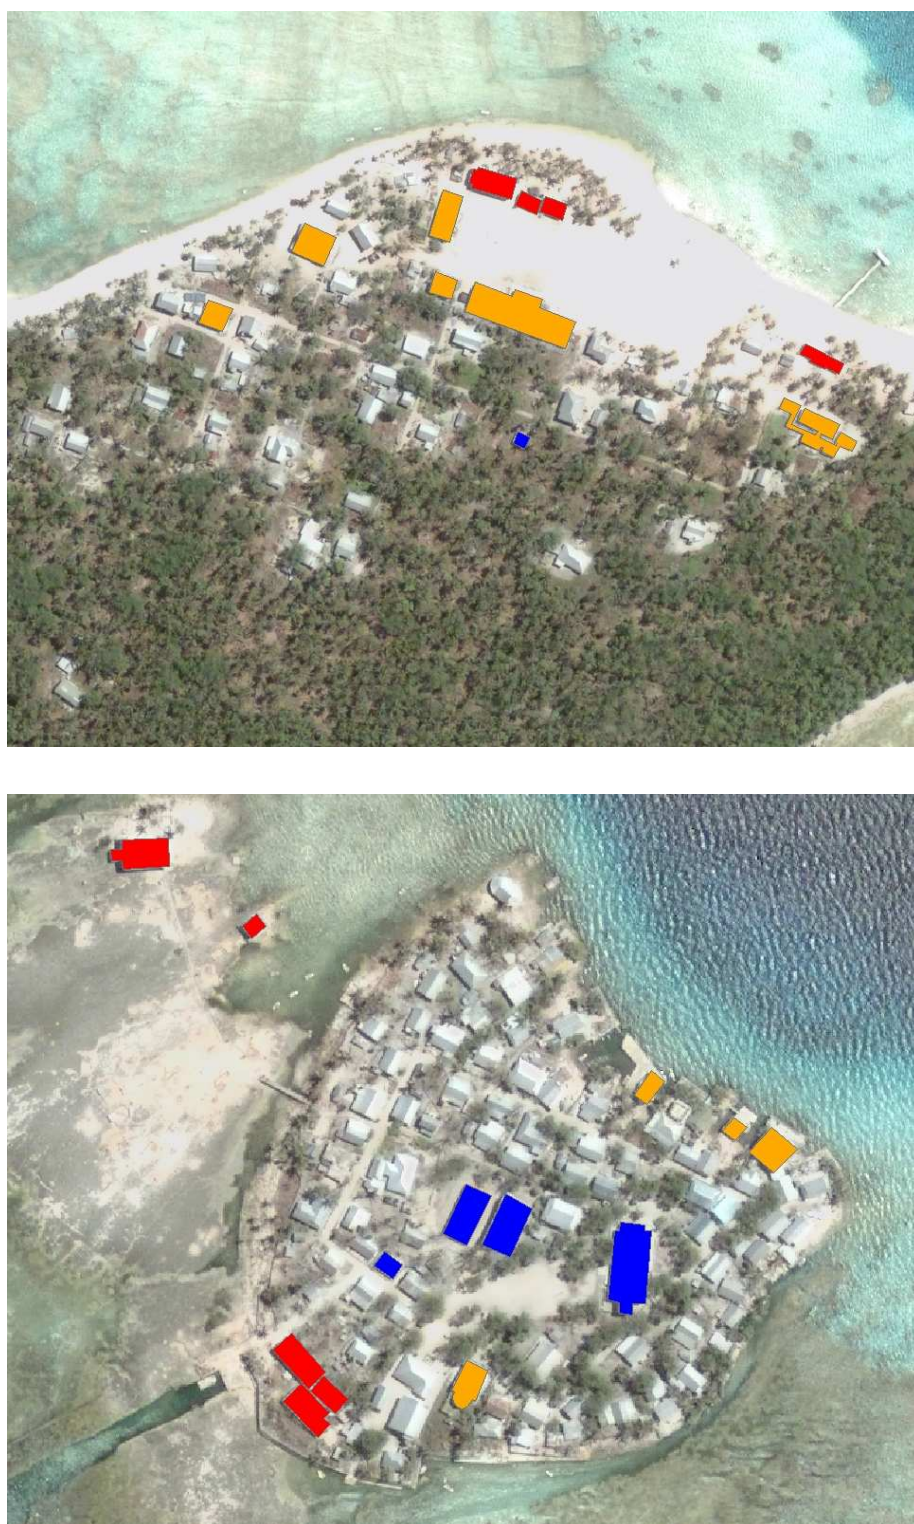
The location of key community buildings on Fakaofu are split between Fale and Fenuafala. Some, such as the power station on Fenuafala are well sited in low risk areas inland. On Fale, the power station (Figure 22), located in one of the raised buildings on the *te papa* to the north west of village, is at very high risk to cyclone damage, either directly to the building or to the power link to the village being damaged, due to its exposed location. However, it is planned that power generation for Fale will be transferred to Fenuafala in the near future and supplied by an undersea cable which is already in place. The bulk storage sheds on Fale (Figure 22) are both high risk due to both their location and the low floor levels, particularly the shed closest to the boat channel. The UNDAC Cyclone Percy damage assessment (Laurence & Hill, 2005) noted that the shed suffered considerable damage, including loss of doors, and despite contents being placed on shelves, there was much damage to stored goods such as cement.

Figure 21: The relative risk of inundation or damage to community buildings on Fenuafala (above) and Fale (below) due to overwhelming waves. Red = high risk, Orange = medium risk, Blue = low risk.

On Fenuafala, the school buildings are all located on low-lying land close to the lagoon shoreline which, given its location and elevation, would be expected to be inundated during cyclone-induced storm surge conditions. However, the potential for damage has been significantly exacerbated by the lack of vegetation to stabilise the surrounding land areas. The relatively low floor levels in a number of the buildings resulted in water entering them but contents had been removed beforehand so losses were minimised.

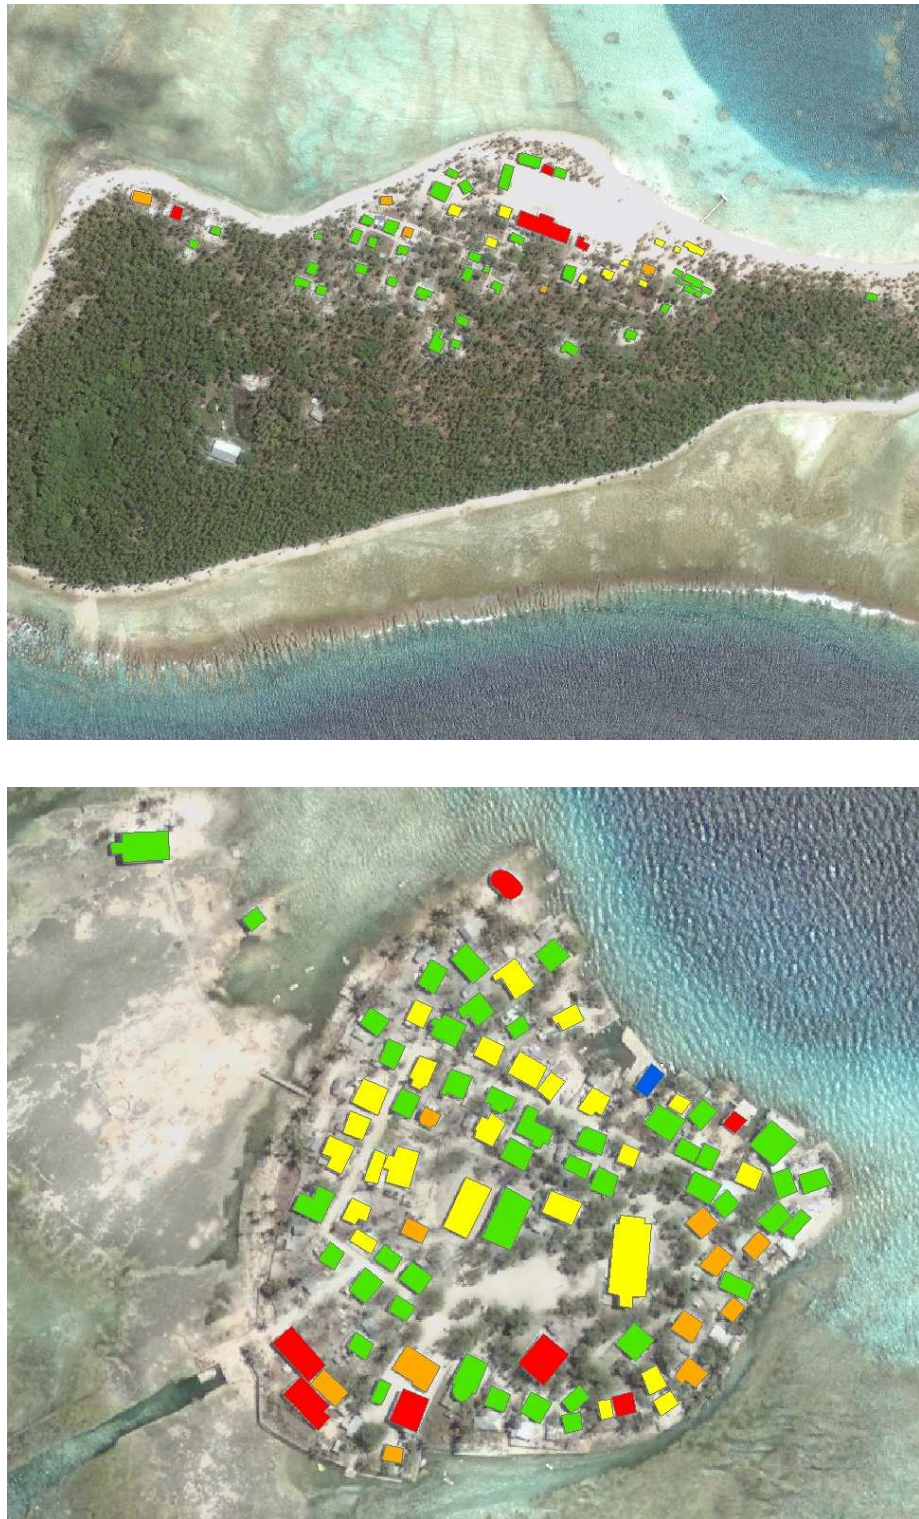
It was noted on all atolls that the level of damage to domestic property and contents was much less during Cyclone Percy than during past cyclone events that have caused substantial inundation of the inhabited sections of the motu. This is largely due to the practice following the introduction of the housing grant scheme, of raising floor levels either by constructing the water tank under the house, or raising the floor level with concrete piles or a raised concrete slab. Figures 23 to 24 summarise the number of houses and their approximate floor elevations (relative to the surrounding ground surface) for both Fale and Fenuafala.

Figure 24: Floor levels of all buildings relative to surrounding ground levels. Red = < 0.2 m, Orange = 0.2 – 0.5 m, Yellow = 0.5 – 1 m, Green = 1 – 2 m, and Blue = > 2 m.

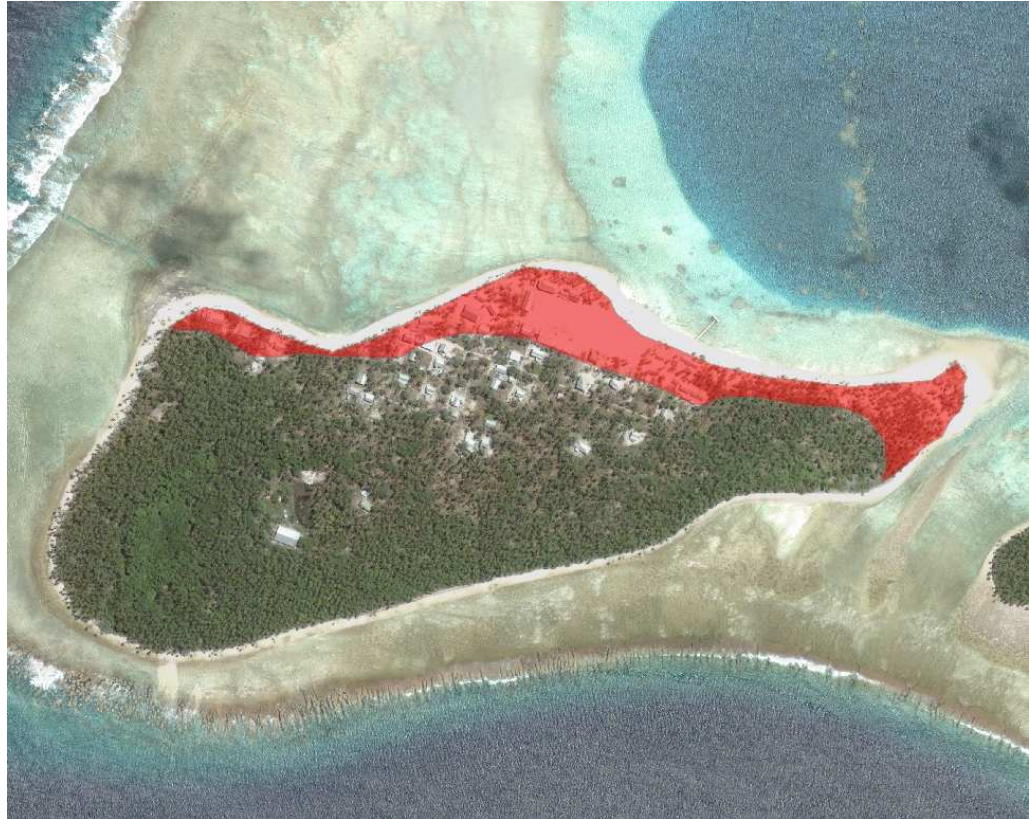
Figure 25: Approximate areas on Fenuafala (lagoon shore) inundated during Cyclone Percy. Note inundation will not have occurred at the same time at all locations. Overtopping of the beach crest is likely to have occurred along much of the ocean shore but does not appear to have caused inundation for any significant distance inland.

The main location where significant inundation occurred was along the lagoon shoreline of Fenuafala, particularly around the school. Given the low lying nature of the lagoon shore, which is a typical characteristic of such motu, inundation due to storm surge during cyclone events will occur, potentially up to around 1 m in depth above land level under most events (and potentially greater during a very severe event). During Cyclone Percy, the lack of vegetation resulted in much of the sand being stripped off the surface of the rugby pitch and surrounding areas.

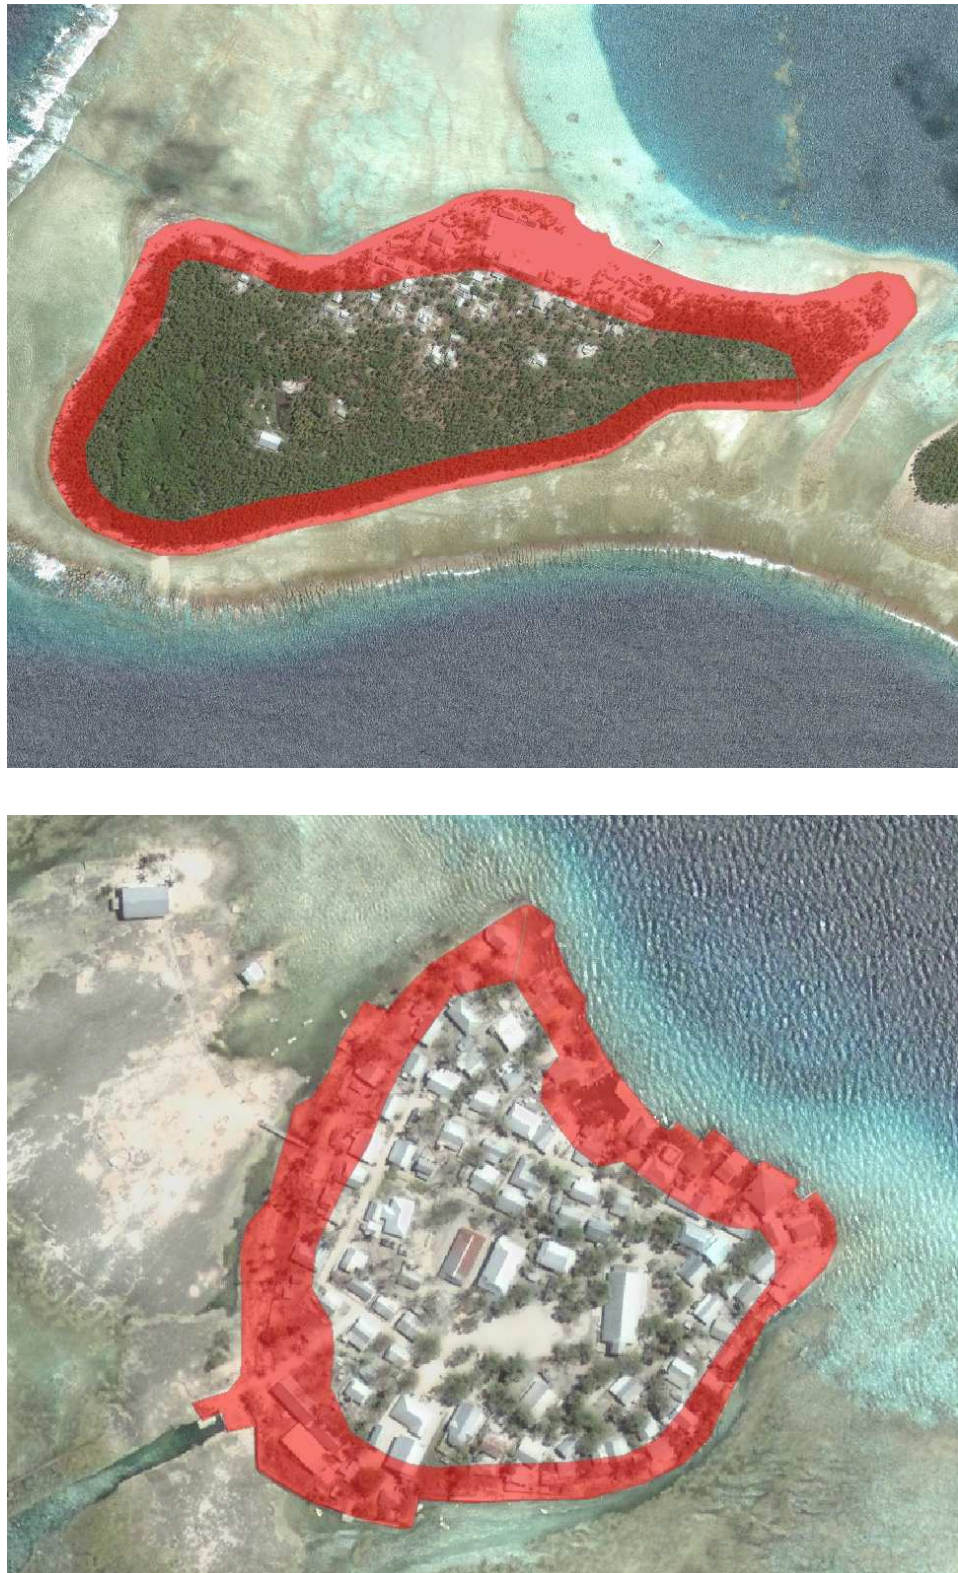
One of the most effective ways to reduce risk is avoiding building or locating essential infrastructure in areas that have been inundated during past cyclone events. From the inundation caused by Cyclone Percy, and from discussions with the community of inundation extents during previous cyclones, Figure 26 summarises for Fenuafala and Fale, in a simple format, the main areas within the villages that can be considered high hazard zones.

These are areas that could or have experienced inundation during past cyclones and can expected to be the areas most likely to be affected in future events. (Note: this does not mean that the areas that are not highlighted will not experience inundation, particularly in a future with accelerated sea-level rise).

On Fale the main damage is due to wave overtopping of the seawall structures. It is suggested that a 10 m wide zone landward from the crest of the seawall (or beach crest where it still remains, or seaward edge of land reclamation) be considered high risk and that the focus needs to shift from any further land reclamation activities to upgrading the standards of defences protecting the existing landmass.

Figure 26: Summary of land areas within Fenuafala (top) and Fale (bottom) at high risk from inundation. This does not imply areas not highlighted will not experience inundation.

Recommendation 8: As far as possible on Fale that no community buildings, land based infrastructure development or residential buildings be constructed with 10 m of the existing high water mark or seawall crests (high hazard red zone shown in Figure 26 above).

Whilst it cannot be stressed strongly enough, it is vital to ensure that further residential property is not constructed within the high hazard zones identified in Figure 26. If for a particular reason this cannot be avoided consideration should be given to the use of piled foundations, ensuring that the piles are well founded to withstand overwashing forces, braced where necessary, and have sufficient structural connection to the main structural frame of the house.

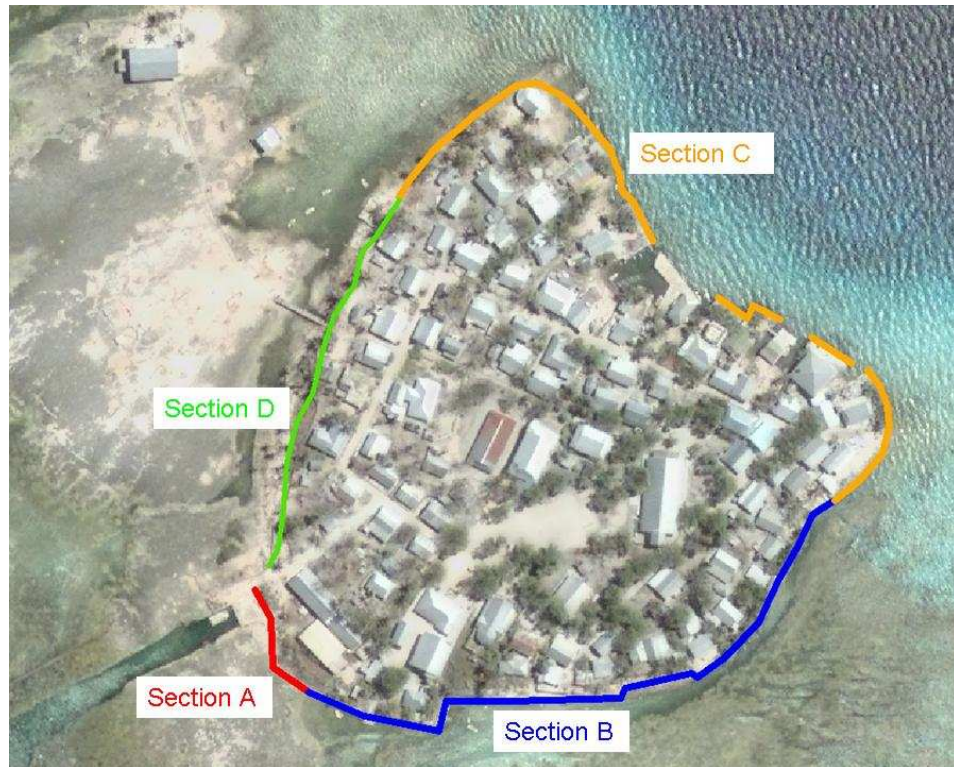
Figure 27 Summary of defence sections for different seawall design profiles around Fale (See Figures 28 to 32 for details)

Different seawall sections will be required at different points around Fale, depending on whether it is a lagoon shoreline or ocean, is fronted by *te papa* etc. Figure 27 summarises the four main sections and, based on the lessons learned (detailed above)

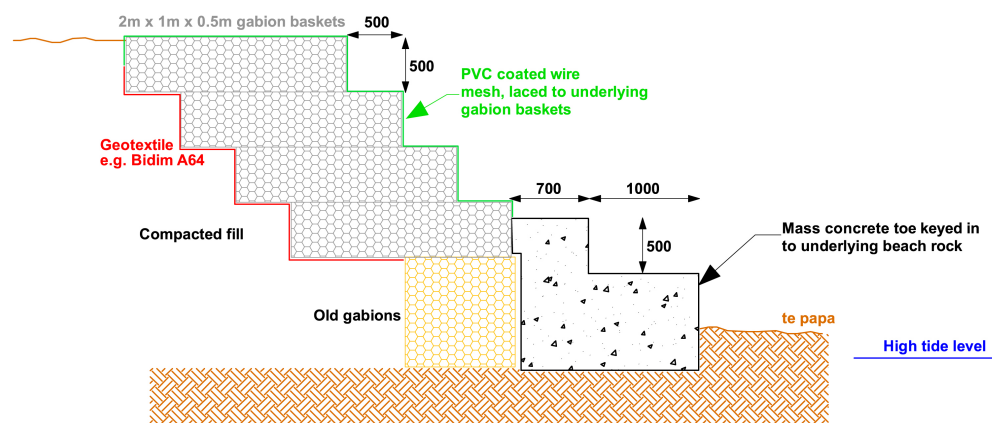
Figure 28: Proposed outline design cross-section along Section A of the Fale shoreline. Dimensions in mm unless stated.

This section is located on top of the raised reef rock (*te papa*). As the toe is founded on the *te papa* it is above normal high tide levels. However, a small, stepped concrete toe beam located in front of the existing gabion wall and keyed in to at least 300 mm in to the *te papa* will be required. The gabions should be stacked to form a stepped profile with at least a 500 mm tread (larger if possible, such as shown in Figure 28).

The gabions profile could be extended higher as long as land levels behind the defence were also raised to be level with the top of the seawall. A concrete crest beam (similar to that shown in Figure 29) could also be placed to further improve structural stability at the crest but again should extend much above the land level behind the wall.

Cost: \$1,131 per linear metre (\$1,390 with mass concrete crest beam)

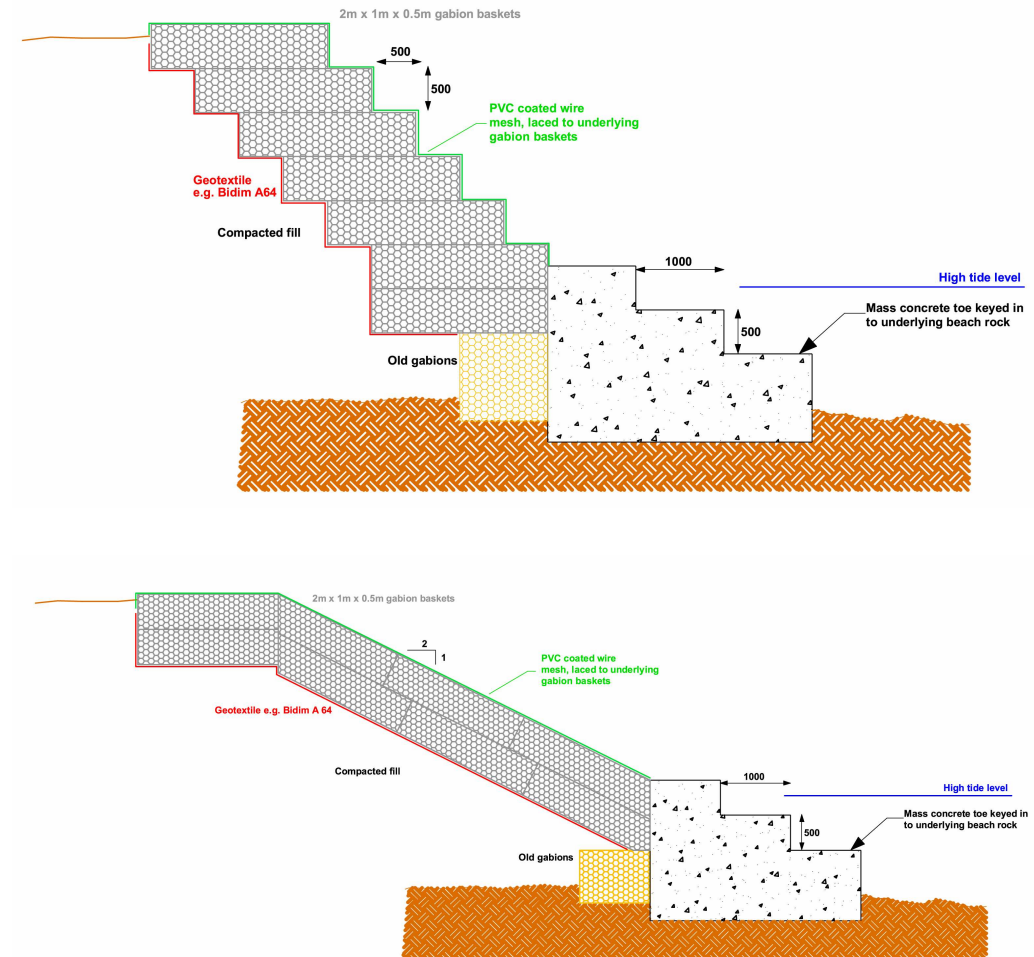
Figure 30: Proposed outline design cross-section along Section B (Fale) for a stepped gabion profile (top) and a sloping gabion profile (bottom). Dimensions in mm unless otherwise stated.

Construction of the gabions could either be stepped (Figure 30 top as described in Section A above) or sloping (Figure 30 bottom). The sloping structure is less prone to damage and easier to maintain but may be more difficult to construct initially. The slope should be at least 1:2 with two layers of the 0.5 m thick gabions used. However, it is important to appreciate that the sloping option will take up more land.

As with Section A, the gabions profile could be extended higher as long as land levels behind the defence were also raised. A concrete crest beam (similar to that shown in Figure 29) could also be placed to further improve structural stability at the crest.

Cost (sloping profile): \$2,547 per linear metre (\$2,806 with mass concrete crest beam)

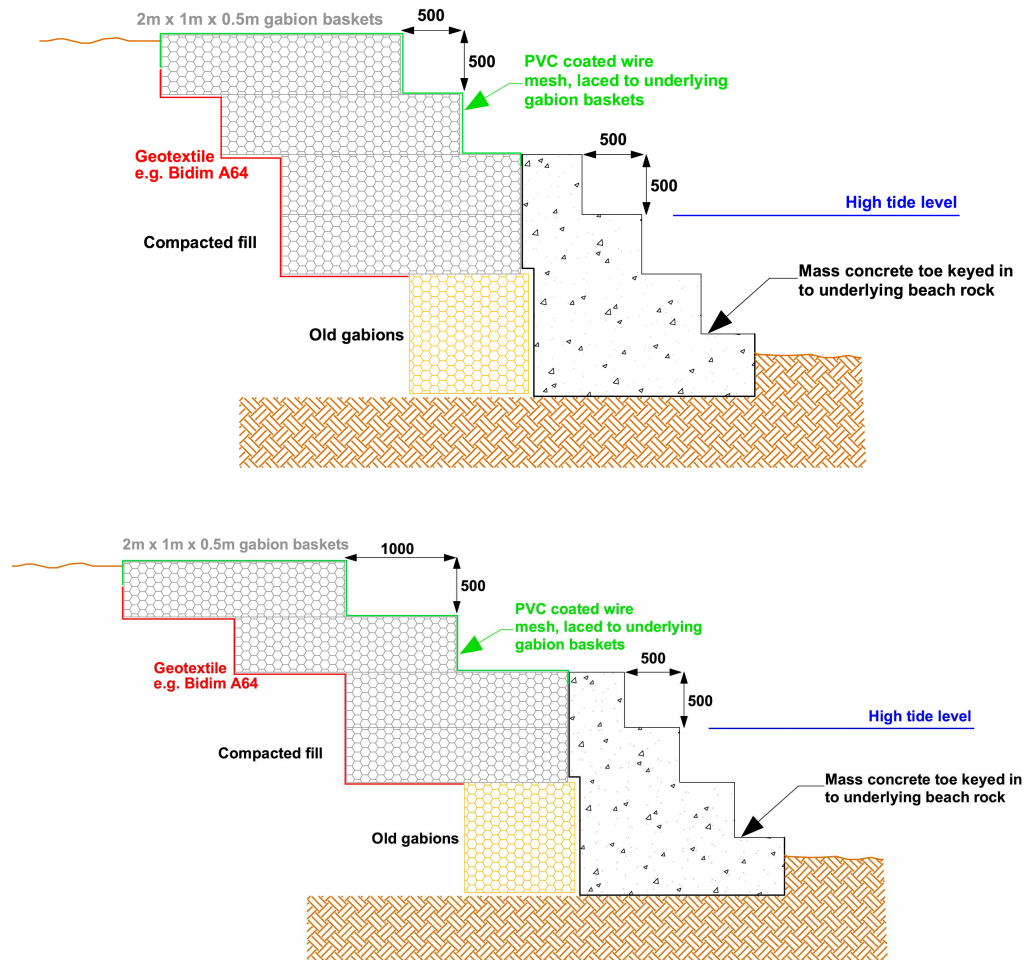
The extent of reclamation out towards the edge of the back reef has resulted in the toe of the defences being in relatively deep water making them difficult to found properly and more exposed to wave damage. However wave conditions generated within the lagoon will tend to be less damaging than those experienced on the ocean side. As a result a steeper stepped mass concrete toe is suggested than that outlined in section B above.

Figure 31 Possible configurations of defences along the lagoon shoreline (Section C) with the main difference being the tread of the upper gabions. Dimensions in mm unless otherwise stated.

As with the other sections, the gabions could either be stepped or sloping, the degree of which depending on available land and could be extended higher as long as land levels behind the defence were also raised. A concrete crest beam (similar to that shown in Figure 29) could also be placed to further improve structural stability at the crest.

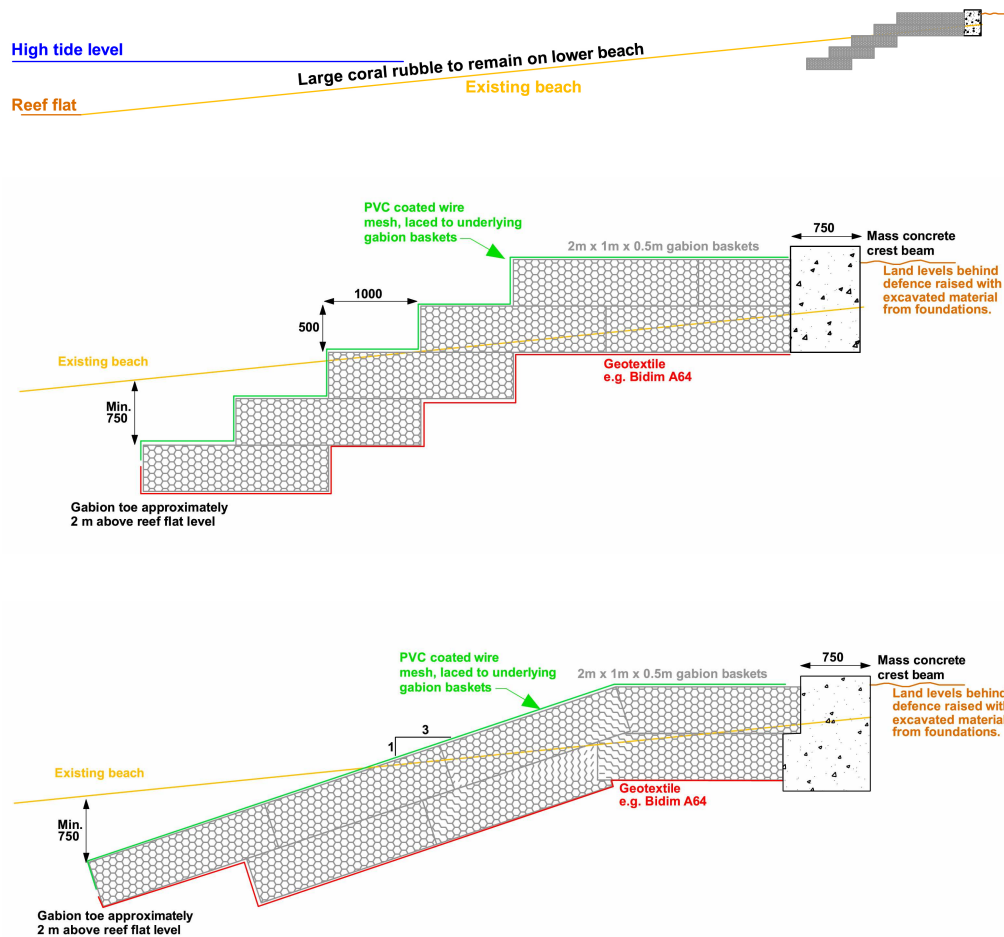
Figure 32 Potential defence cross-sections along the northern coastline of Fale (Section D). The top figure shows the location of the defence relative to the beach and reef. The defence can be constructed using either a stepped (middle) or alternatively a sloping (bottom) gabion profile. Dimensions in mm unless otherwise stated.

Figure 32 summarises potential design cross sections for the northern coastline. The primary aim is to provide increased protection to the properties along this coastline from potential scouring of foundations of significant wave damage. It does not aim to reclaim land over the beach, with the lower section of the beach being an integral component of the scheme.

The toe of the defence should be around 2 m above the level of the reef flat (above the level of normal high tides). The toe needs to be buried by at least 0.75 – 1 m or down to any underlying beach rock to prevent any toe scour resulting in damage to the structure. Given the relatively low elevation of the land upon which the first row of

properties are located it is suggested that the fill excavated from the foundation be used to build up land levels behind the defence to allow the crest elevation of the structure to be increased. A wider crest and concrete crest beam will help prevent damage to the crest and help reduce overtopping volumes.

The gabion defence could be either stepped or sloping but it is recommended that a consistent cross-section be used along the entire length of the defence.
